# LAWSON ARMY AIRFIELD STORMWATER ASSESSMENT AND CAPITAL IMPROVEMENT PLAN

Prepared for: **Columbus Water Works**

File: 3577421  
June 30, 2017

**BWSC** | BARGE  
WAGGONER  
SUMNER &  
CANNON, INC.®

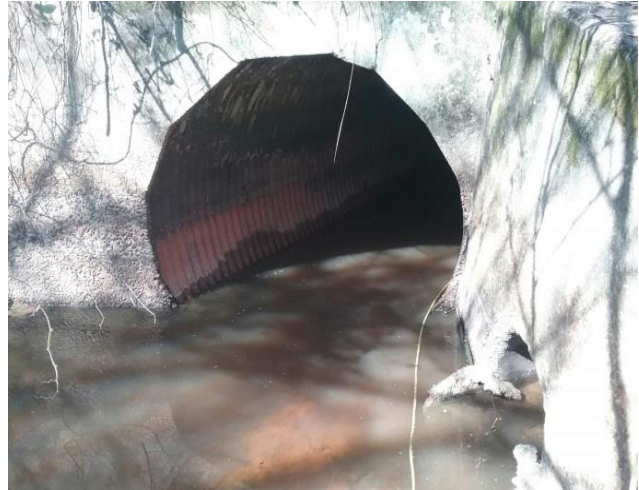
Repairs were recommended for structures and storm drains with Grades 4 and 5 due to the imminent or current failure. Several different issues contributed to Grade 4 assets depending on the storm drain material. As mentioned previously, a combination of the following defects often led to the assignment of a Grade 4 asset: holes, settled deposits, infiltration with sinkholes, joint separation, missing coating, and rusted surfaces (Figure 18). Additionally, multiple headwalls need to be repaired due to cracking or other various issues, as shown in Figure 19.

**Figure 18: Rusted CMP**

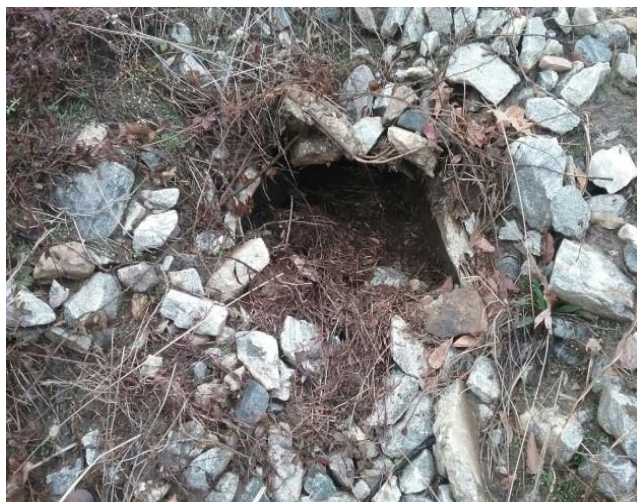
**Figure 19: Defective Headwall**

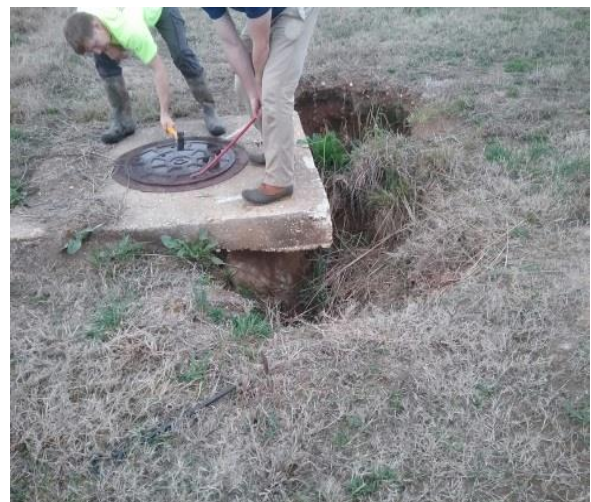
**Figure 20: Sinkhole**

Grade 5 was most often assigned to assets that had failed, classified by collapse, holes, etc. Additionally, Grade 5 was assigned when pipes are bricked up, but infiltration is causing above ground sinkholes as shown in Figure 20 above. These pipes need to be removed or filled. In addition to storm drains, structures that were categorized as Grade 5 included inlets which need to be removed and replaced (Figure 21), and headwalls which need to be rebuilt (Figure 22).

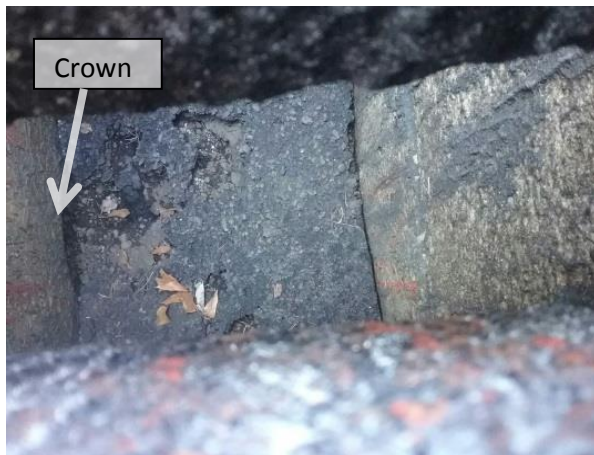
**Figure 21: Inlet Full of Asphalt to Pipe Crown**

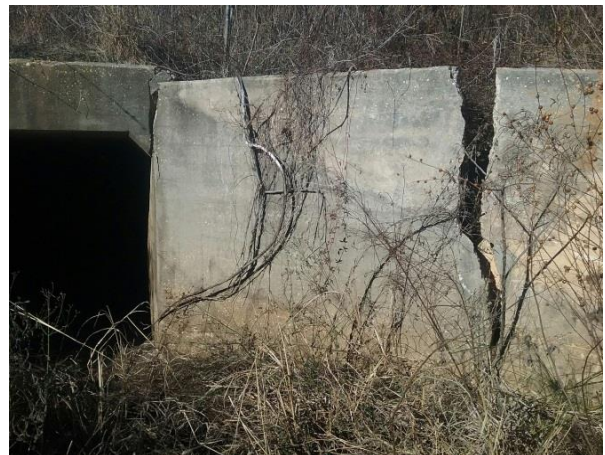
**Figure 22: Cracked Headwall**

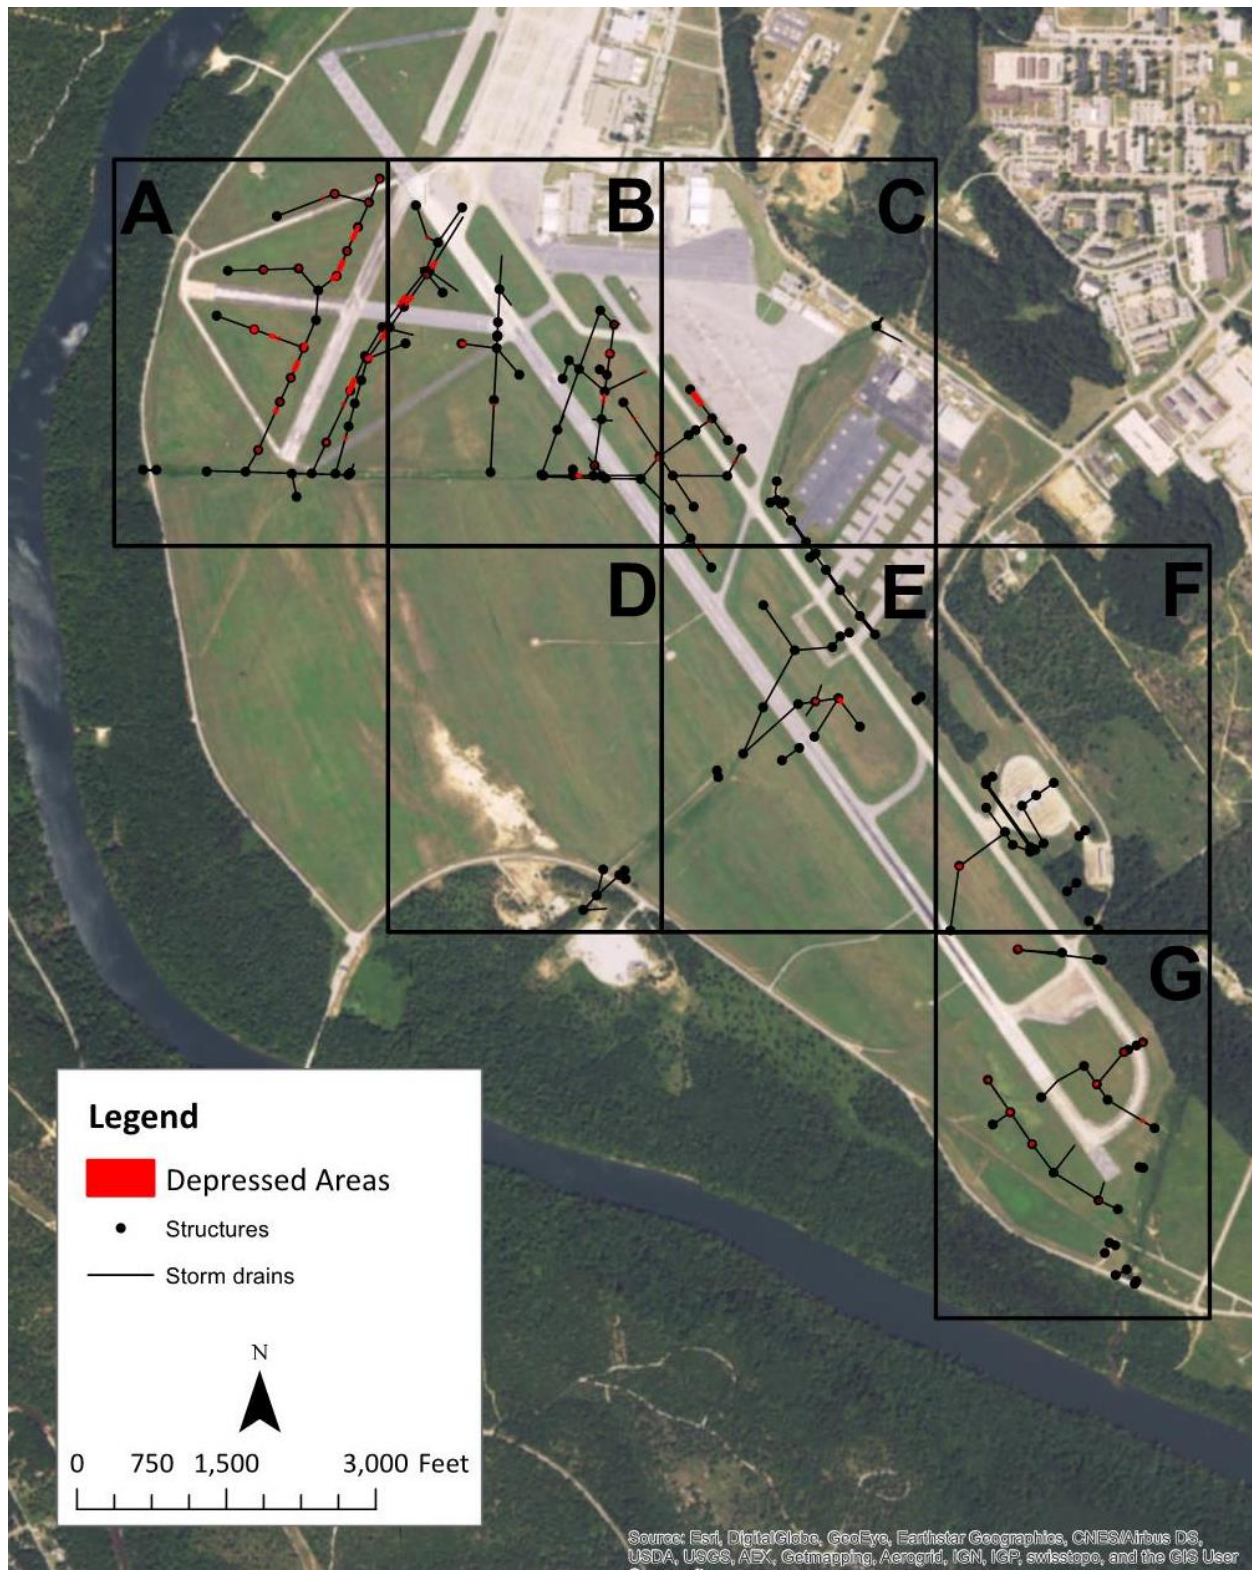
**Figure 23: Lawson Army Airfield Depressed Areas**

Figure 23 illustrates the depressed areas identified during our field work within the study area. When compared with the condition assessment of the storm drain pipes, it was discovered that the depressed areas were not largely due to pipe collapses, but rather infiltration in pipe joints or poorly compacted soils which have consolidated over time. Due to these findings, depressed areas throughout LAAF are recommended to be addressed according to three different criteria:

1. In situations where there is a depressed area above a pipe with no detectable infiltration of sediment into the pipe, remove the soil above the pipe and replace the soil in compacted lifts (imported soil will be utilized to match adjacent grades as necessary).
2. In situations where there is a sinkhole present over pipes with significant infiltration of sediment into the pipe and for instances in which the pipe diameter is large enough for man entry, the recommended repair is to either wipe the joints with mortar, use internal mechanical joint sealants, or Spraycast. Then, remove the soil above the pipe and replace

- the soil in compacted lifts (imported soil will be utilized to match adjacent grades as necessary).
3. In situations where there is a sinkhole present over pipes with significant infiltration of sediment into the pipe and for instances in which the pipe diameter is **not** large enough for man entry and Spraycast is not possible, the recommended repair is CIPP. Then, remove the soil above the pipe and replace the soil in compacted lifts (imported soil will be utilized to match adjacent grades as necessary).

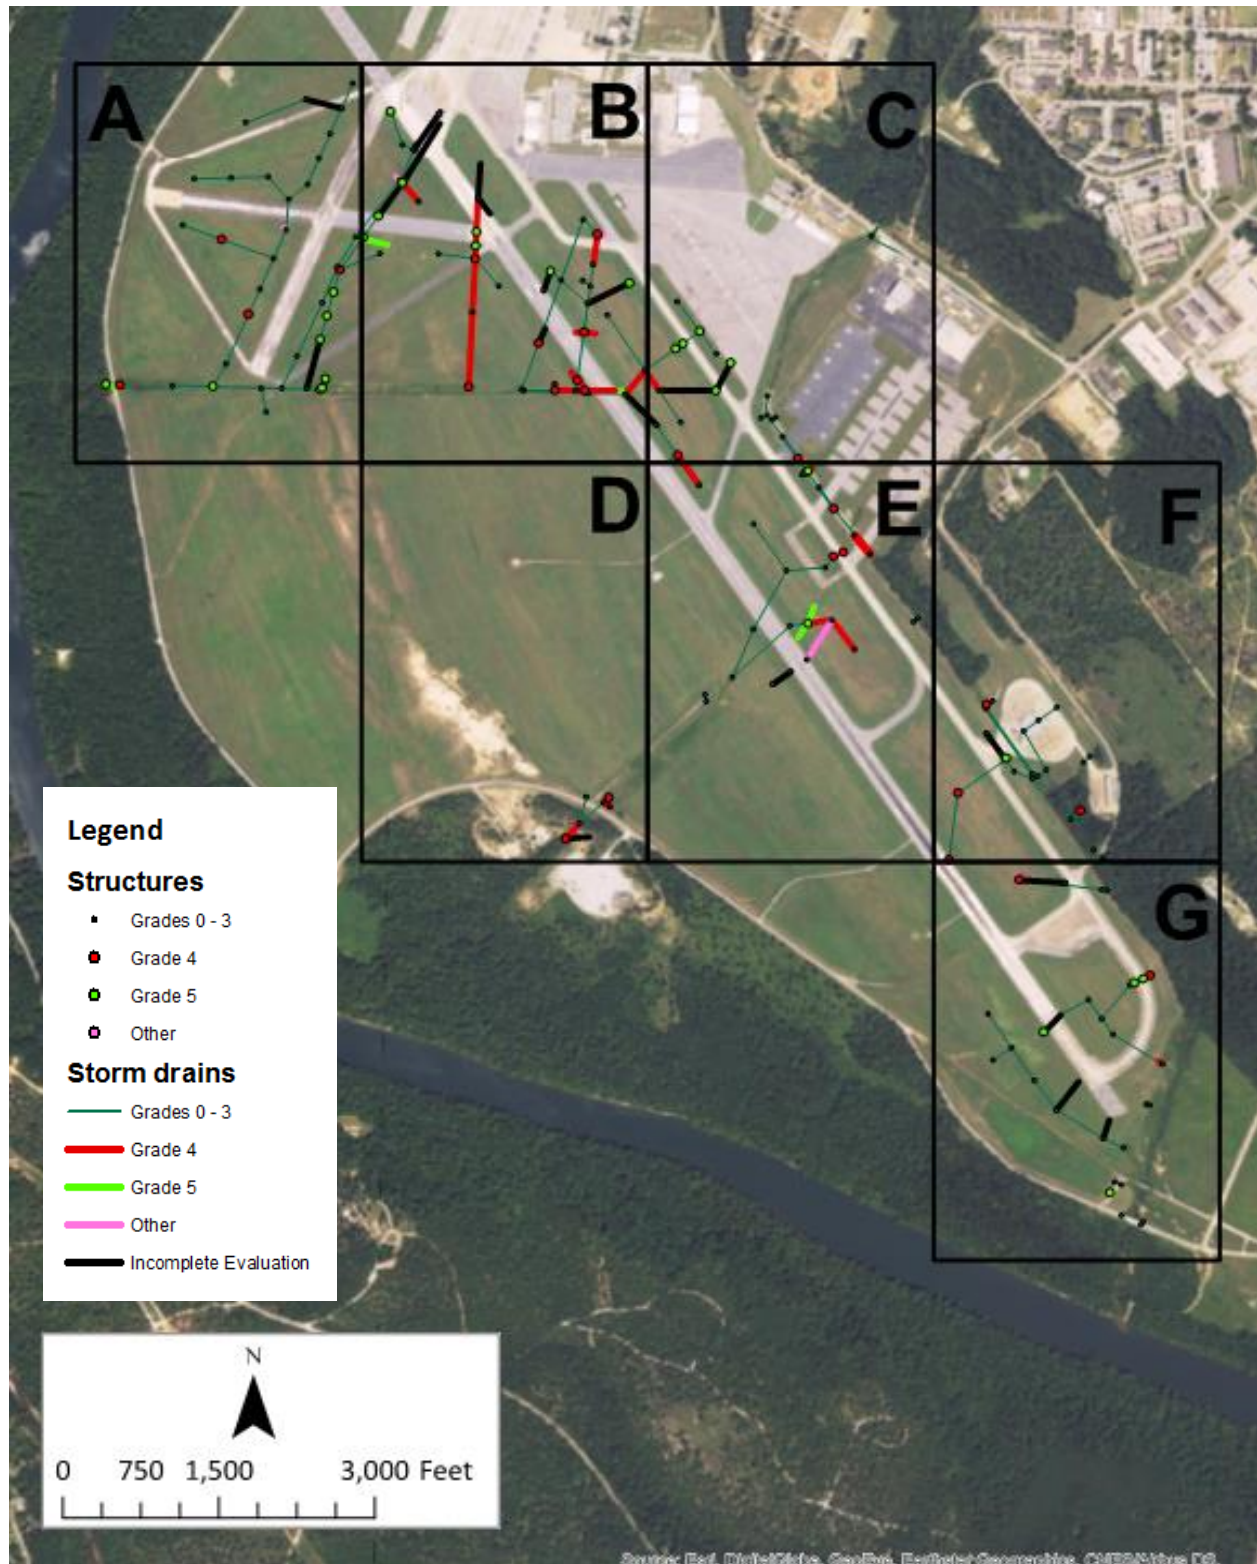
Figure 24: Overview of Assets with Recommended Repairs

Storm structures and storm drains which received a Grade 4 or 5 in the condition assessment (see Figure 24), pipes which need to be upsized as indicated by the hydraulic capacity analysis, and the identified depressed areas are recommended for repair. The recommended repairs have been broken down into two recommended projects based on the type of work required:

1. Open trench replacement and earthwork

## 2. Trenchless rehabilitation

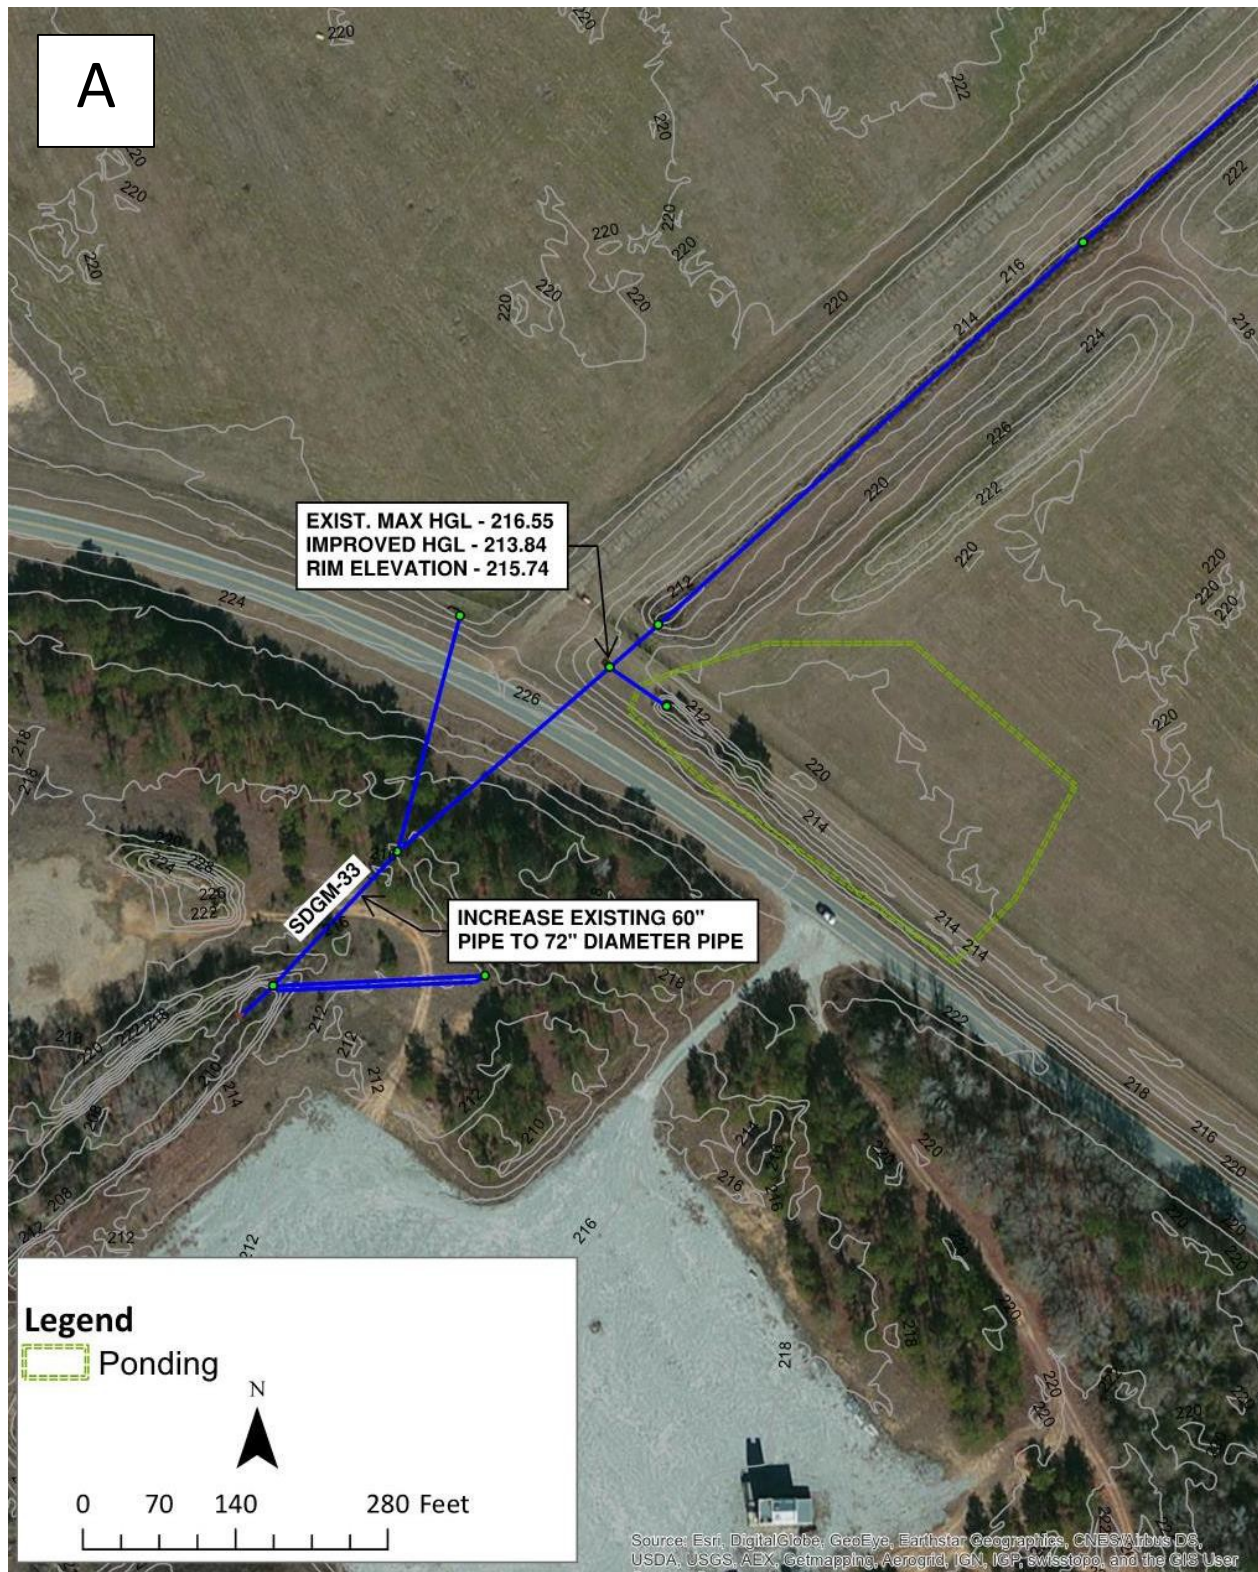
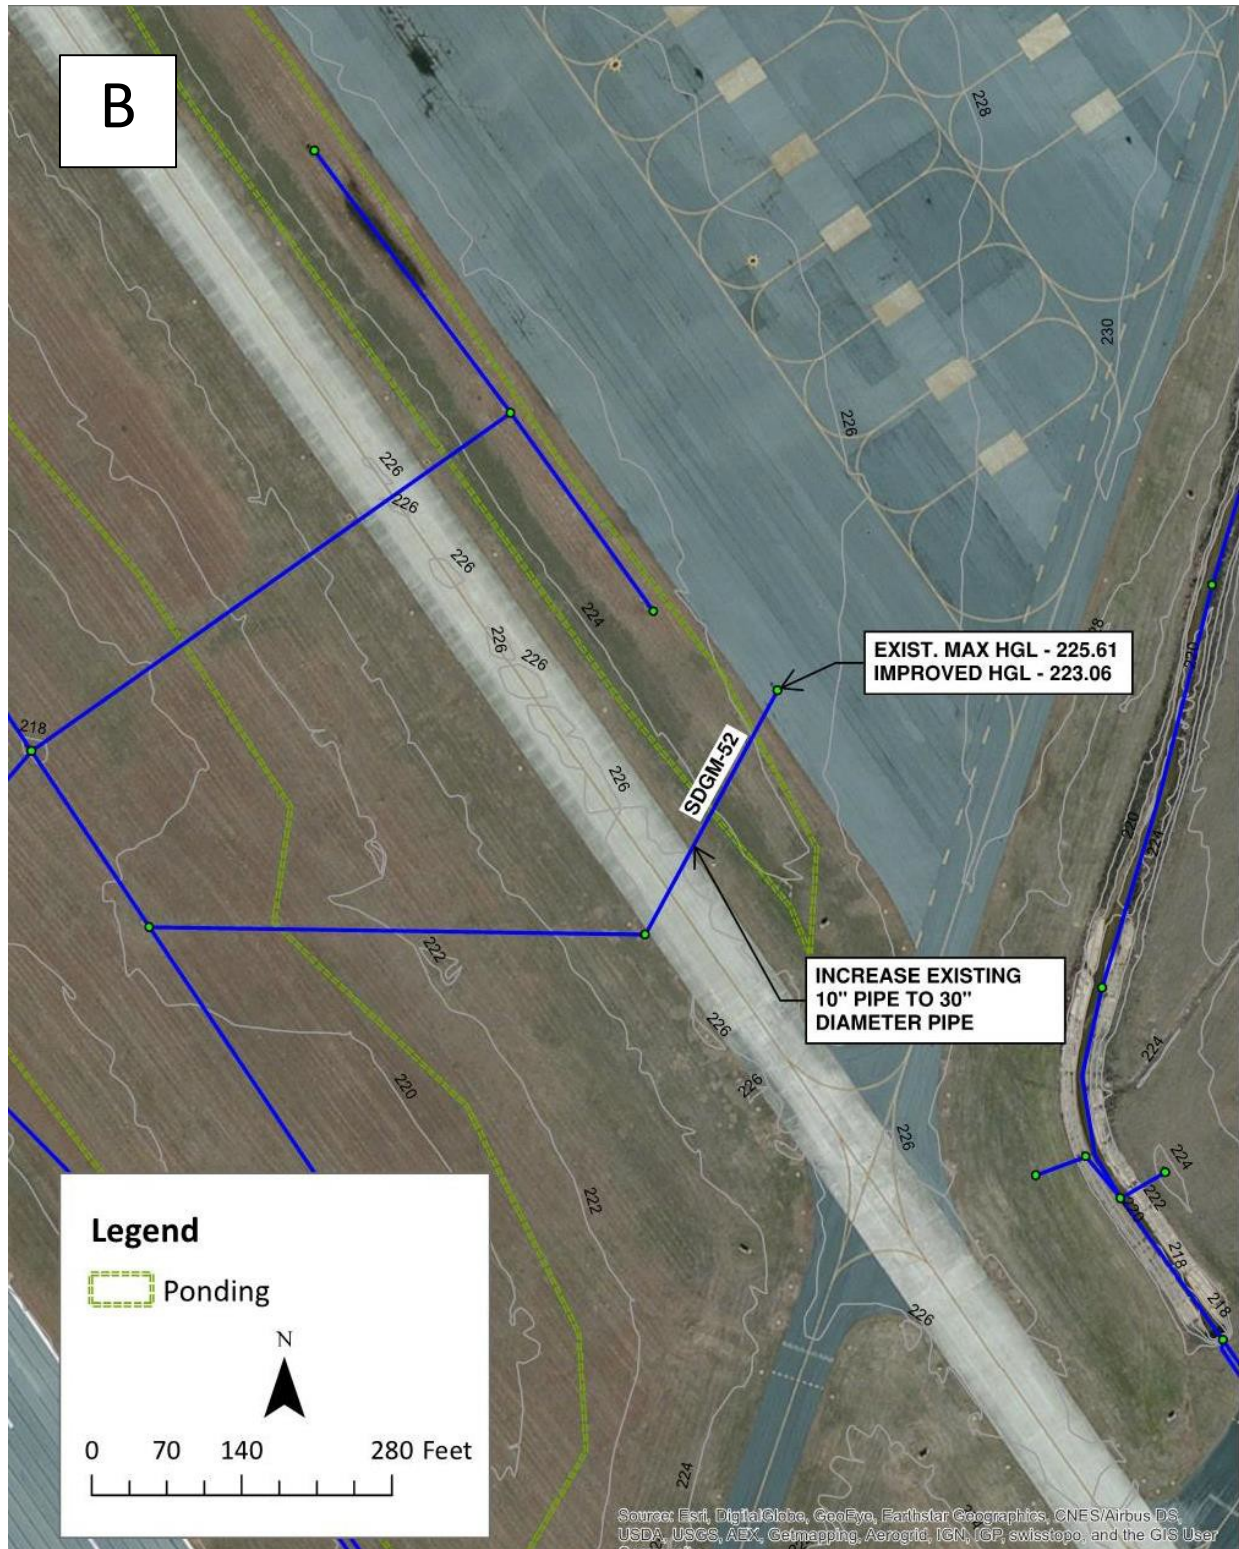
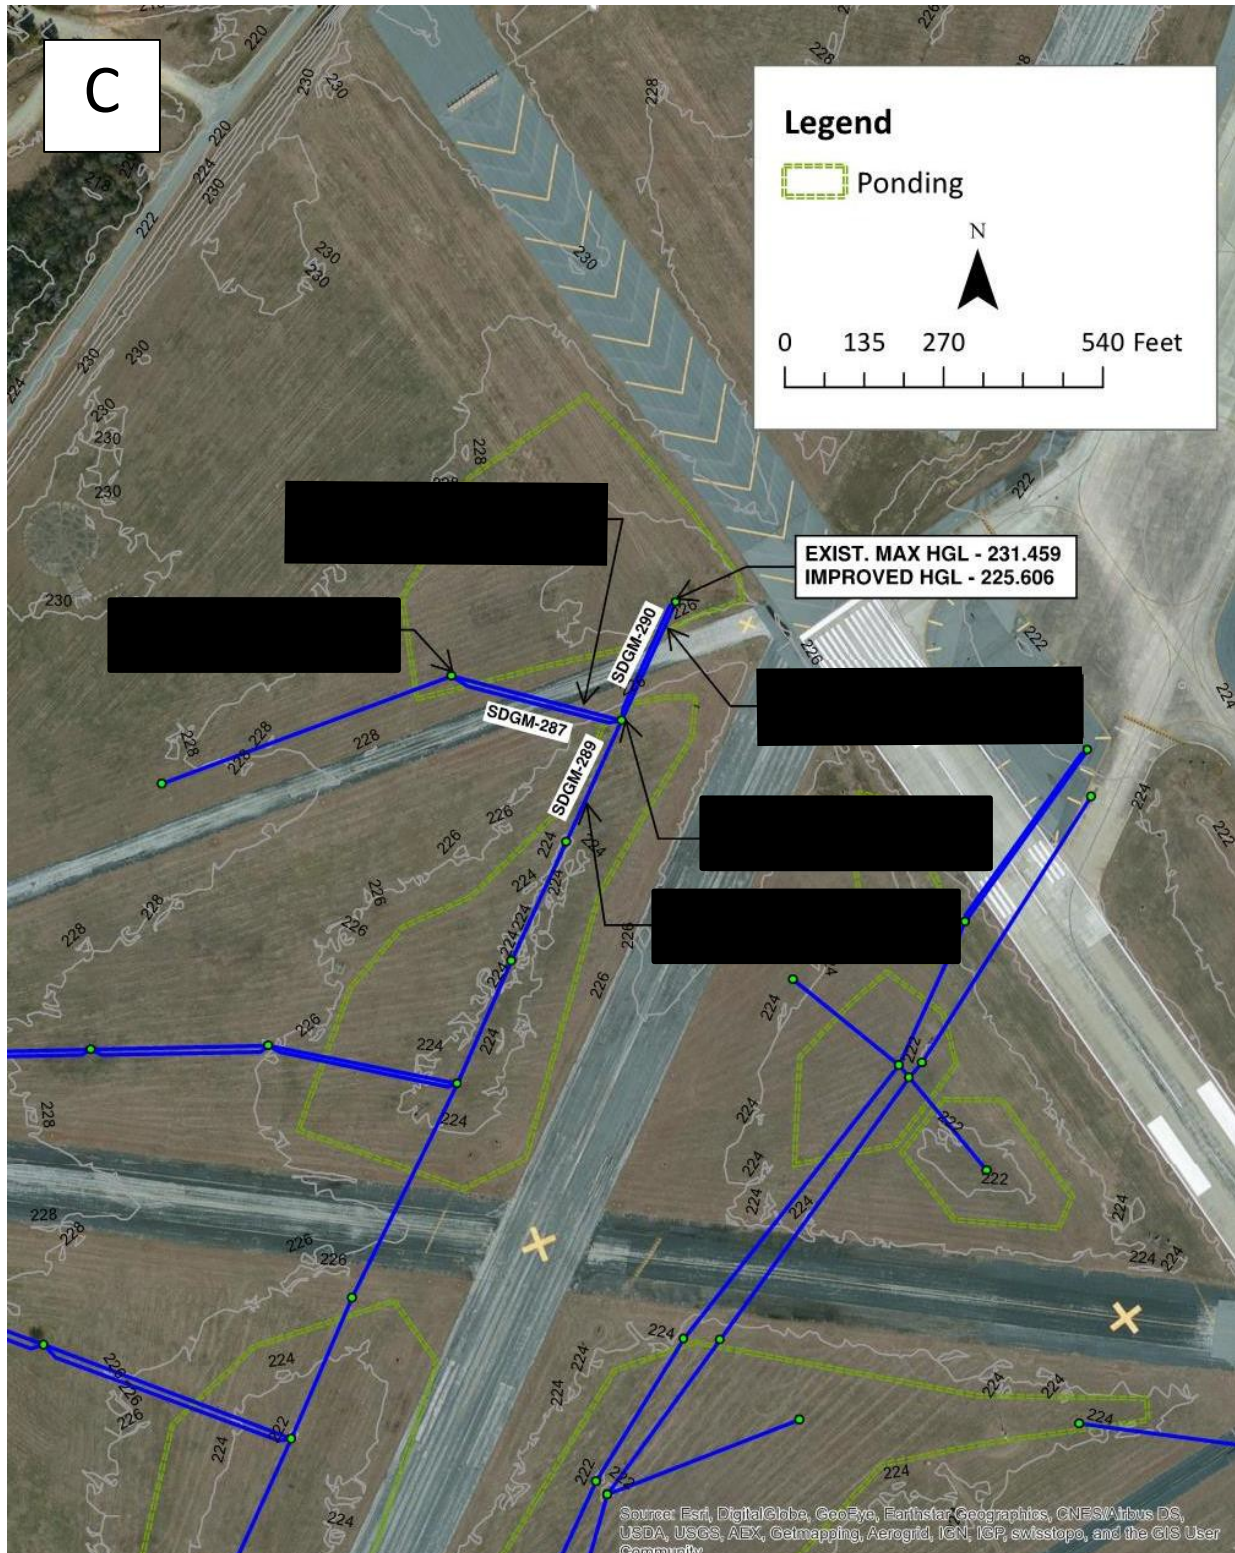
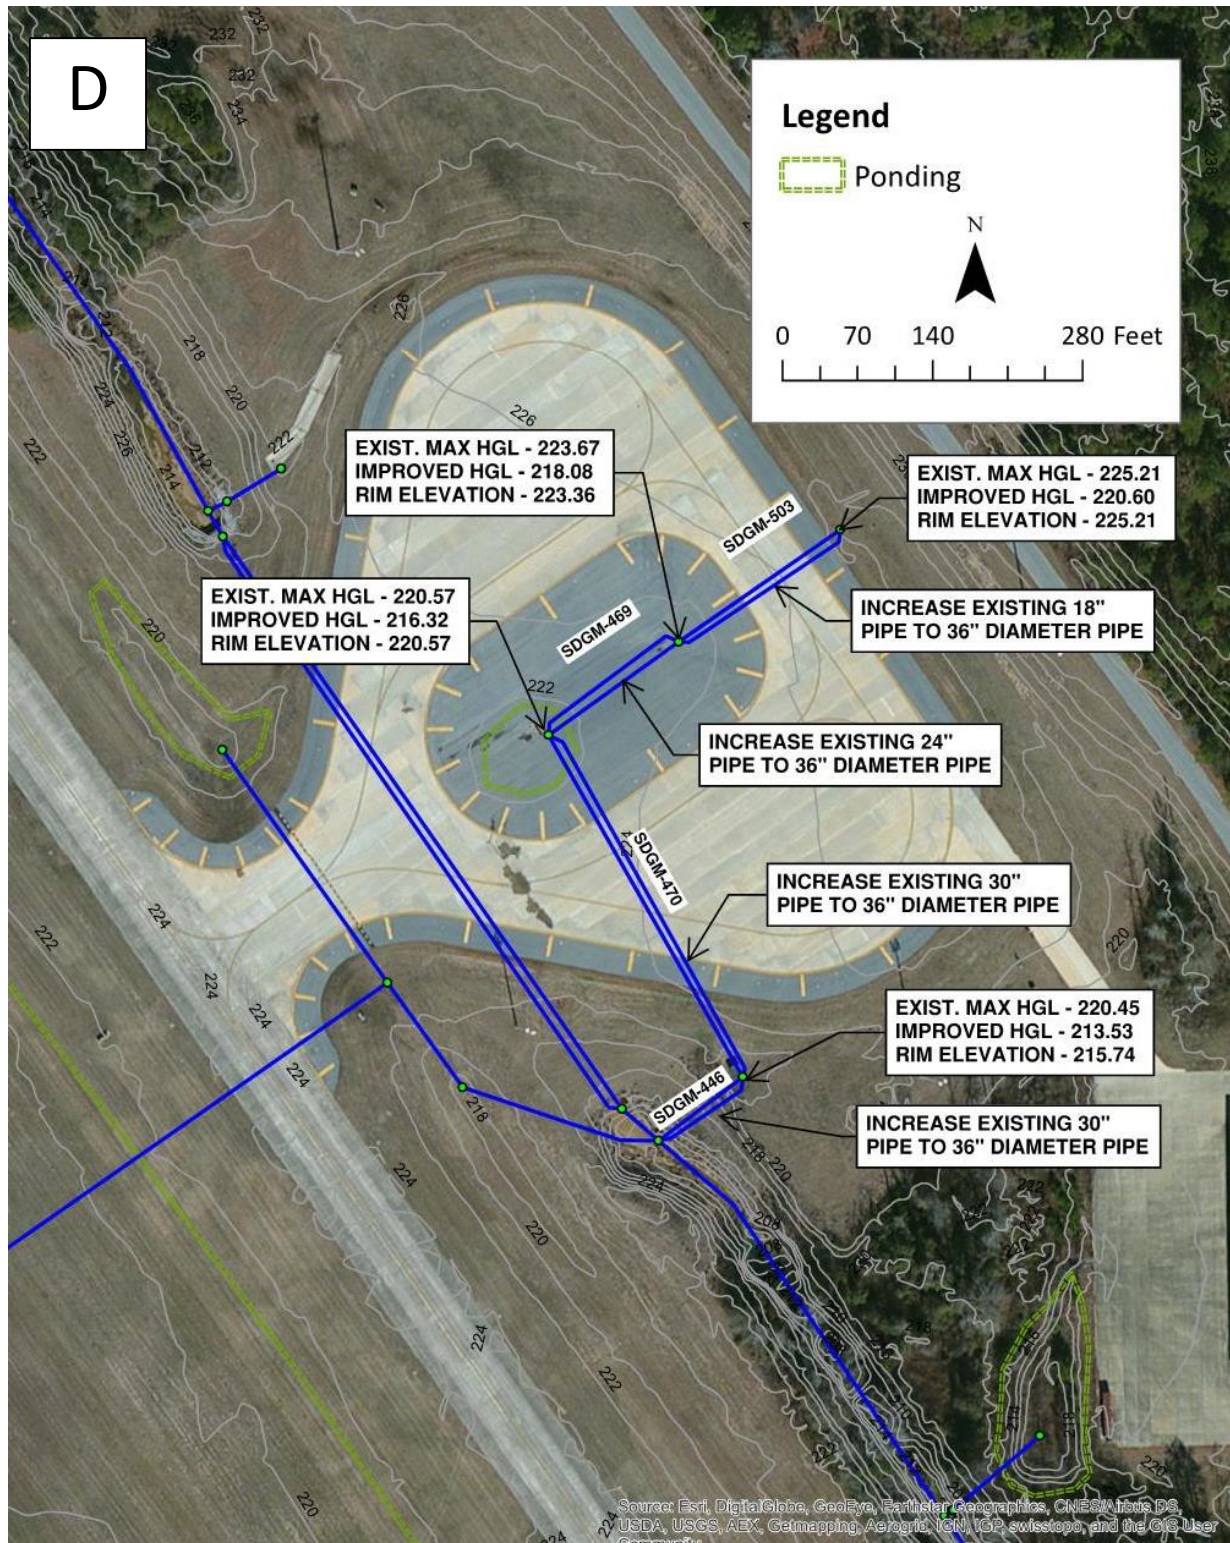
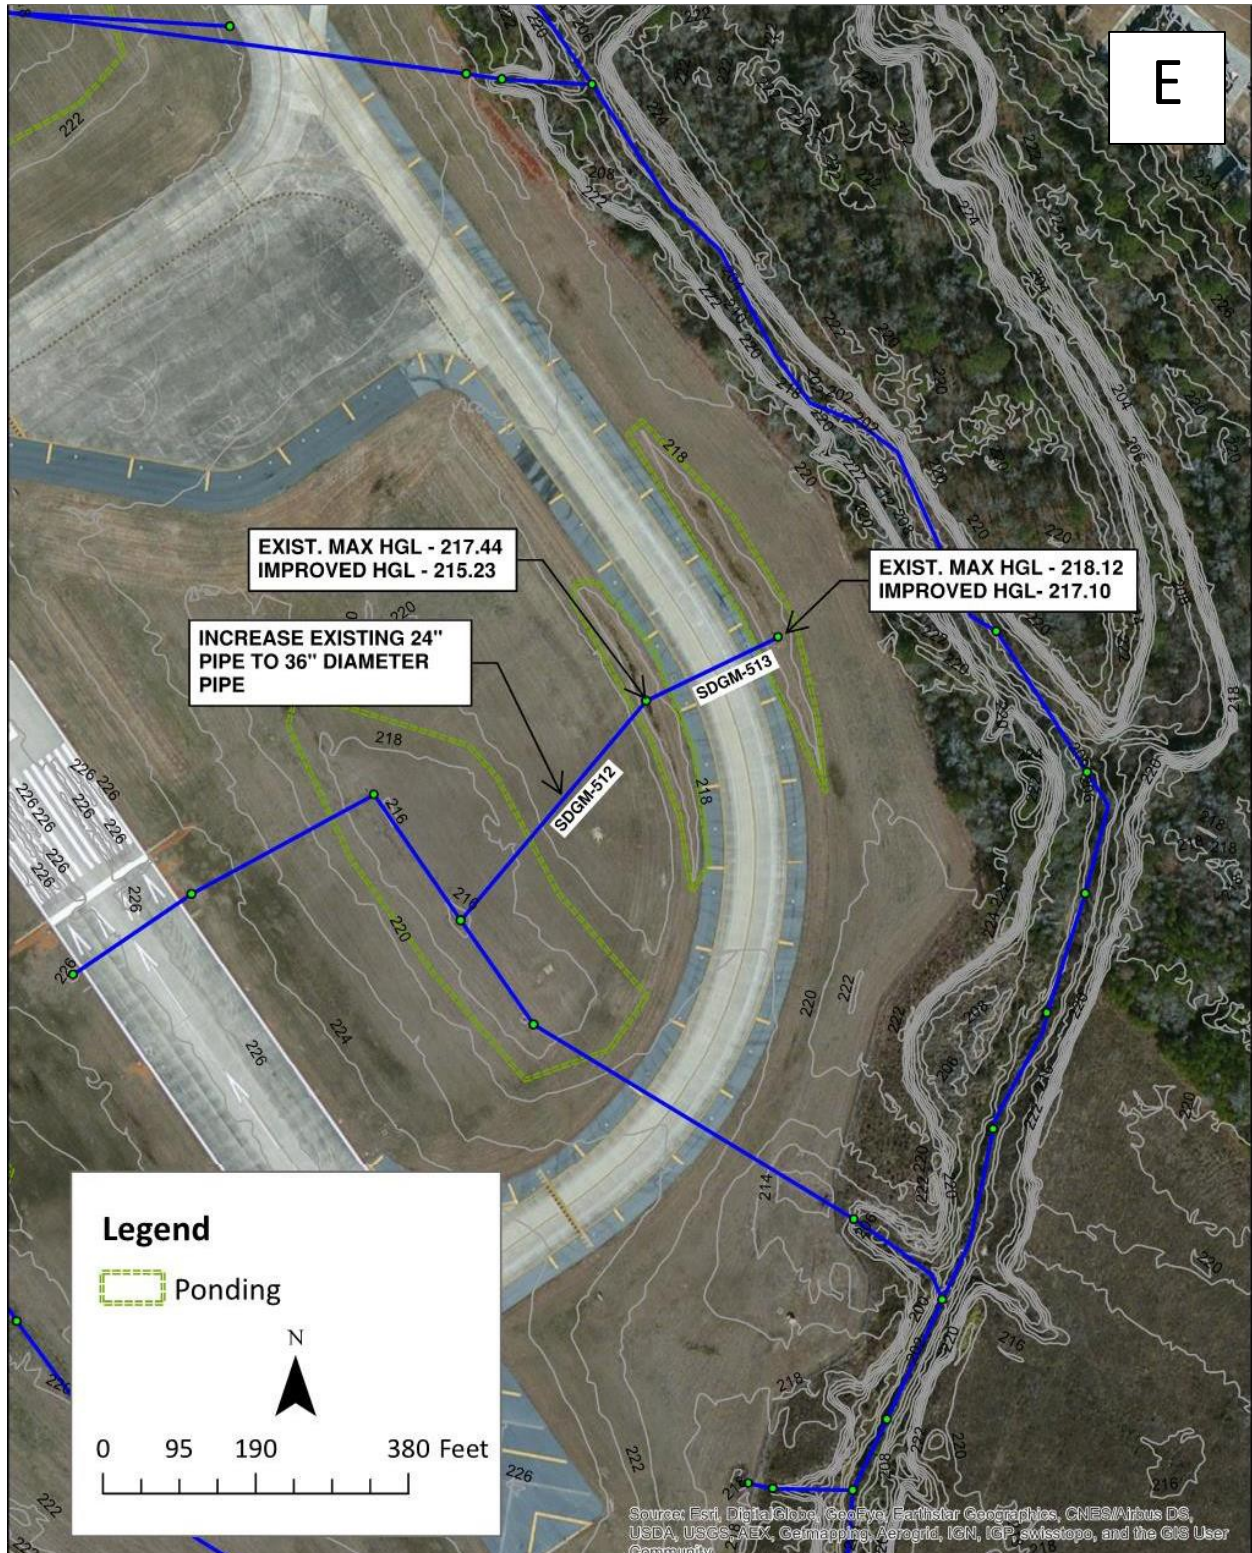
## **APPENDIX E: HYDRAULIC CAPACITY IMPROVEMENTS A-E**

replaced with a larger pipe. 10 pipes met this criteria and it is therefore recommended that these pipes be replaced with larger diameter pipes as proposed in Table 2. Attached in Appendix E, Figures A-E show the improvements when the pipe was upsized based on sizes in the table. The recommended improvements either eliminated or minimized overflows to appropriate ponding elevations in suitable areas for the 25-year, 24-hour design storm considered in this analysis.
