# LAWSON ARMY AIRFIELD PHASE II/MAIN POST PHASE I STORMWATER ASSESSMENT AND CAPITAL IMPROVEMENT PLAN

Prepared  
For: Columbus Water Works

September 2018

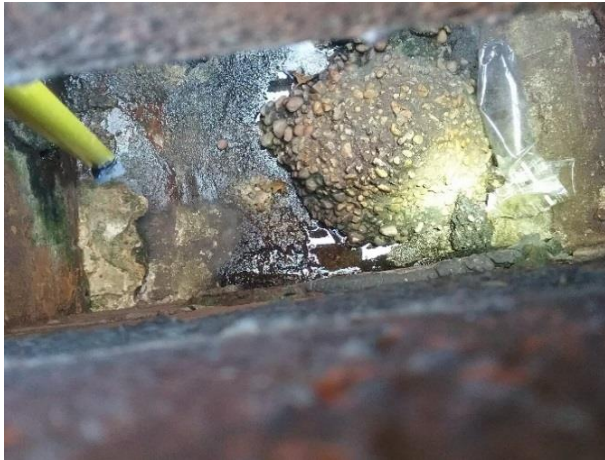
Replacement or repair was recommended for structures and storm drains with Grades 4 and 5 due to current or imminent failure. Several issues contributed to Grade 4 assets depending on the storm drain material. As previously described, a combination of the following defects often led to the assignment of a Grade 4 asset: holes, settled deposits (Figure 27, Figure 28), infiltration with sinkholes, joint separation, rusted surfaces (Figure 29), and missing coating (Figure 30).

**Figure 27: Concrete Deposits**

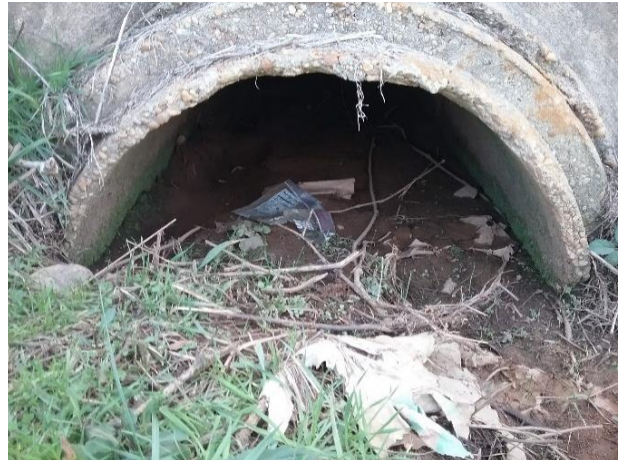
**Figure 28: Settled Deposits**

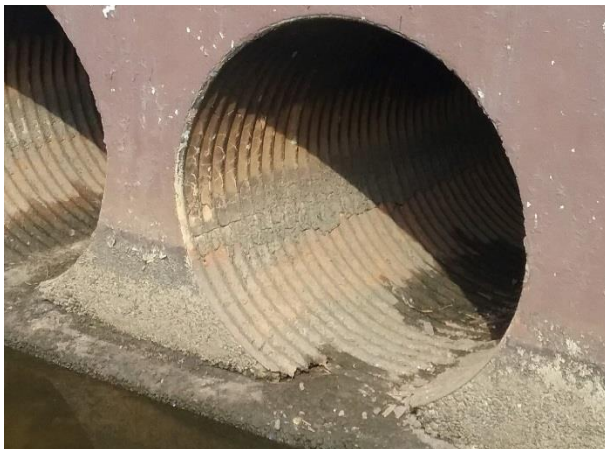
**Figure 29: Rusted Invert**

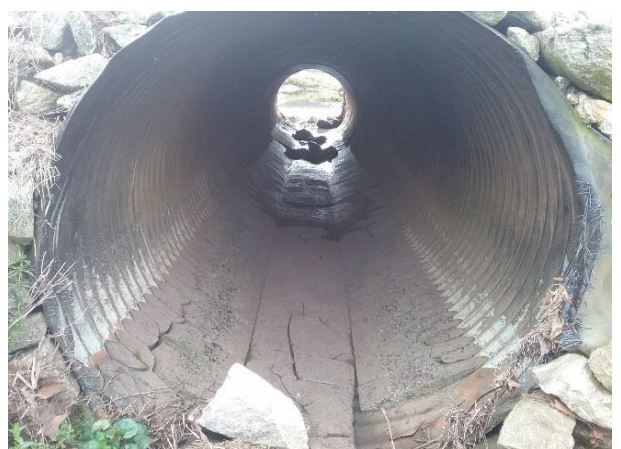
**Figure 30: Missing Coating**

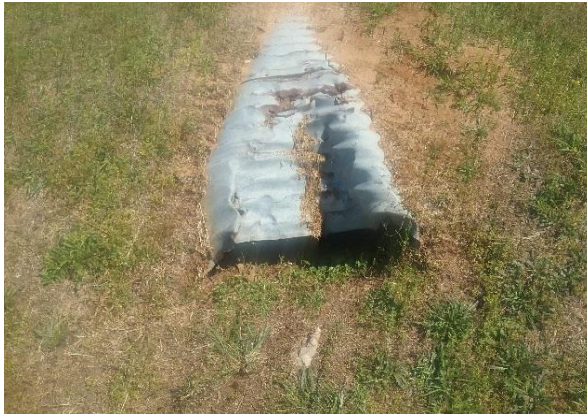
Grade 5 was assigned to assets that had failed, classified by crushed pipes (Figure 31), broken pipes (Figure 32), major holes, etc. In addition to storm drains, structures that were categorized as Grade 5 included inlets which need to be removed and replaced (Figure 33), headwalls which need to be rebuilt (Figure 34), and flumes which were cracked and washed out (Figure 35).

**Figure 31: Crushed Pipe**

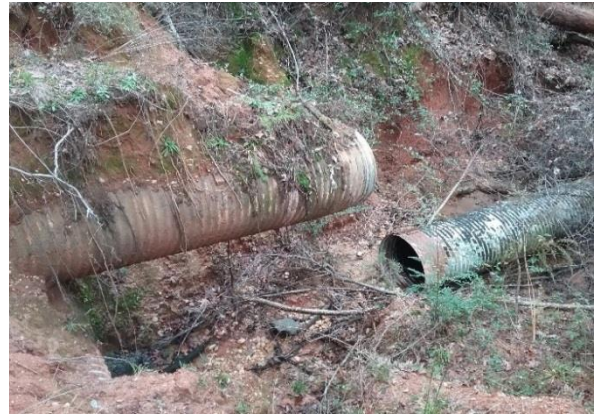
**Figure 32: Broken Pipe**

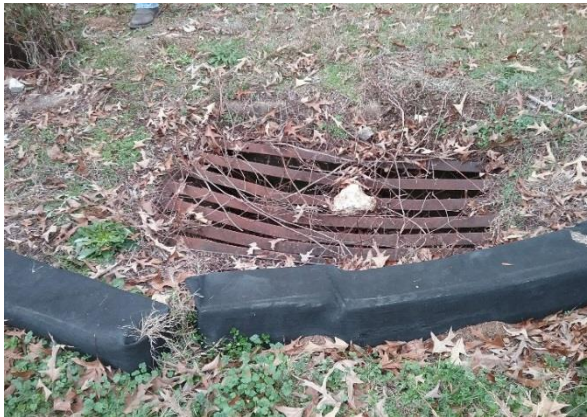
**Figure 33: Damaged Grate**

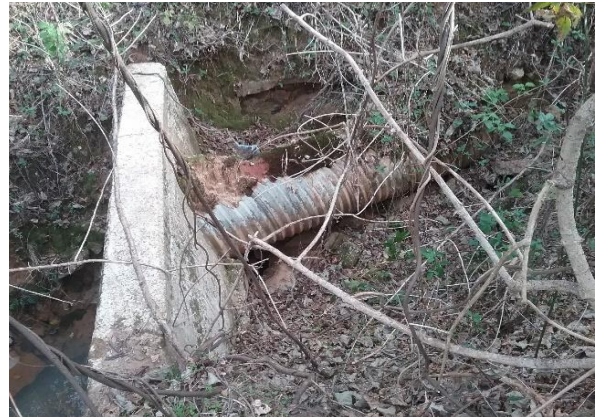
**Figure 34: Damaged Headwall**

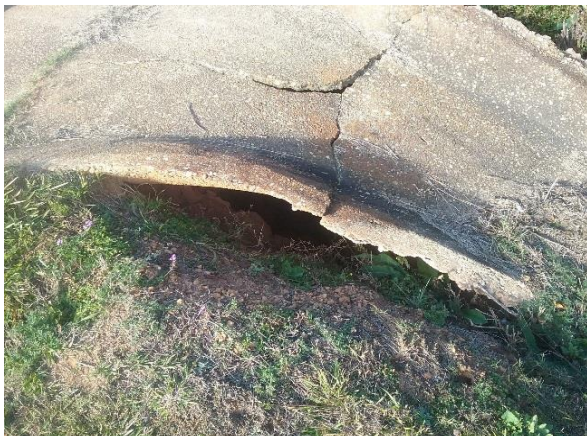
**Figure 35: Cracked Flume with Erosion**
