# LAWSON ARMY AIRFIELD STORMWATER ASSESSMENT AND CAPITAL IMPROVEMENT PLAN

Prepared for: **Columbus Water Works**

File: 3577421  
June 30, 2017

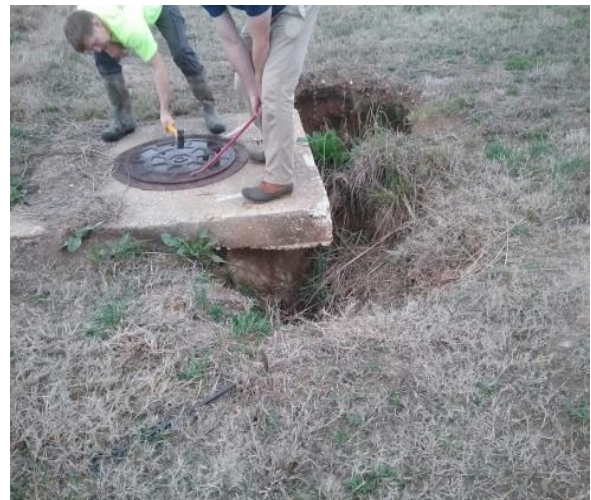
**Figure 20: Sinkhole**

Grade 5 was most often assigned to assets that had failed, classified by collapse, holes, etc. Additionally, Grade 5 was assigned when pipes are bricked up, but infiltration is causing above ground sinkholes as shown in Figure 20 above. These pipes need to be removed or filled. In addition to storm drains, structures that were categorized as Grade 5 included inlets which need to be removed and replaced (Figure 21), and headwalls which need to be rebuilt (Figure 22).

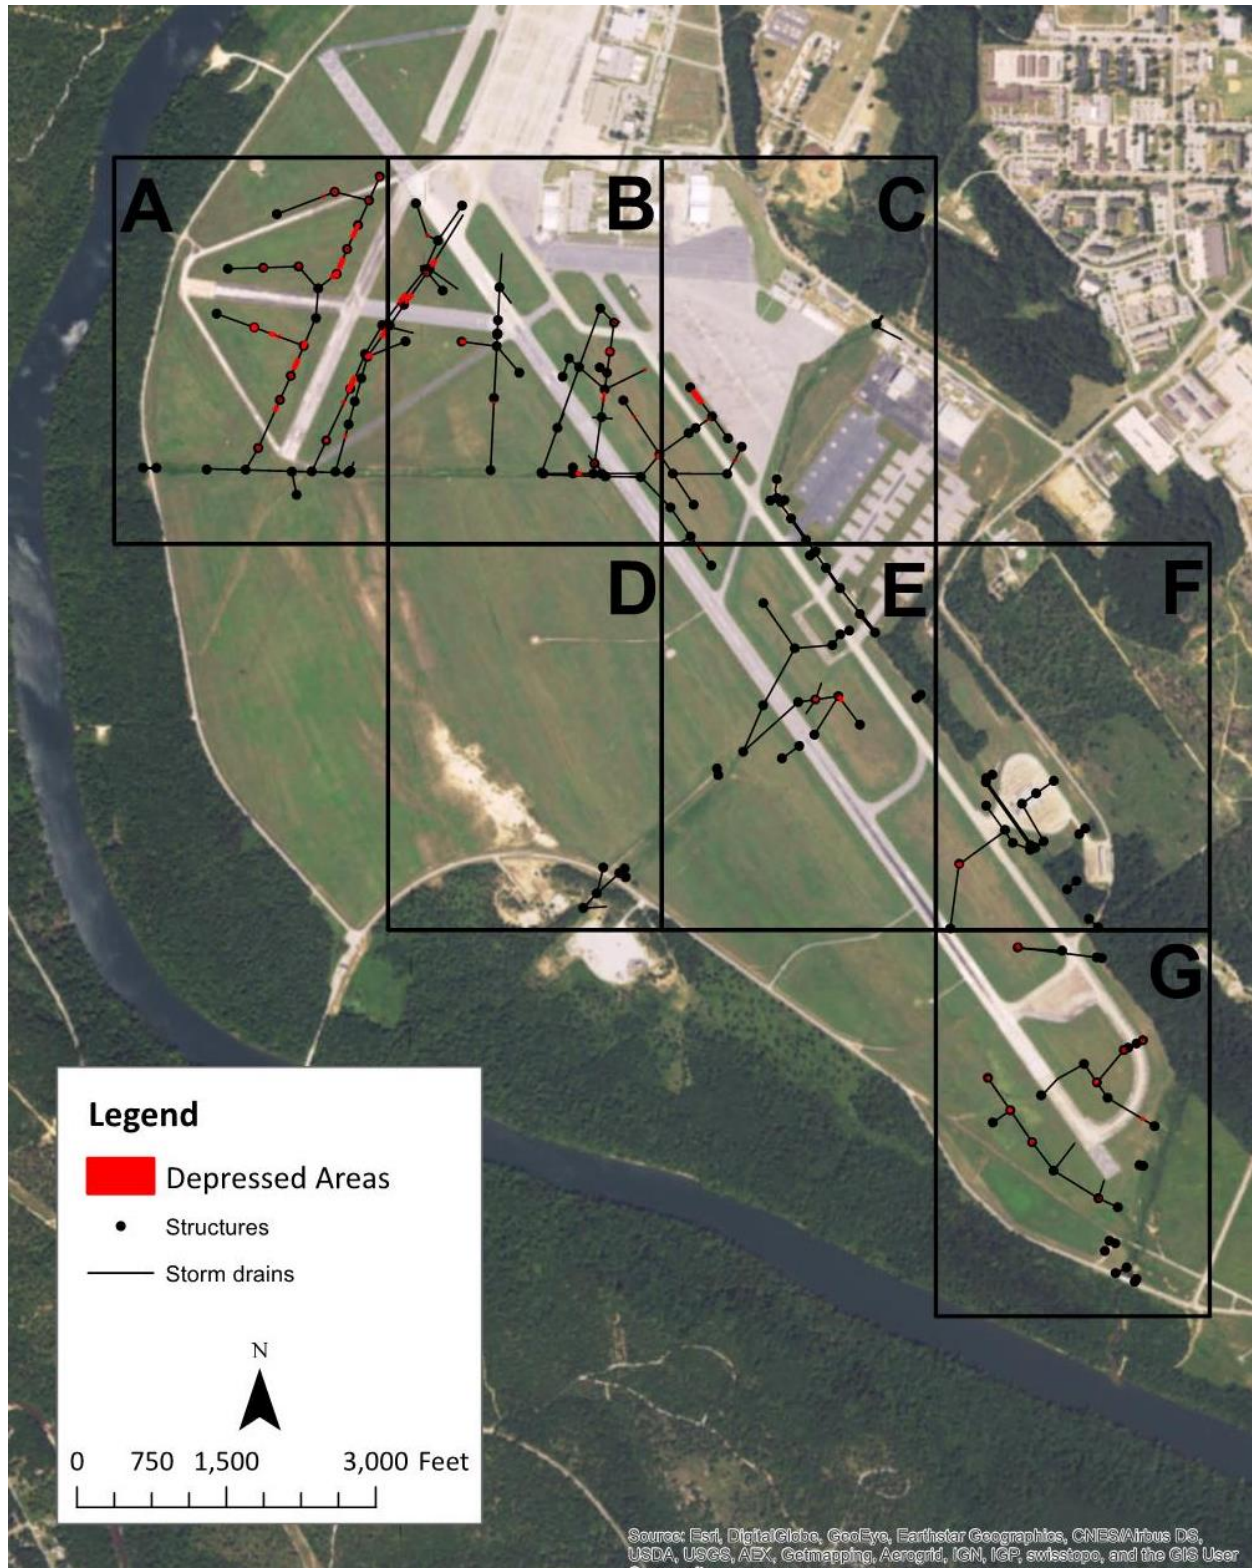
**Figure 23: Lawson Army Airfield Depressed Areas**

Figure 23 illustrates the depressed areas identified during our field work within the study area. When compared with the condition assessment of the storm drain pipes, it was discovered that the depressed areas were not largely due to pipe collapses, but rather infiltration in pipe joints or poorly compacted soils which have consolidated over time. Due to these findings, depressed areas throughout LAAF are recommended to be addressed according to three different criteria:

1. In situations where there is a depressed area above a pipe with no detectable infiltration of sediment into the pipe, remove the soil above the pipe and replace the soil in compacted lifts (imported soil will be utilized to match adjacent grades as necessary).
2. In situations where there is a sinkhole present over pipes with significant infiltration of sediment into the pipe and for instances in which the pipe diameter is large enough for man entry, the recommended repair is to either wipe the joints with mortar, use internal mechanical joint sealants, or Spraycast. Then, remove the soil above the pipe and replace

- the soil in compacted lifts (imported soil will be utilized to match adjacent grades as necessary).
3. In situations where there is a sinkhole present over pipes with significant infiltration of sediment into the pipe and for instances in which the pipe diameter is **not** large enough for man entry and Spraycast is not possible, the recommended repair is CIPP. Then, remove the soil above the pipe and replace the soil in compacted lifts (imported soil will be utilized to match adjacent grades as necessary).
