# LAWSON ARMY AIRFIELD PHASE II/MAIN POST PHASE I STORMWATER ASSESSMENT AND CAPITAL IMPROVEMENT PLAN

Prepared  
For: Columbus Water Works

September 2018

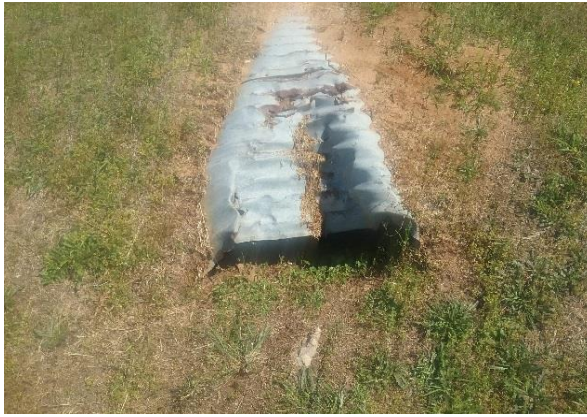
Grade 5 was assigned to assets that had failed, classified by crushed pipes (Figure 31), broken pipes (Figure 32), major holes, etc. In addition to storm drains, structures that were categorized as Grade 5 included inlets which need to be removed and replaced (Figure 33), headwalls which need to be rebuilt (Figure 34), and flumes which were cracked and washed out (Figure 35).

**Figure 31: Crushed Pipe**

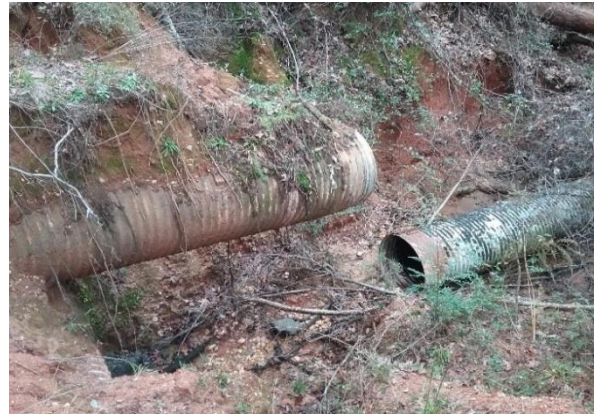
**Figure 32: Broken Pipe**
