**The Road Inventory  
of  
Cape Hatteras National Seashore  
CAHA – 5190  
Cycle 4**

**Prepared By:  
Federal Highway Administration  
Road Inventory Program  
Cycle 4**

# Cape Hatteras National Seashore in North Carolina

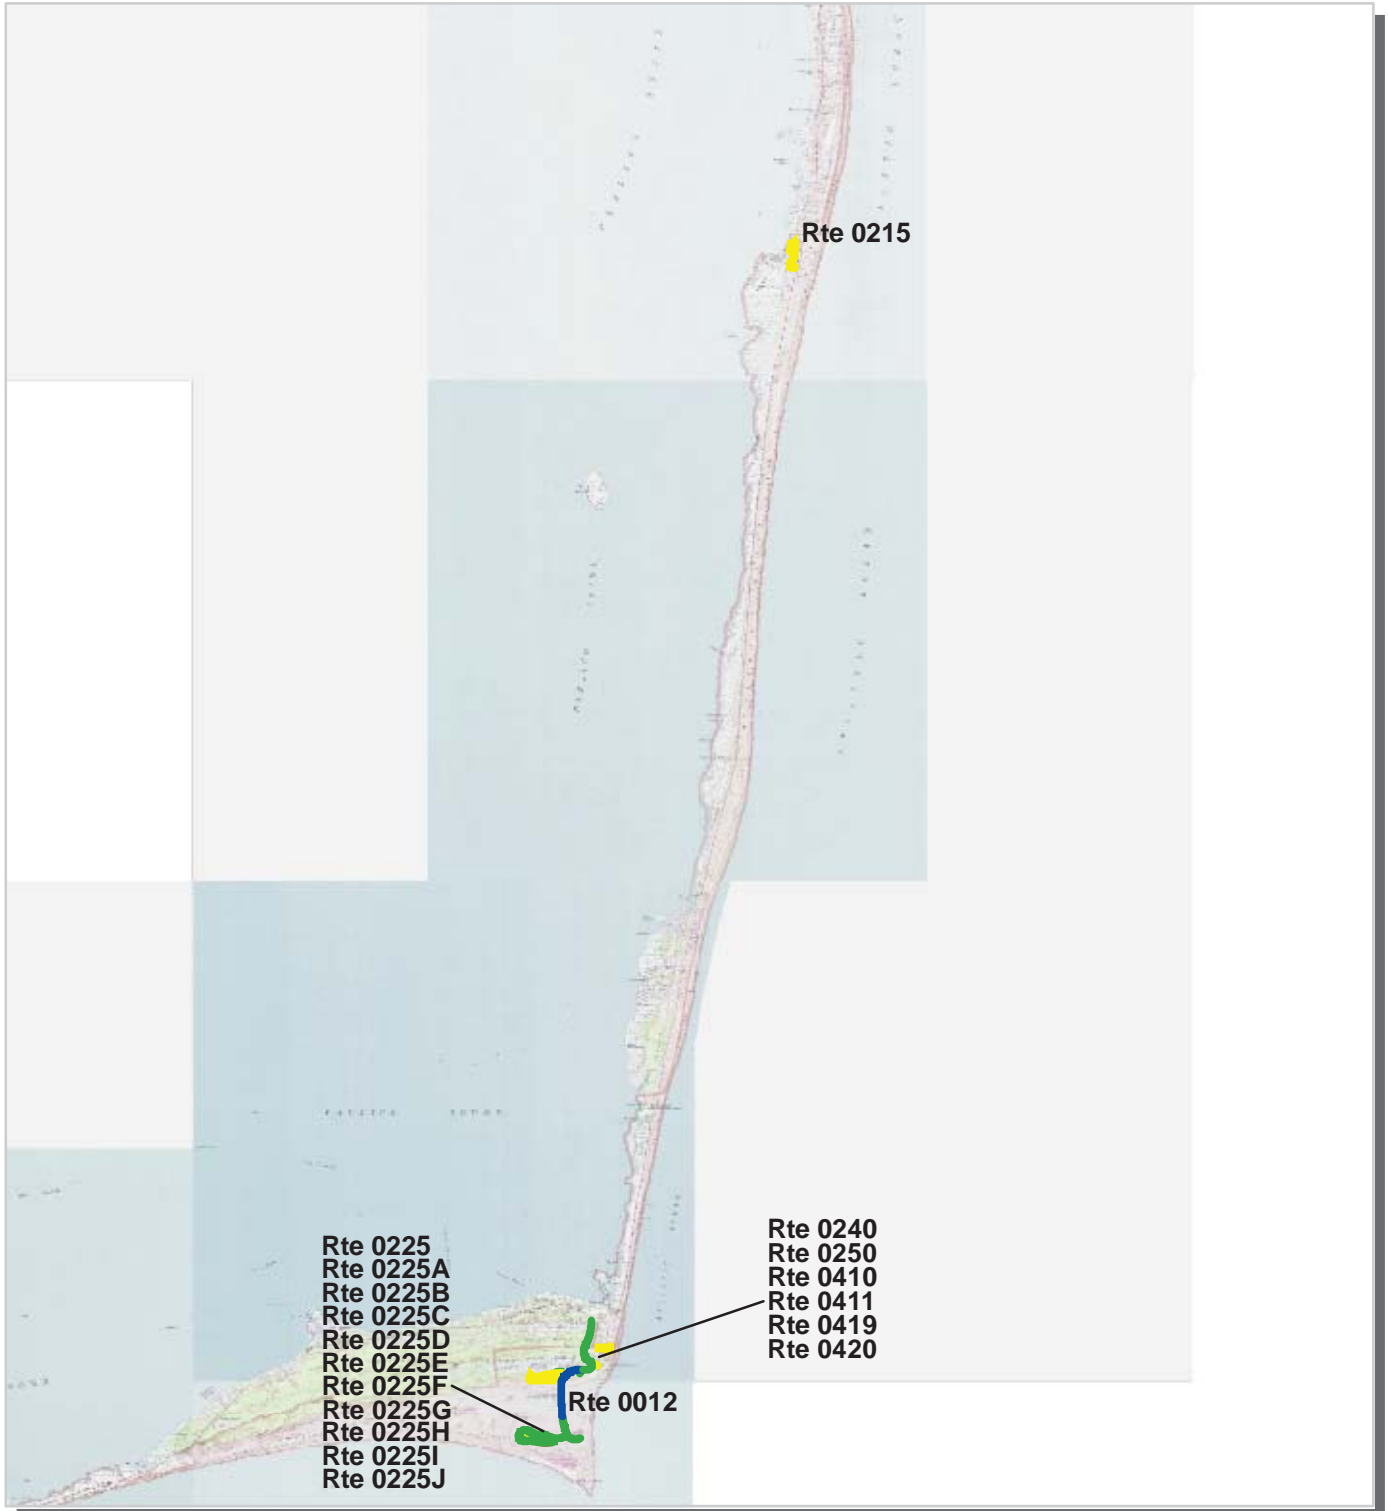
# Cape Hatteras National Seashore Route Condition Map PCR - Mile by Mile Area 1

PCR	Poor	Fair	Good	Excellent
	<span style="display: inline-block; width: 20px; height: 10px; background-color: red; border: 1px solid black;"></span>	<span style="display: inline-block; width: 20px; height: 10px; background-color: yellow; border: 1px solid black;"></span>	<span style="display: inline-block; width: 20px; height: 10px; background-color: green; border: 1px solid black;"></span>	<span style="display: inline-block; width: 20px; height: 10px; background-color: blue; border: 1px solid black;"></span>
	(<=60)	(61 - 84)	(85 - 94)	(95 - 100)

\* If the PCR rating is not available for a section, the SCR rating will be displayed. See appendix for definitions and formulas.

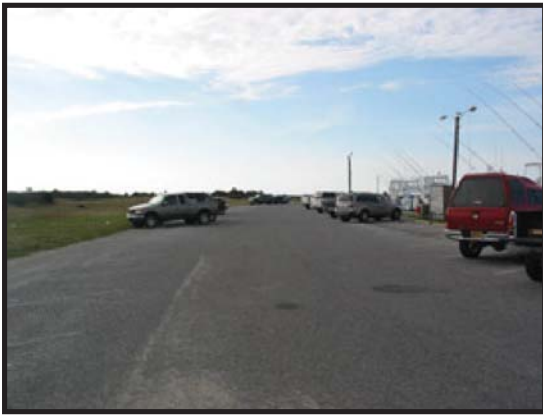
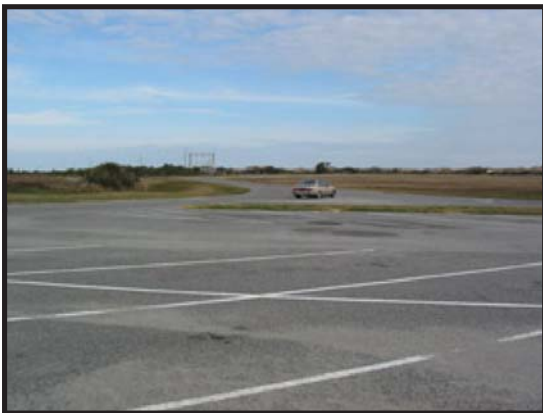
Route Number	Public / NonPublic	Date Visited		Area (sq ft)	Lane Miles *	Surface Type
0208	PUBLIC	1/12/2007		144,404	2.49	AS
Culverts	Drop Inlets	Gates	Fire Hydrants	Curb & Gutter	Curb	PCR
0	6	0	3	CONCRETE CURB AND GUTTER	NO CURB	FAIR/73

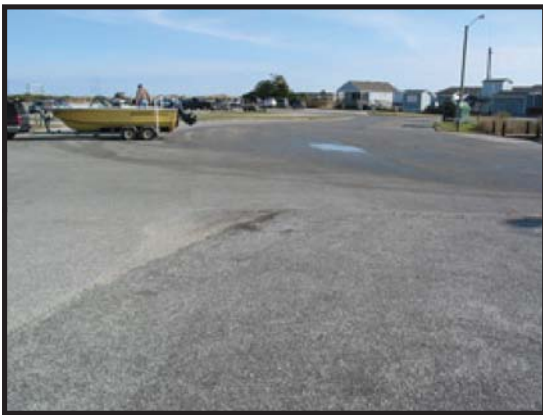
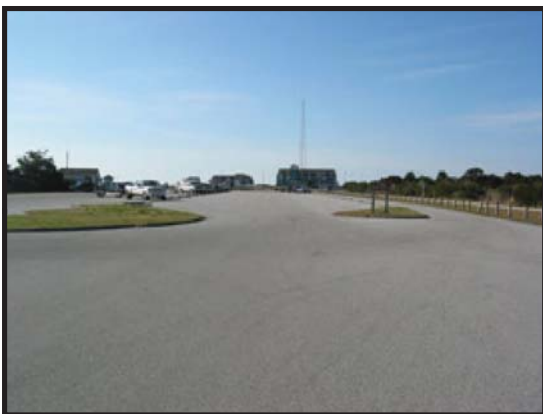
## Route 0209

Route Number	Public / NonPublic	Date Visited		Area (sq ft)	Lane Miles *	Surface Type
0209	PUBLIC	1/12/2007		129,345	2.23	AS
Culverts	Drop Inlets	Gates	Fire Hydrants	Curb & Gutter	Curb	PCR
0	0	0	0	NO CURB AND GUTTER	NO CURB	GOOD/90

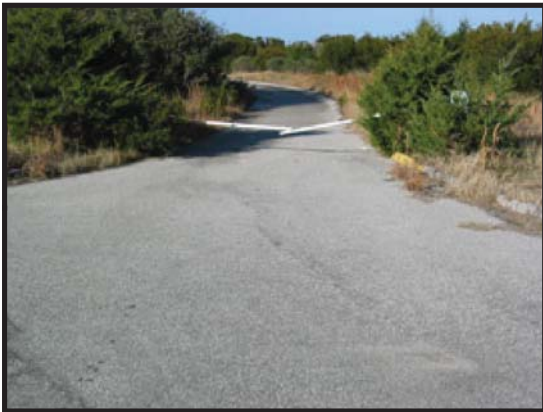
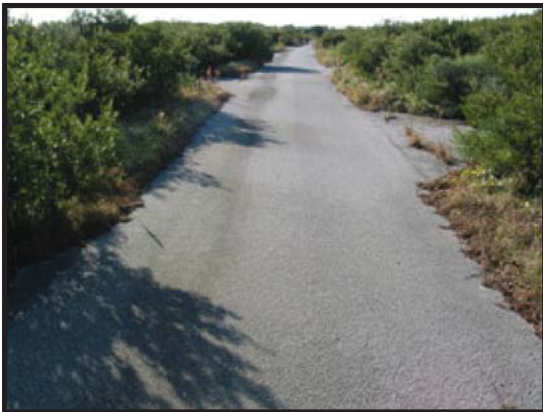
## Route 0215A

Route Number	Public / NonPublic	Date Visited		Area (sq ft)	Lane Miles *	Surface Type
0215A	PUBLIC	1/13/2007		42,134	0.73	AS
Culverts	Drop Inlets	Gates	Fire Hydrants	Curb & Gutter	Curb	PCR
0	0	0	0	NO CURB AND GUTTER	NO CURB	GOOD/90

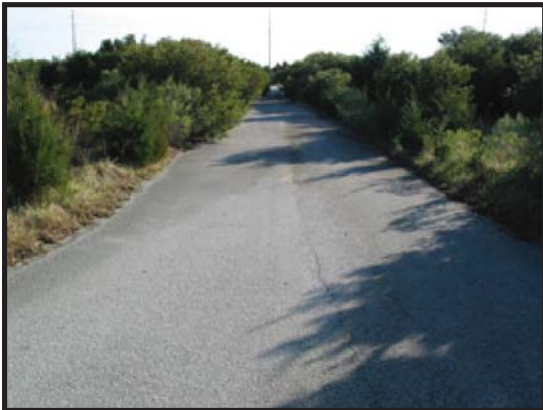
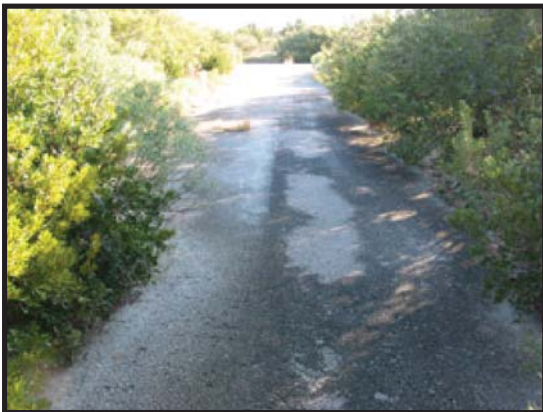
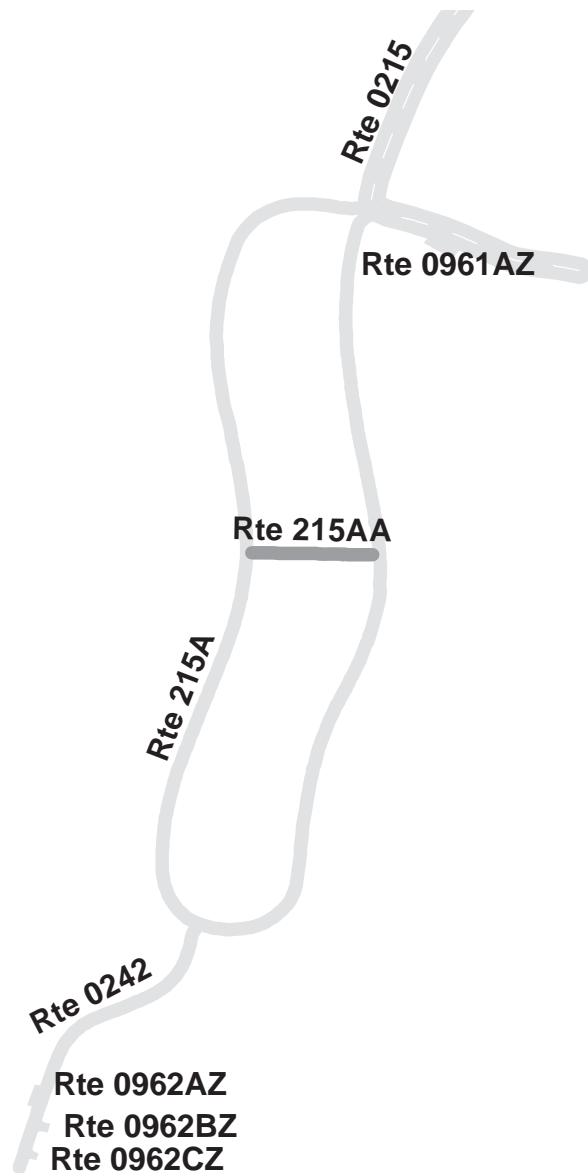
Route Number	Public / NonPublic	Date Visited		Area (sq ft)	Lane Miles *	Surface Type
0215AA	PUBLIC	1/13/2007		2,772	0.05	AS
Culverts	Drop Inlets	Gates	Fire Hydrants	Curb & Gutter	Curb	PCR
0	0	0	0	NO CURB AND GUTTER	NO CURB	GOOD/90

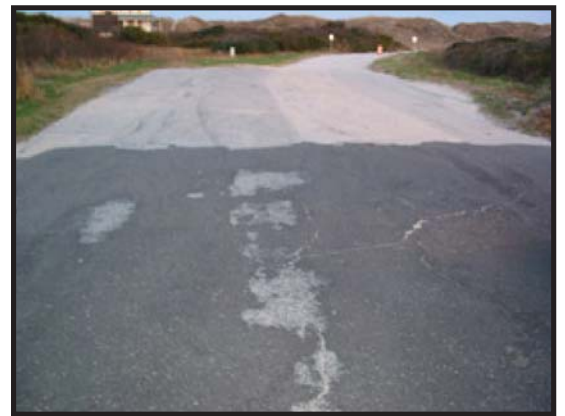
Route Number	Public / NonPublic	Date Visited		Area (sq ft)	Lane Miles *	Surface Type
0404	PUBLIC	1/0/1900		0	0.00	AS
Culverts	Drop Inlets	Gates	Fire Hydrants	Curb & Gutter	Curb	PCR
0	0	0	0	N/A	N/A	NC/-1

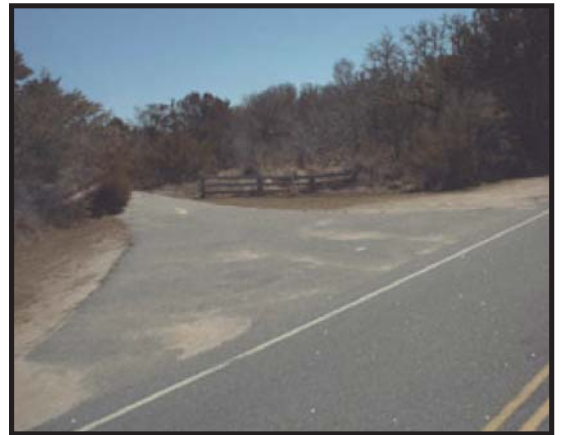
## Route 0418

Route Number	Public / NonPublic	Date Visited		Area (sq ft)	Lane Miles *	Surface Type
0418	NONPUBLIC	1/9/2007		6,653	0.12	AS
Culverts	Drop Inlets	Gates	Fire Hydrants	Curb & Gutter	Curb	PCR
0	0	0	0	NO CURB AND GUTTER	NO CURB	FAIR/73

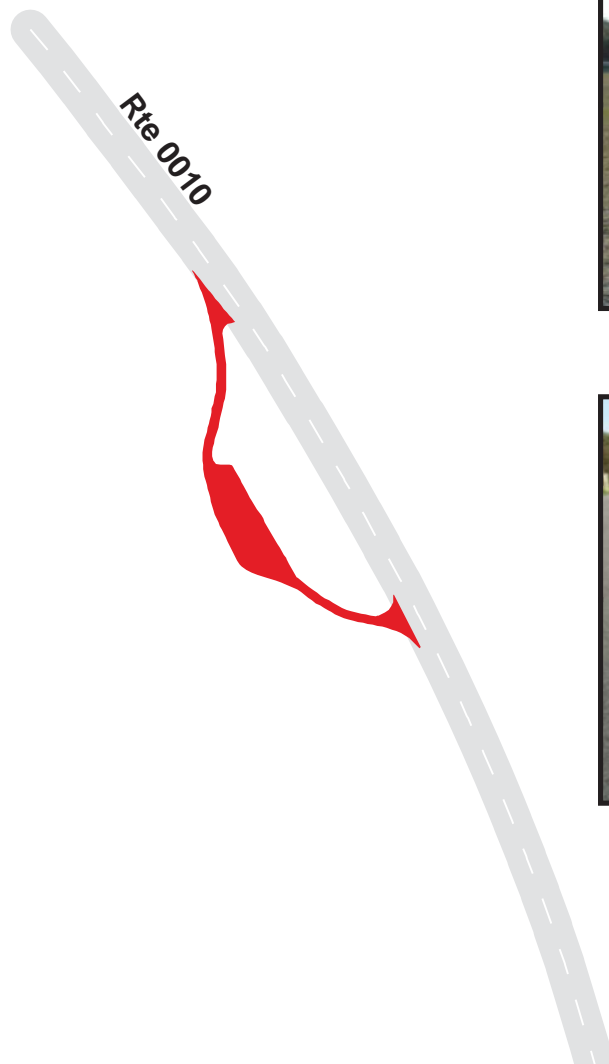
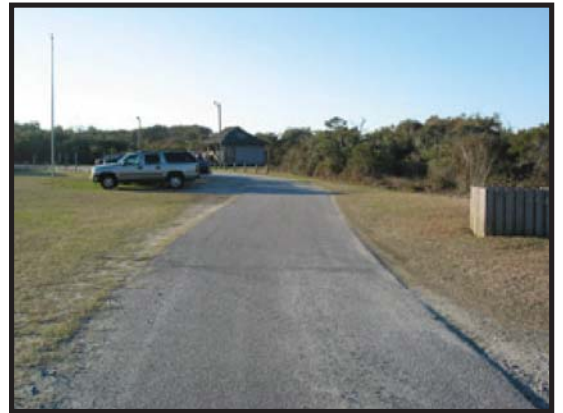
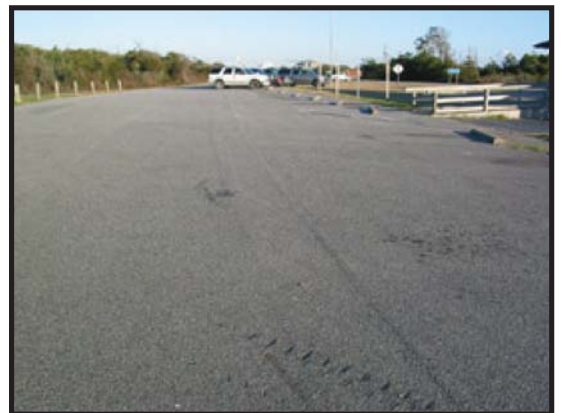
Route Number	Public / NonPublic	Date Visited		Area (sq ft)	Lane Miles *	Surface Type
0901	PUBLIC	1/12/2007		14,094	0.24	AS
Culverts	Drop Inlets	Gates	Fire Hydrants	Curb & Gutter	Curb	PCR
0	0	0	0	NO CURB AND GUTTER	NO CURB	GOOD/90

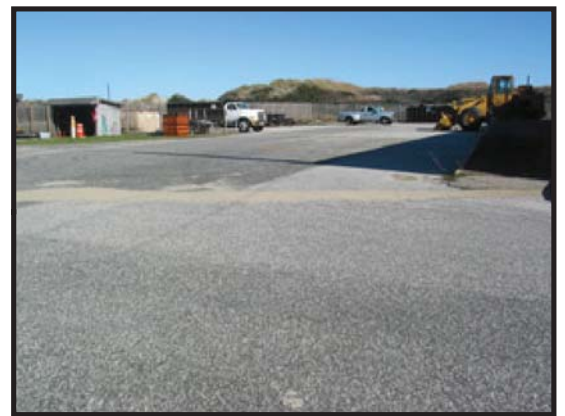
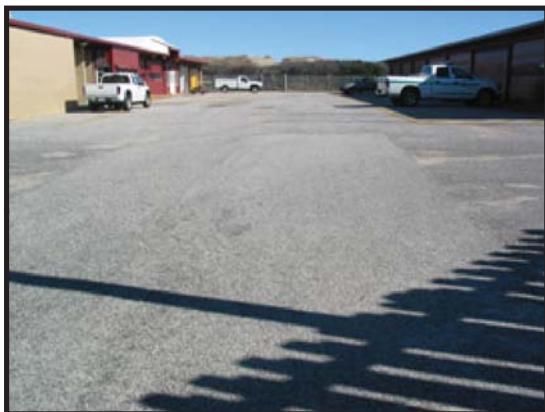
## Route 0902

Route Number	Public / NonPublic	Date Visited		Area (sq ft)	Lane Miles *	Surface Type
0902	NONPUBLIC	1/9/2007		46,419	0.80	AS
Culverts	Drop Inlets	Gates	Fire Hydrants	Curb & Gutter	Curb	PCR
1	0	1	2	NO CURB AND GUTTER	CONCRETE CURB	POOR/45

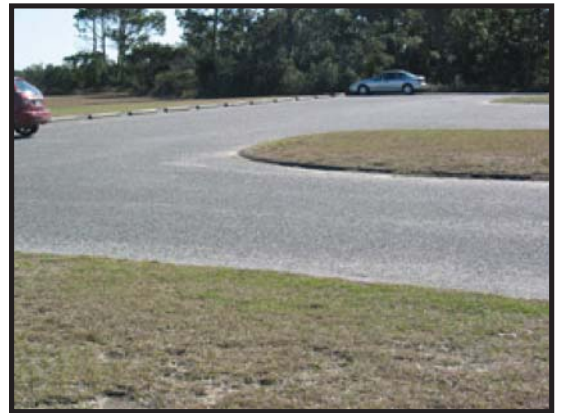
Route Number	Public / NonPublic	Date Visited		Area (sq ft)	Lane Miles *	Surface Type
0903AZ	PUBLIC	1/9/2007		11,259	0.19	AS
Culverts	Drop Inlets	Gates	Fire Hydrants	Curb & Gutter	Curb	PCR
0	0	0	0	NO CURB AND GUTTER	ASPHALT CURB	POOR/45

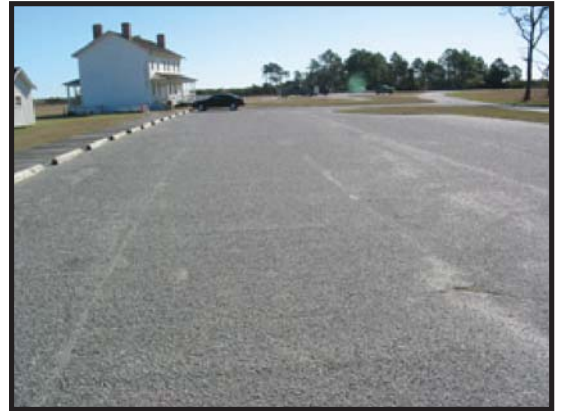
## Route 0903BZ

Route Number	Public / NonPublic	Date Visited		Area (sq ft)	Lane Miles *	Surface Type
0903BZ	PUBLIC	1/9/2007		11,010	0.19	AS
Culverts	Drop Inlets	Gates	Fire Hydrants	Curb & Gutter	Curb	PCR
0	0	0	0	NO CURB AND GUTTER	ASPHALT CURB	POOR/45

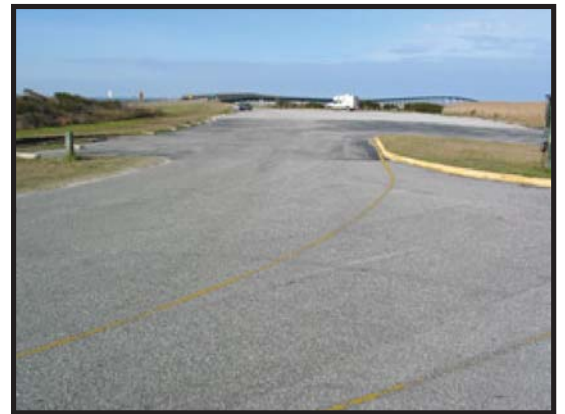
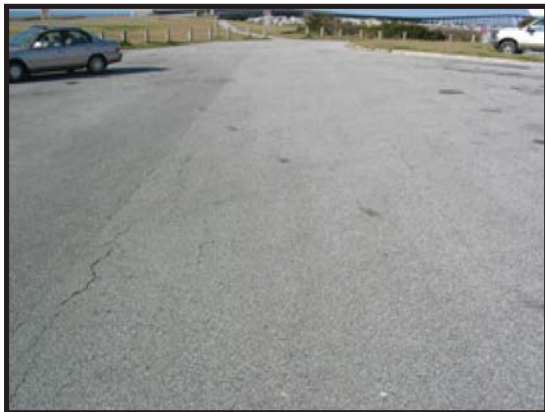
## Route 0906

Route Number	Public / NonPublic	Date Visited		Area (sq ft)	Lane Miles *	Surface Type
0906	PUBLIC	1/12/2007		48,538	0.84	AS
Culverts	Drop Inlets	Gates	Fire Hydrants	Curb & Gutter	Curb	PCR
0	0	0	0	NO CURB AND GUTTER	CONCRETE CURB	FAIR/73

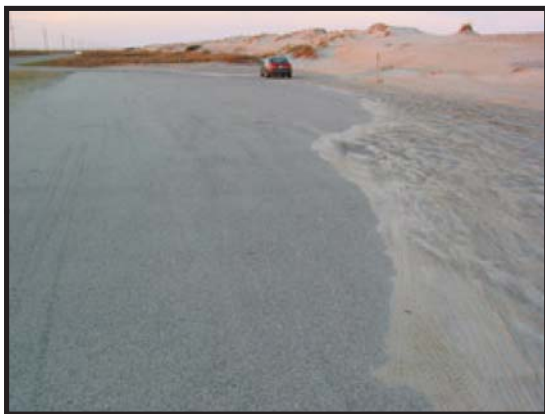
## Route 0908

Route Number	Public / NonPublic	Date Visited		Area (sq ft)	Lane Miles *	Surface Type
0908	PUBLIC	1/12/2007		13,060	0.23	OC
Culverts	Drop Inlets	Gates	Fire Hydrants	Curb & Gutter	Curb	PCR
0	0	0	0	NO CURB AND GUTTER	NO CURB	FAIR/73

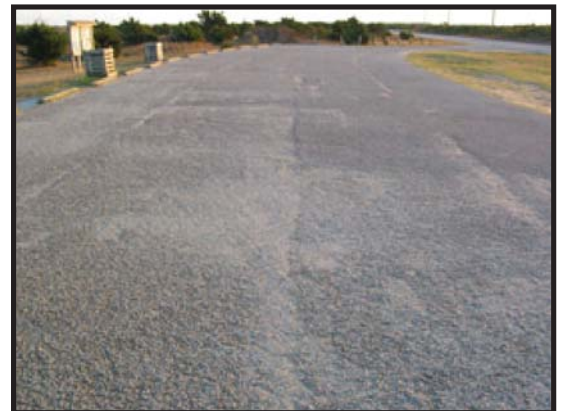
## Route 0909

Route Number	Public / NonPublic	Date Visited		Area (sq ft)	Lane Miles *	Surface Type
0909	PUBLIC	1/12/2007		10,006	0.17	AS
Culverts	Drop Inlets	Gates	Fire Hydrants	Curb & Gutter	Curb	PCR
0	0	0	0	NO CURB AND GUTTER	NO CURB	POOR/45

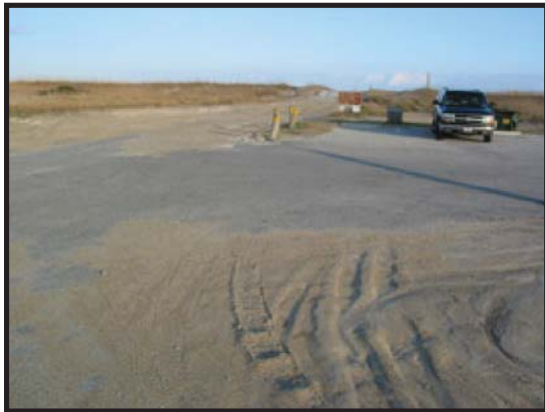
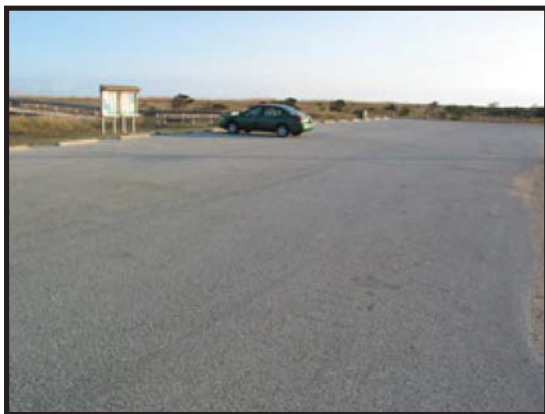
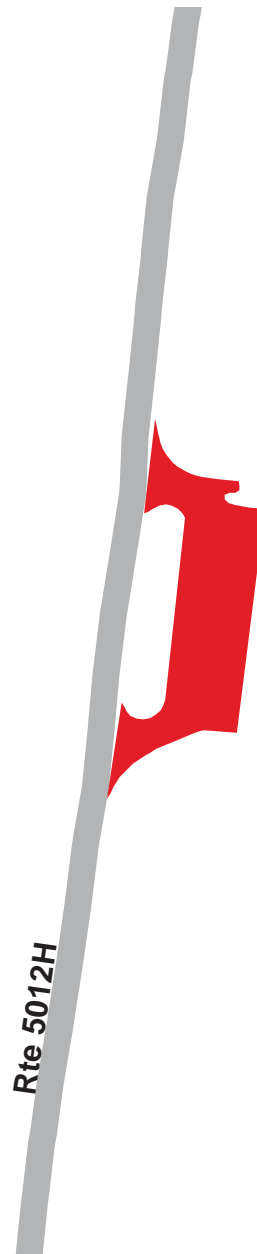
## Route 0910

Route Number	Public / NonPublic	Date Visited		Area (sq ft)	Lane Miles *	Surface Type
0910	PUBLIC	1/12/2007		14,956	0.26	AS
Culverts	Drop Inlets	Gates	Fire Hydrants	Curb & Gutter	Curb	PCR
0	0	0	0	NO CURB AND GUTTER	NO CURB	GOOD/90

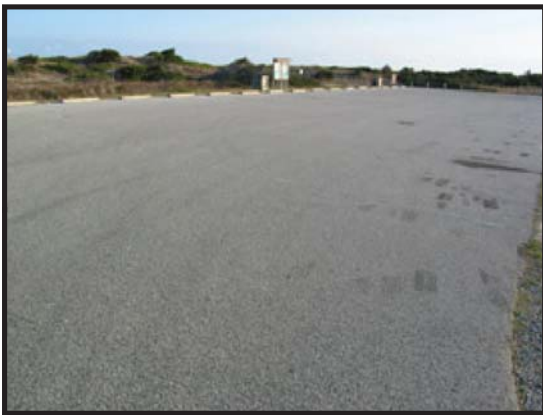
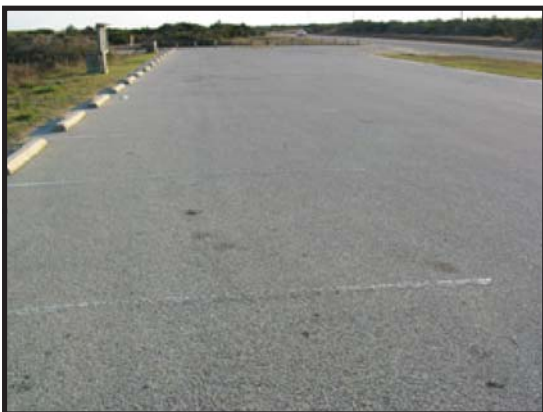
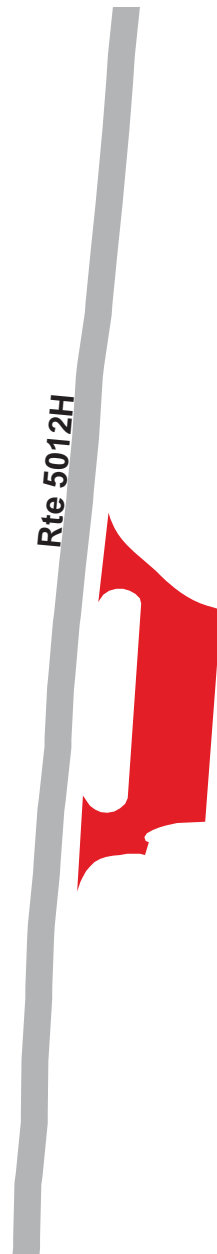
## Route 0911

Route Number	Public / NonPublic	Date Visited		Area (sq ft)	Lane Miles *	Surface Type
0911	PUBLIC	1/12/2007		13,929	0.24	AS
Culverts	Drop Inlets	Gates	Fire Hydrants	Curb & Gutter	Curb	PCR
0	0	0	0	NO CURB AND GUTTER	NO CURB	GOOD/90

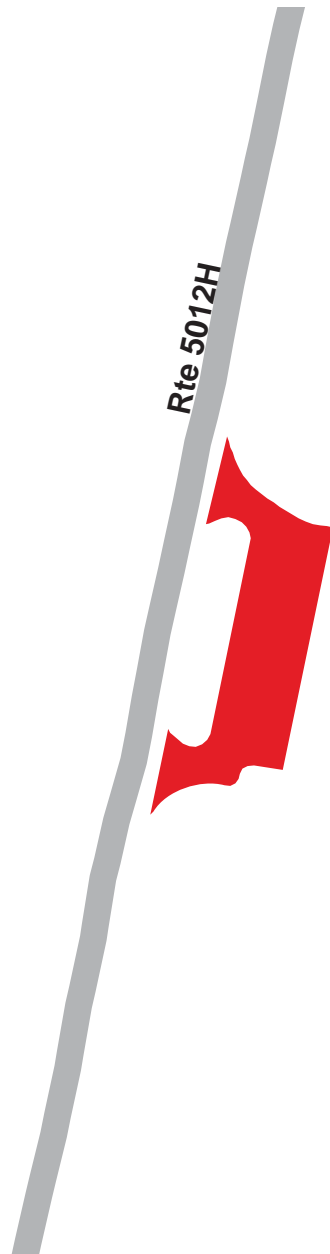
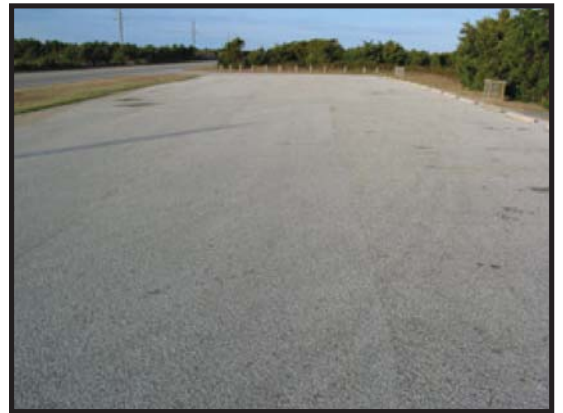
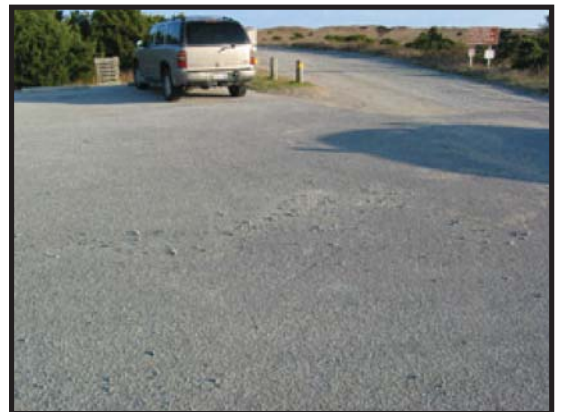
## Route 0912

Route Number	Public / NonPublic	Date Visited		Area (sq ft)	Lane Miles *	Surface Type
0912	PUBLIC	1/12/2007		13,858	0.24	AS
Culverts	Drop Inlets	Gates	Fire Hydrants	Curb & Gutter	Curb	PCR
0	0	0	0	NO CURB AND GUTTER	NO CURB	GOOD/90

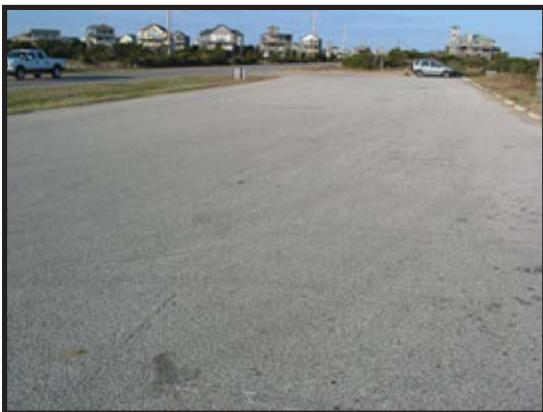
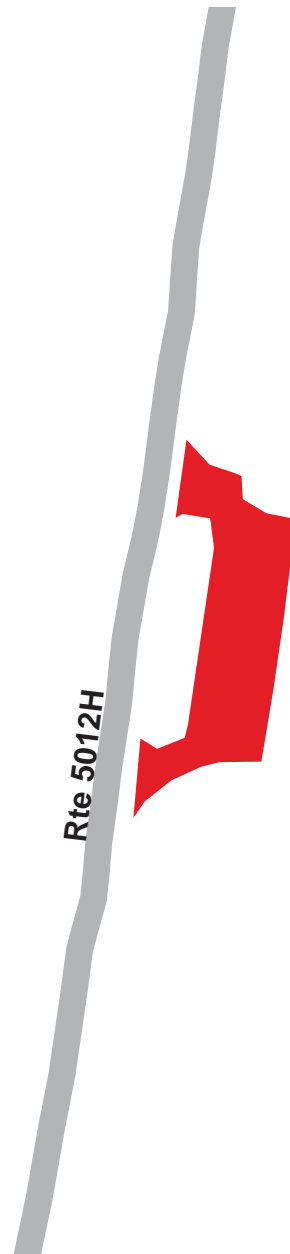
## Route 0913

Route Number	Public / NonPublic	Date Visited		Area (sq ft)	Lane Miles *	Surface Type
0913	PUBLIC	1/12/2007		13,371	0.23	AS
Culverts	Drop Inlets	Gates	Fire Hydrants	Curb & Gutter	Curb	PCR
0	0	0	0	NO CURB AND GUTTER	NO CURB	FAIR/73

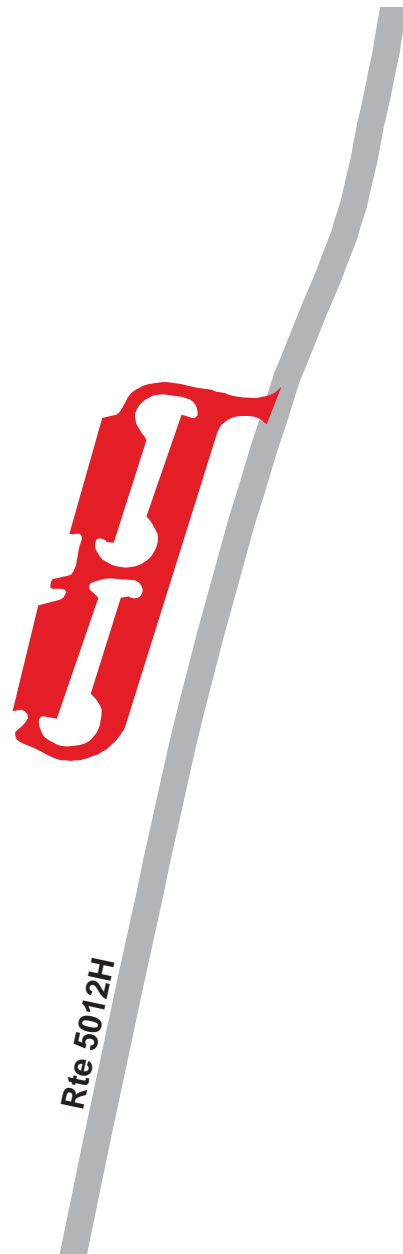
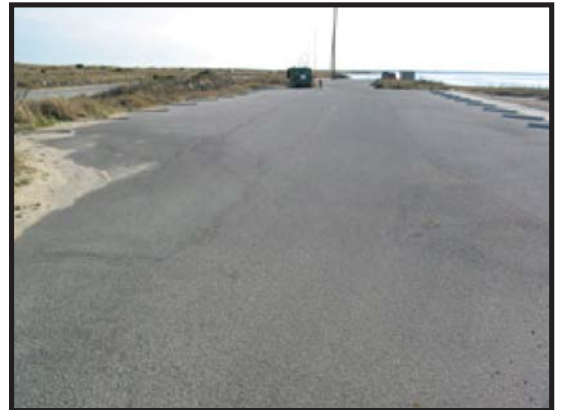
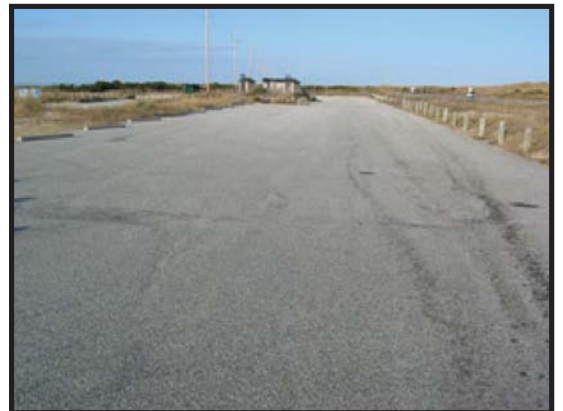
## Route 0914

Route Number	Public / NonPublic	Date Visited		Area (sq ft)	Lane Miles *	Surface Type
0914	PUBLIC	1/12/2007		48,529	0.84	AS
Culverts	Drop Inlets	Gates	Fire Hydrants	Curb & Gutter	Curb	PCR
0	0	0	0	NO CURB AND GUTTER	NO CURB	GOOD/90

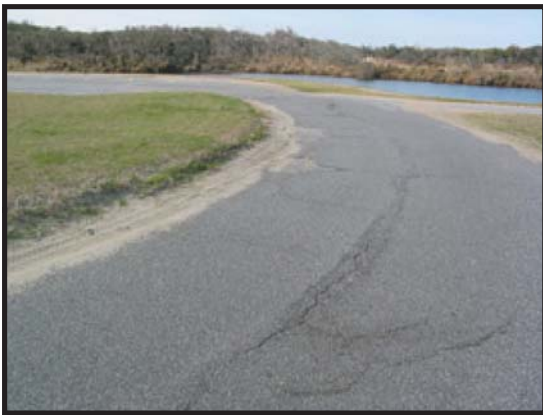
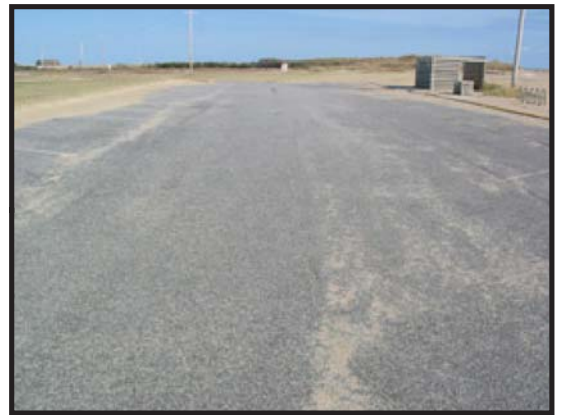
## Route 0916

Route Number	Public / NonPublic	Date Visited		Area (sq ft)	Lane Miles *	Surface Type
0916	PUBLIC	1/12/2007		33,587	0.58	AS
Culverts	Drop Inlets	Gates	Fire Hydrants	Curb & Gutter	Curb	PCR
0	0	0	0	CONCRETE CURB AND GUTTER	NO CURB	POOR/45

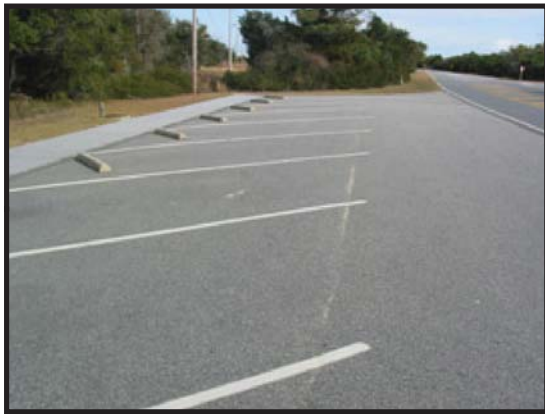
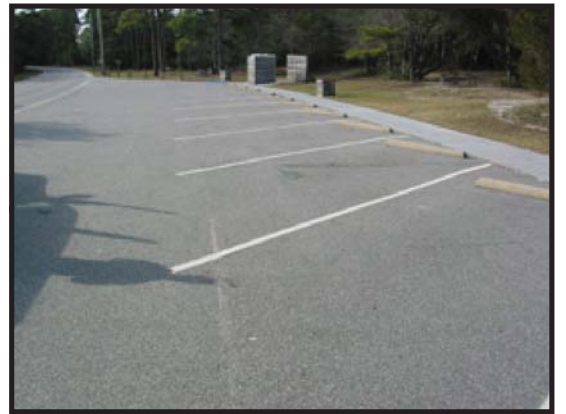
## Route 0917

Route Number	Public / NonPublic	Date Visited		Area (sq ft)	Lane Miles *	Surface Type
0917	PUBLIC	1/12/2007		10,290	0.18	AS
Culverts	Drop Inlets	Gates	Fire Hydrants	Curb & Gutter	Curb	PCR
0	0	0	0	NO CURB AND GUTTER	NO CURB	GOOD/90

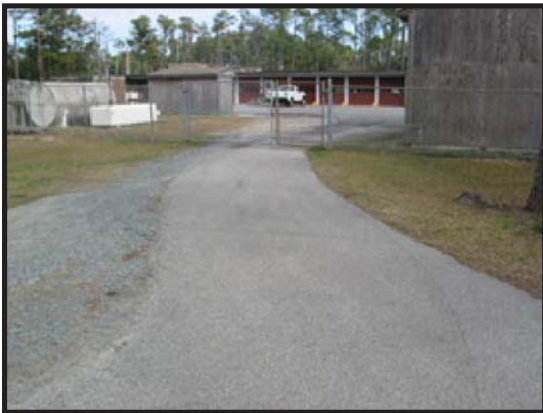
## Route 0918

Route Number	Public / NonPublic	Date Visited		Area (sq ft)	Lane Miles *	Surface Type
0918	NONPUBLIC	1/12/2007		28,860	0.50	AS
Culverts	Drop Inlets	Gates	Fire Hydrants	Curb & Gutter	Curb	PCR
0	0	2	1	NO CURB AND GUTTER	ASPHALT CURB	FAIR/73

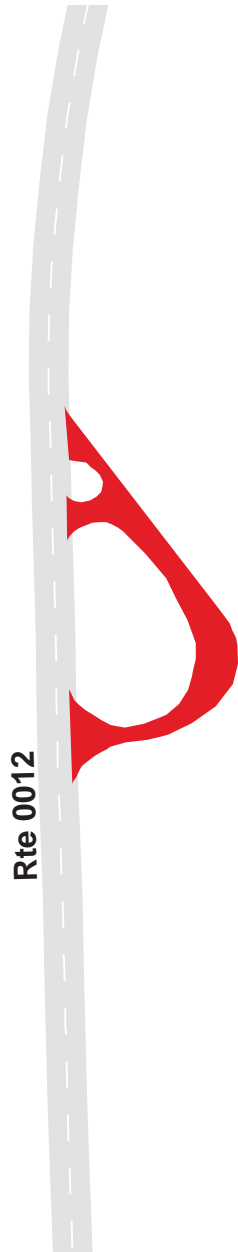
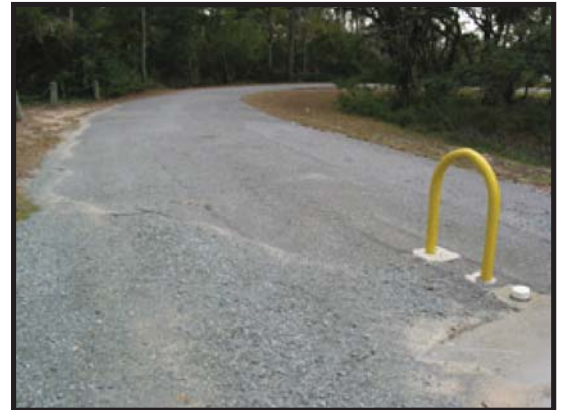
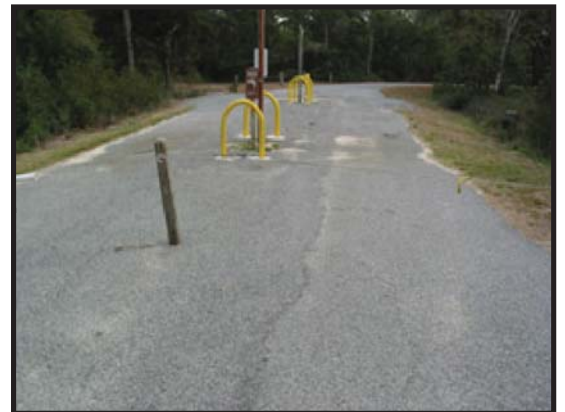
## Route 0919

Route Number	Public / NonPublic	Date Visited		Area (sq ft)	Lane Miles *	Surface Type
0919	NONPUBLIC	1/12/2007		7,664	0.13	AS
Culverts	Drop Inlets	Gates	Fire Hydrants	Curb & Gutter	Curb	PCR
0	0	0	0	NO CURB AND GUTTER	NO CURB	POOR/45

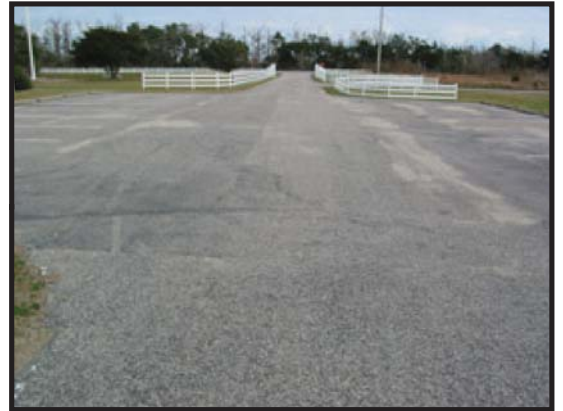
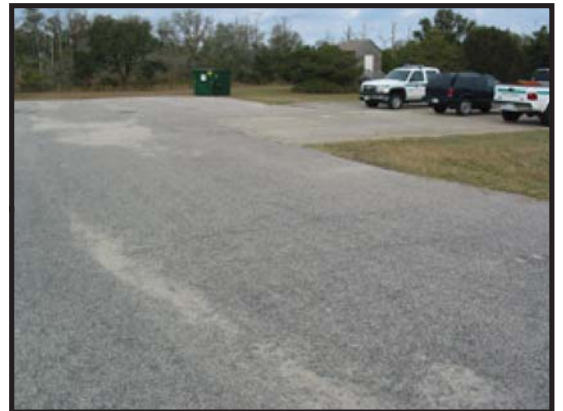
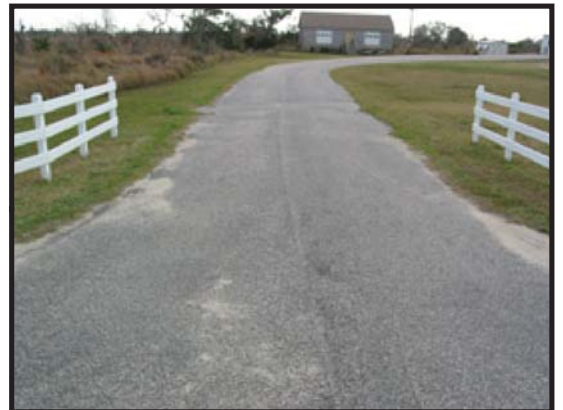
Route Number	Public / NonPublic	Date Visited		Area (sq ft)	Lane Miles *	Surface Type
0920	PUBLIC	1/12/2007		29,814	0.51	AS
Culverts	Drop Inlets	Gates	Fire Hydrants	Curb & Gutter	Curb	PCR
0	0	0	1	NO CURB AND GUTTER	NO CURB	POOR/45

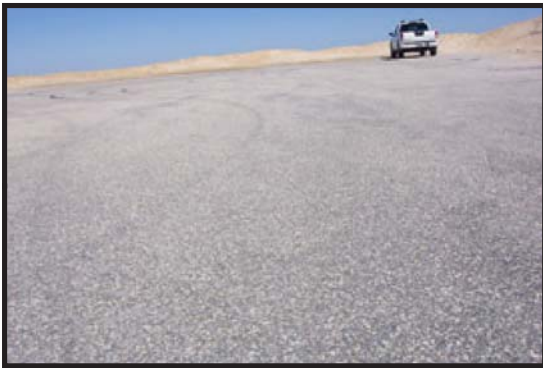
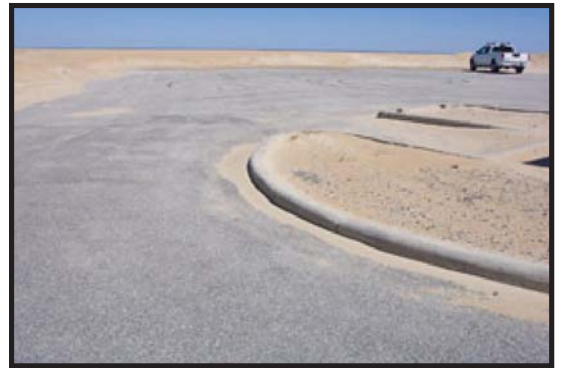
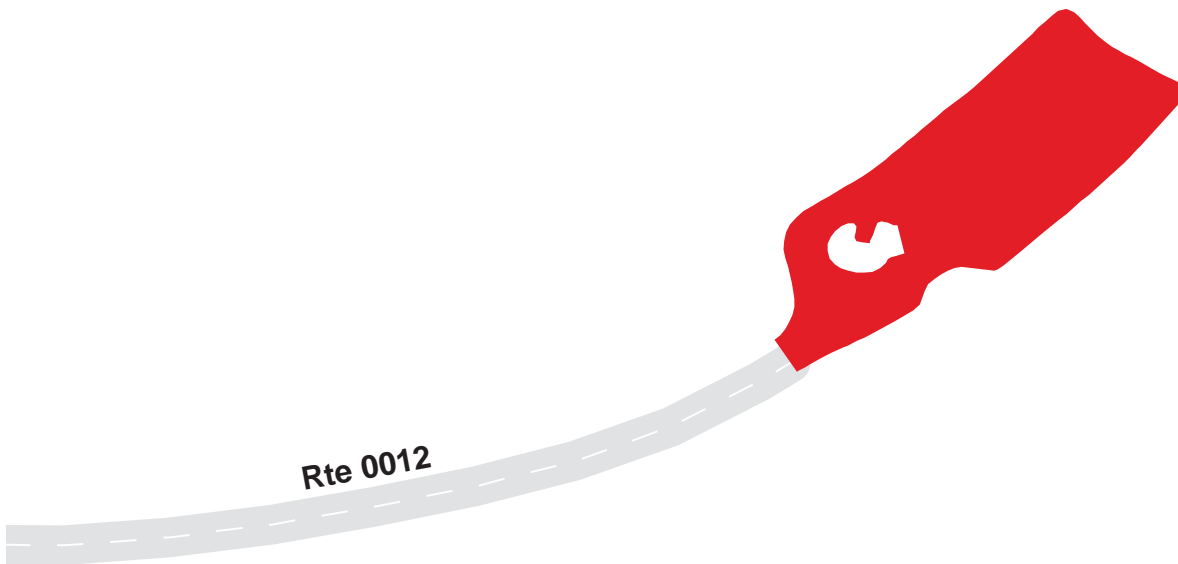
## Route 0921

Route Number	Public / NonPublic	Date Visited		Area (sq ft)	Lane Miles *	Surface Type
0921	PUBLIC	1/11/2007		18,386	0.32	AS
Culverts	Drop Inlets	Gates	Fire Hydrants	Curb & Gutter	Curb	PCR
0	0	0	0	NO CURB AND GUTTER	CONCRETE CURB	POOR/45

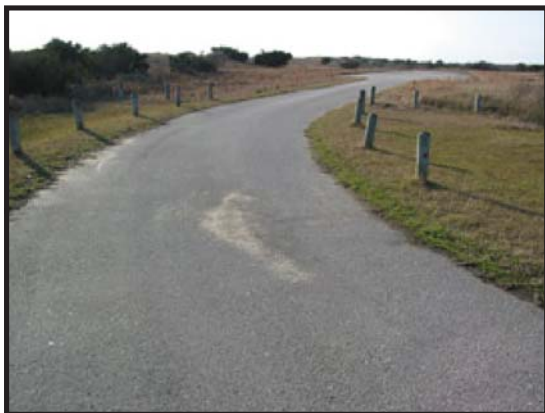
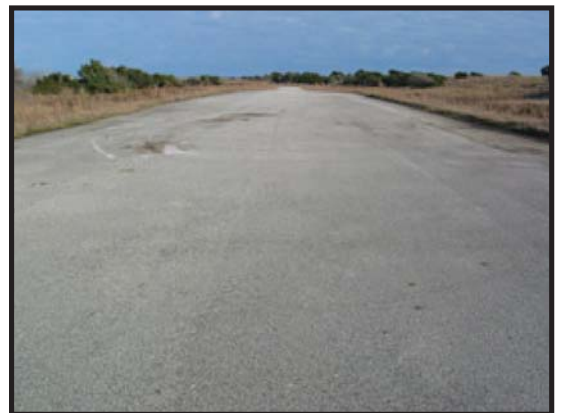
## Route 0922

Route Number	Public / NonPublic	Date Visited		Area (sq ft)	Lane Miles *	Surface Type
0922	PUBLIC	1/12/2007		22,509	0.39	AS
Culverts	Drop Inlets	Gates	Fire Hydrants	Curb & Gutter	Curb	PCR
0	0	0	0	NO CURB AND GUTTER	ASPHALT AND CONCRETE	FAIR/73

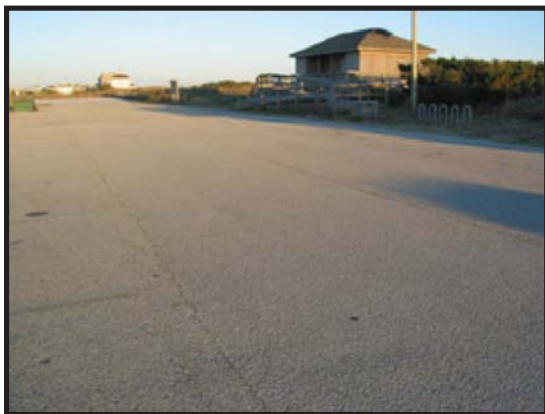
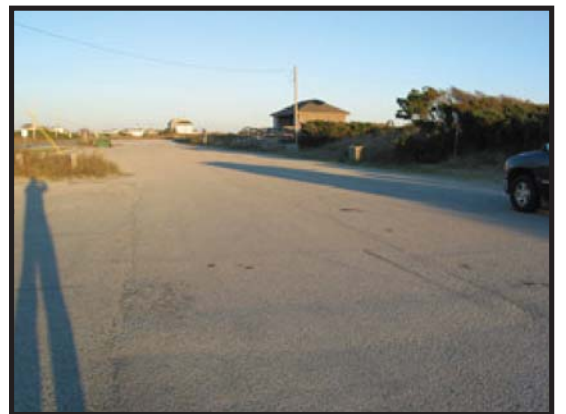
## Route 0923

Route Number	Public / NonPublic	Date Visited		Area (sq ft)	Lane Miles *	Surface Type
0923	PUBLIC	1/10/2007		35,283	0.61	AS
Culverts	Drop Inlets	Gates	Fire Hydrants	Curb & Gutter	Curb	PCR
0	0	0	0	NO CURB AND GUTTER	NO CURB	FAIR/73

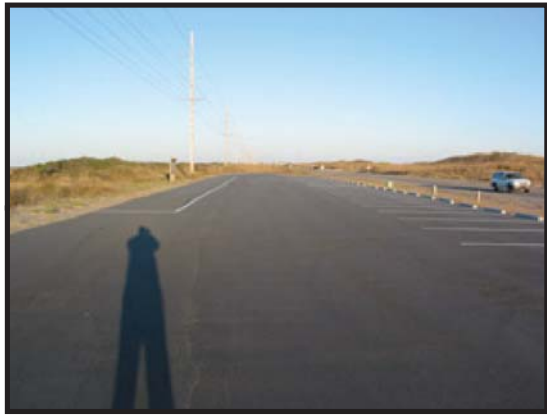
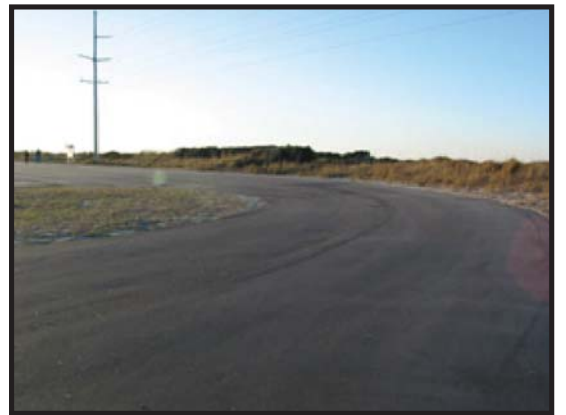
## Route 0924

Route Number	Public / NonPublic	Date Visited		Area (sq ft)	Lane Miles *	Surface Type
0924	PUBLIC	1/10/2007		21,511	0.37	AS
Culverts	Drop Inlets	Gates	Fire Hydrants	Curb & Gutter	Curb	PCR
0	0	0	0	NO CURB AND GUTTER	NO CURB	EXCELLENT/97

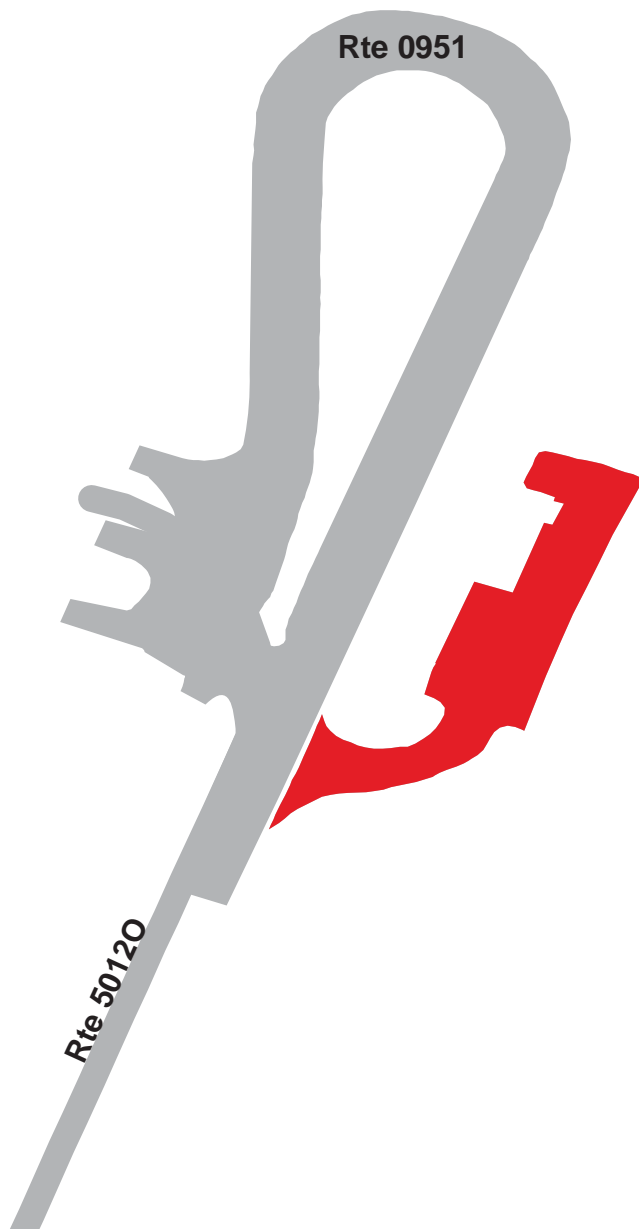
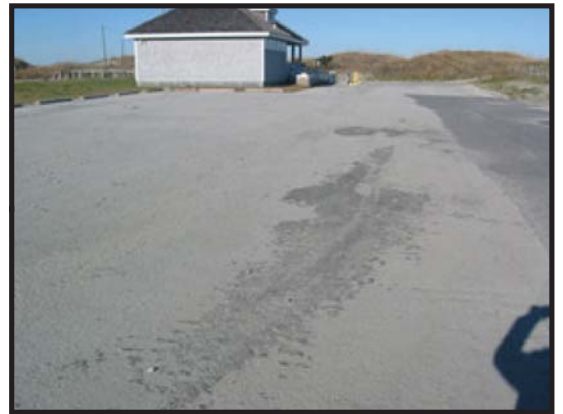
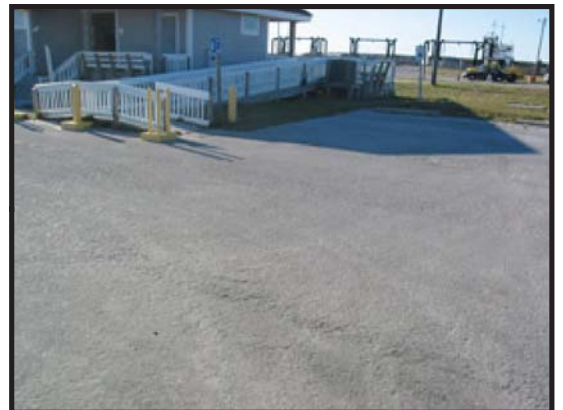
## Route 0926

Route Number	Public / NonPublic	Date Visited		Area (sq ft)	Lane Miles *	Surface Type
0926	PUBLIC	1/10/2007		15,481	0.27	AS
Culverts	Drop Inlets	Gates	Fire Hydrants	Curb & Gutter	Curb	PCR
0	0	0	0	NO CURB AND GUTTER	NO CURB	POOR/45

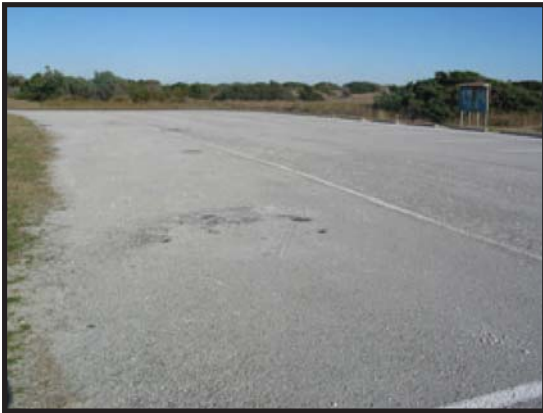
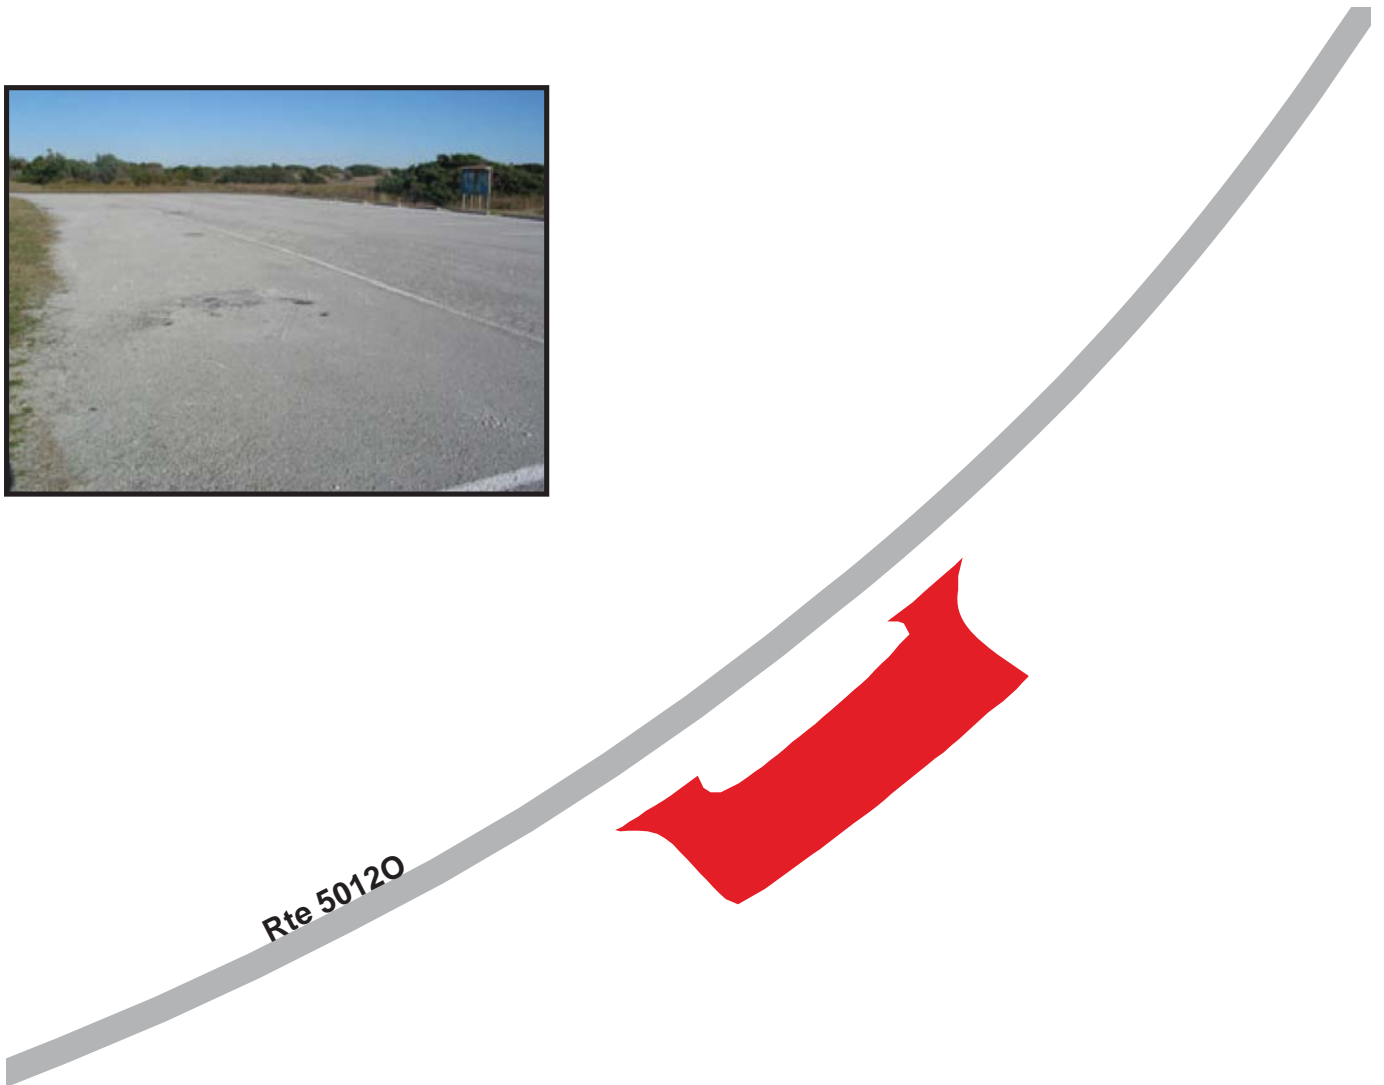
## Route 0927

Route Number	Public / NonPublic	Date Visited		Area (sq ft)	Lane Miles *	Surface Type
0927	PUBLIC	1/10/2007		12,089	0.21	AS
Culverts	Drop Inlets	Gates	Fire Hydrants	Curb & Gutter	Curb	PCR
0	0	0	0	NO CURB AND GUTTER	NO CURB	FAIR/73

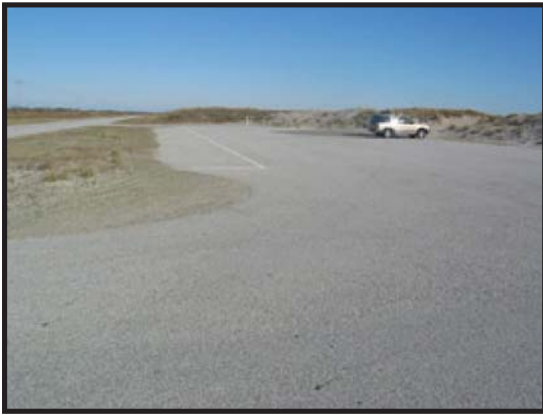
## Route 0928

Route Number	Public / NonPublic	Date Visited		Area (sq ft)	Lane Miles *	Surface Type
0928	PUBLIC	1/10/2007		17,169	0.30	AS
Culverts	Drop Inlets	Gates	Fire Hydrants	Curb & Gutter	Curb	PCR
0	0	0	0	NO CURB AND GUTTER	NO CURB	FAIR/73
