**The Road Inventory  
of  
Cape Hatteras National Seashore  
CAHA – 5190  
Cycle 4**

**Prepared By:  
Federal Highway Administration  
Road Inventory Program  
Cycle 4**

# Cape Hatteras National Seashore in North Carolina

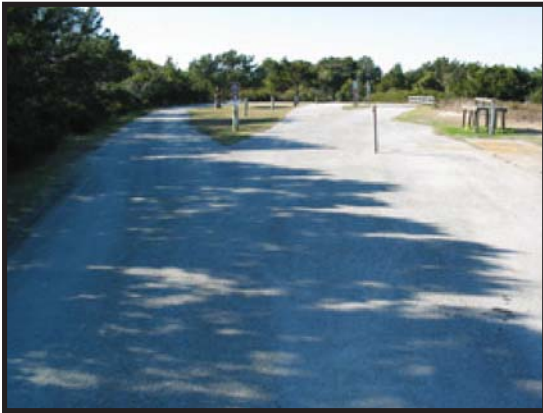
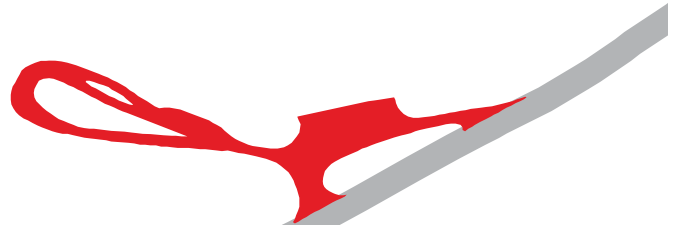
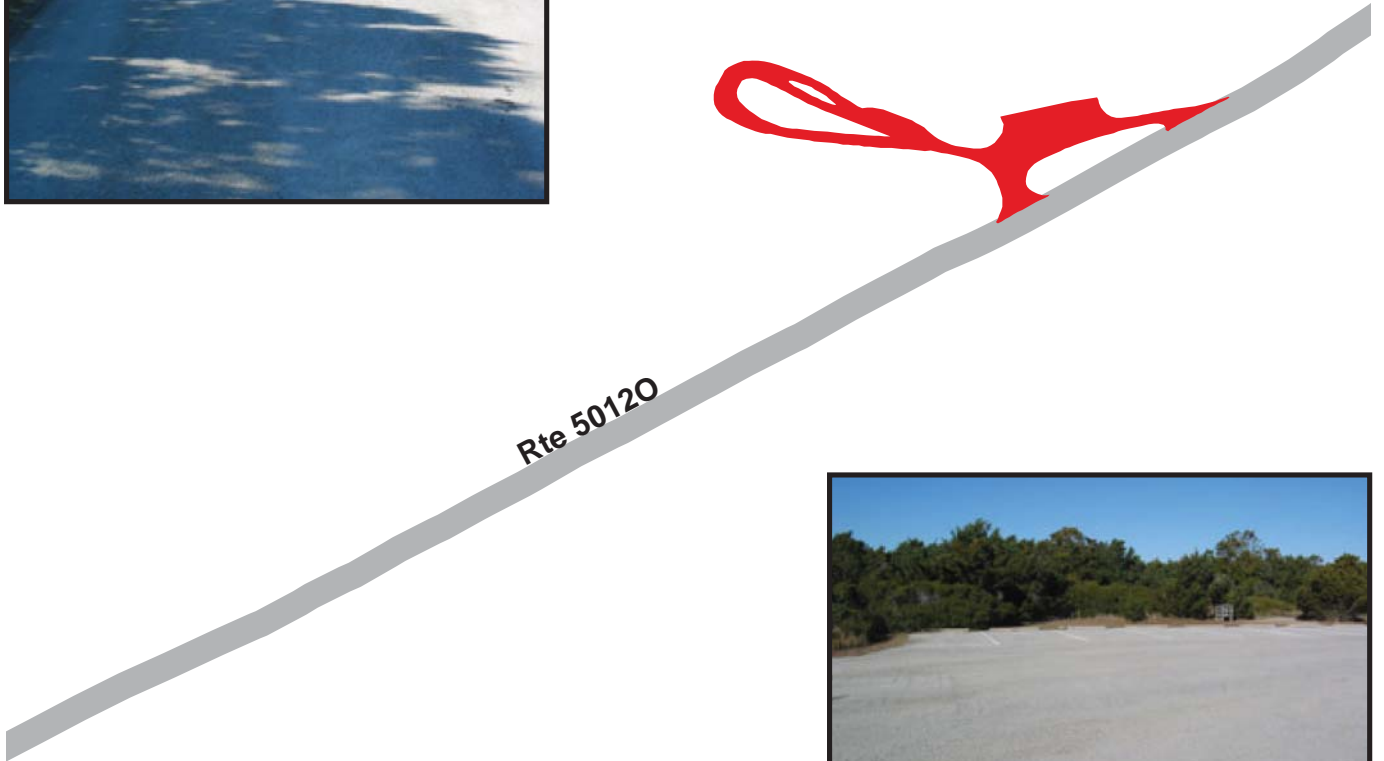
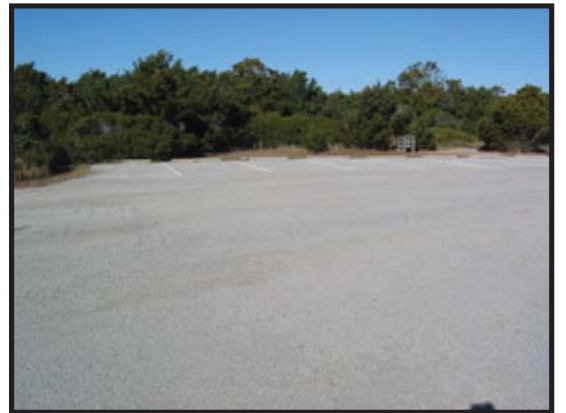
## Route 0930

Route Number	Public / NonPublic	Date Visited		Area (sq ft)	Lane Miles *	Surface Type
0930	PUBLIC	1/10/2007		18,986	0.33	AS
Culverts	Drop Inlets	Gates	Fire Hydrants	Curb & Gutter	Curb	PCR
0	0	0	0	NO CURB AND GUTTER	NO CURB	FAIR/73

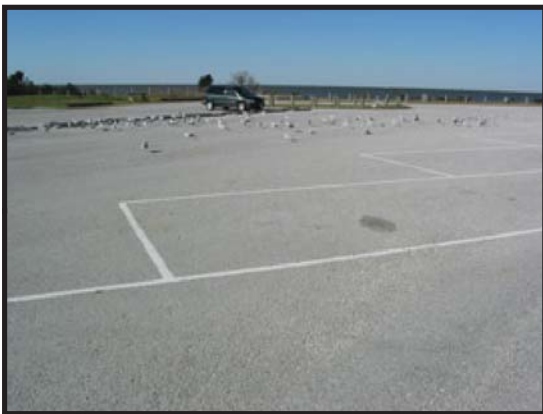
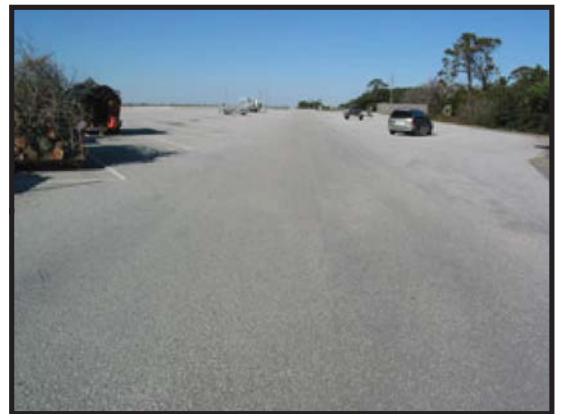
Route Number	Public / NonPublic	Date Visited		Area (sq ft)	Lane Miles *	Surface Type
0933	PUBLIC	1/10/2007		117,726	2.03	AS
Culverts	Drop Inlets	Gates	Fire Hydrants	Curb & Gutter	Curb	PCR
0	0	0	0	NO CURB AND GUTTER	NO CURB	FAIR/73

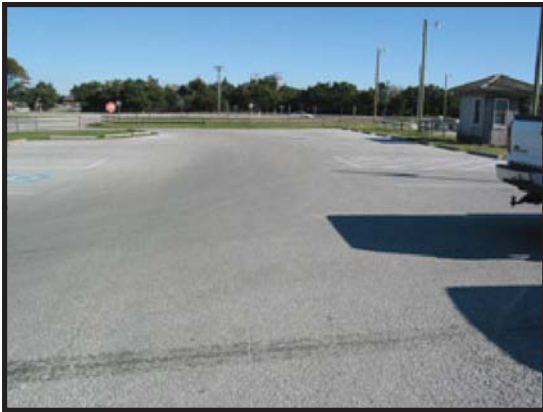
## Route 0934

Route Number	Public / NonPublic	Date Visited		Area (sq ft)	Lane Miles *	Surface Type
0934	PUBLIC	1/10/2007		11,592	0.20	AS
Culverts	Drop Inlets	Gates	Fire Hydrants	Curb & Gutter	Curb	PCR
0	0	0	0	NO CURB AND GUTTER	NO CURB	FAIR/73

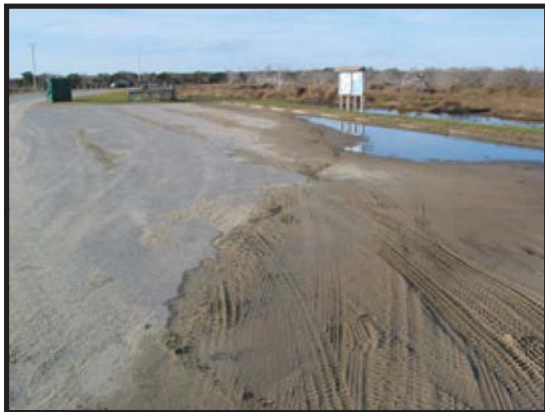
## Route 0939

Route Number	Public / NonPublic	Date Visited		Area (sq ft)	Lane Miles *	Surface Type
0939	PUBLIC	1/12/2007		5,769	0.10	AS
Culverts	Drop Inlets	Gates	Fire Hydrants	Curb & Gutter	Curb	PCR
0	0	0	0	NO CURB AND GUTTER	NO CURB	GOOD/90

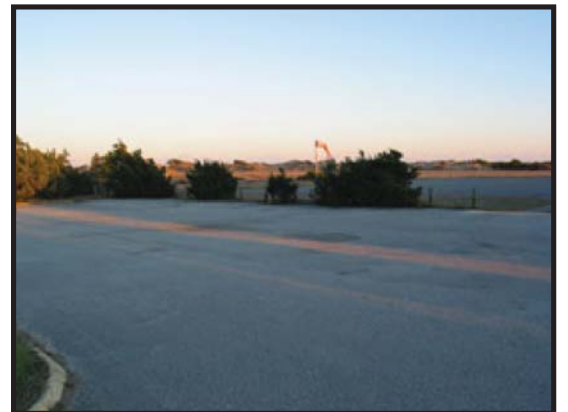
## Route 0940

Route Number	Public / NonPublic	Date Visited		Area (sq ft)	Lane Miles *	Surface Type
0940	PUBLIC	1/10/2007		8,817	0.15	AS
Culverts	Drop Inlets	Gates	Fire Hydrants	Curb & Gutter	Curb	PCR
0	0	0	0	NO CURB AND GUTTER	CONCRETE CURB	FAIR/73

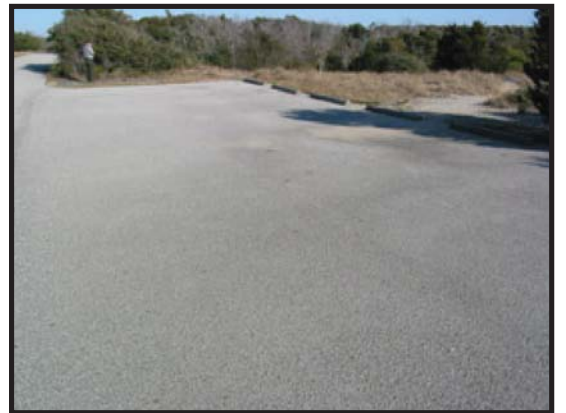
## Route 0941

Route Number	Public / NonPublic	Date Visited		Area (sq ft)	Lane Miles *	Surface Type
0941	PUBLIC	1/11/2007		1,998	0.03	AS
Culverts	Drop Inlets	Gates	Fire Hydrants	Curb & Gutter	Curb	PCR
0	0	0	0	NO CURB AND GUTTER	NO CURB	GOOD/90

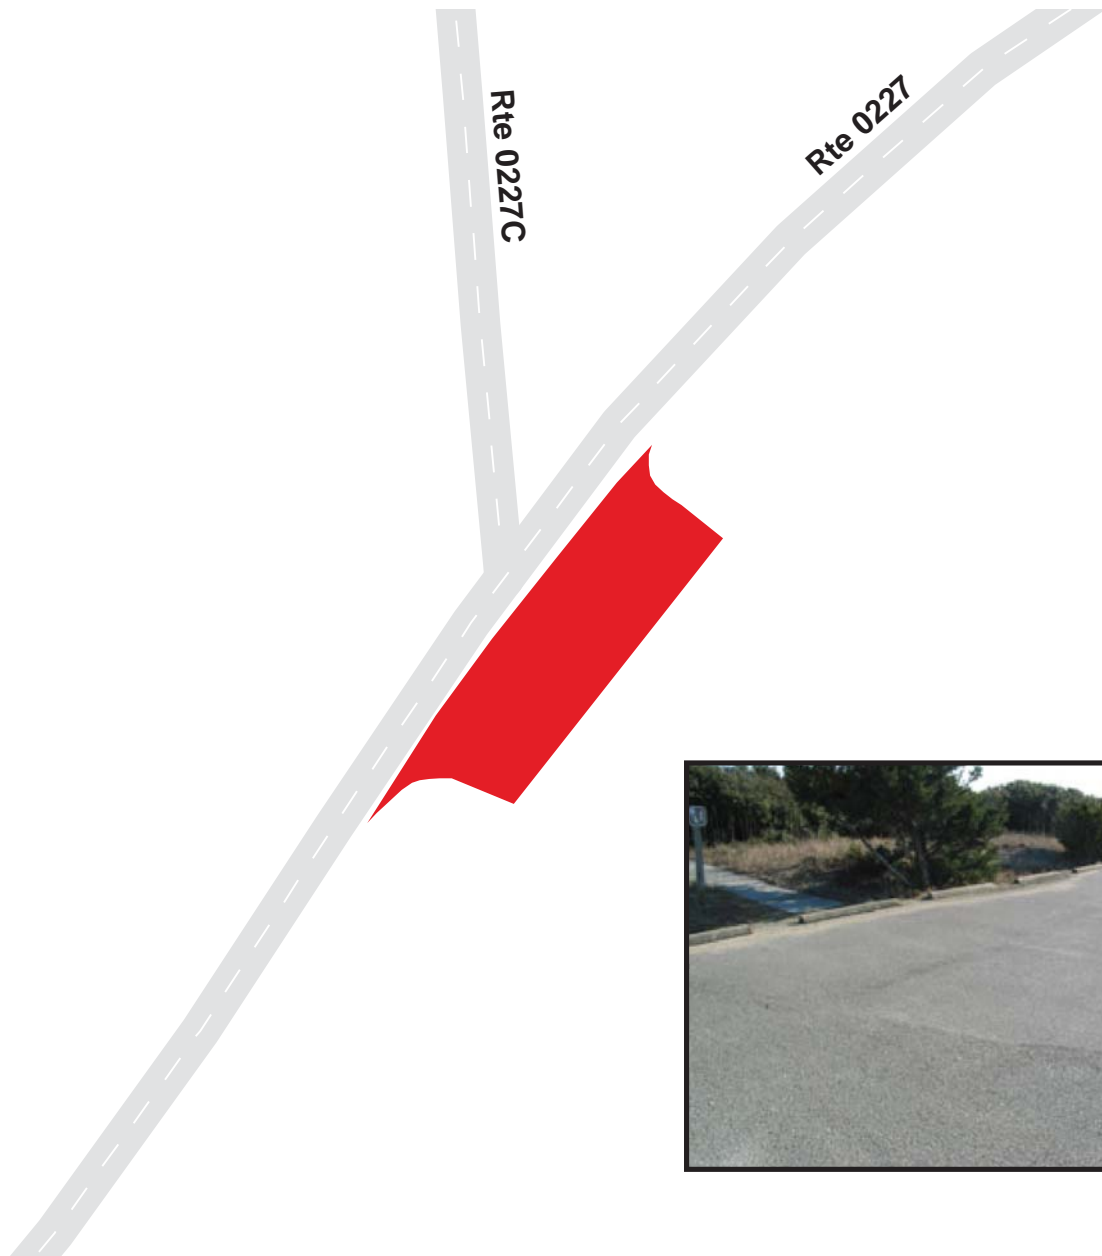
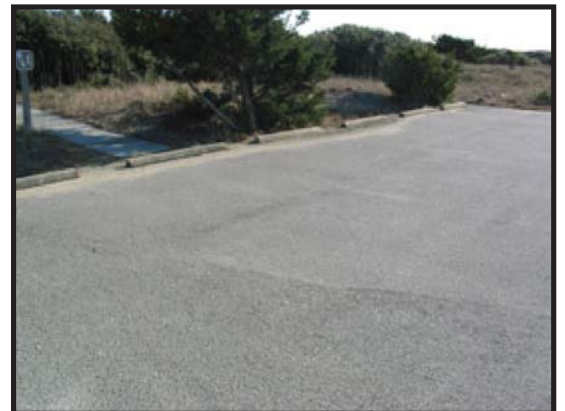
## Route 0942

Route Number	Public / NonPublic	Date Visited		Area (sq ft)	Lane Miles *	Surface Type
0942	PUBLIC	1/11/2007		1,791	0.03	AS
Culverts	Drop Inlets	Gates	Fire Hydrants	Curb & Gutter	Curb	PCR
0	0	0	0	NO CURB AND GUTTER	NO CURB	GOOD/90

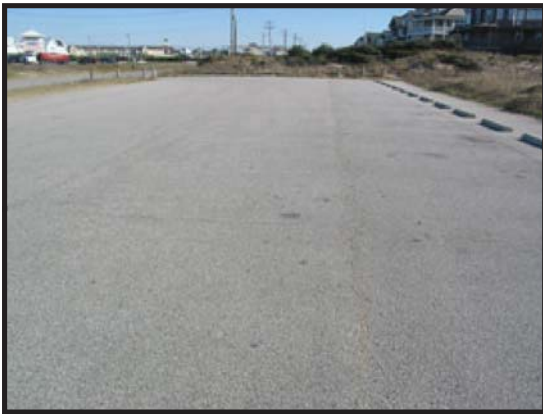
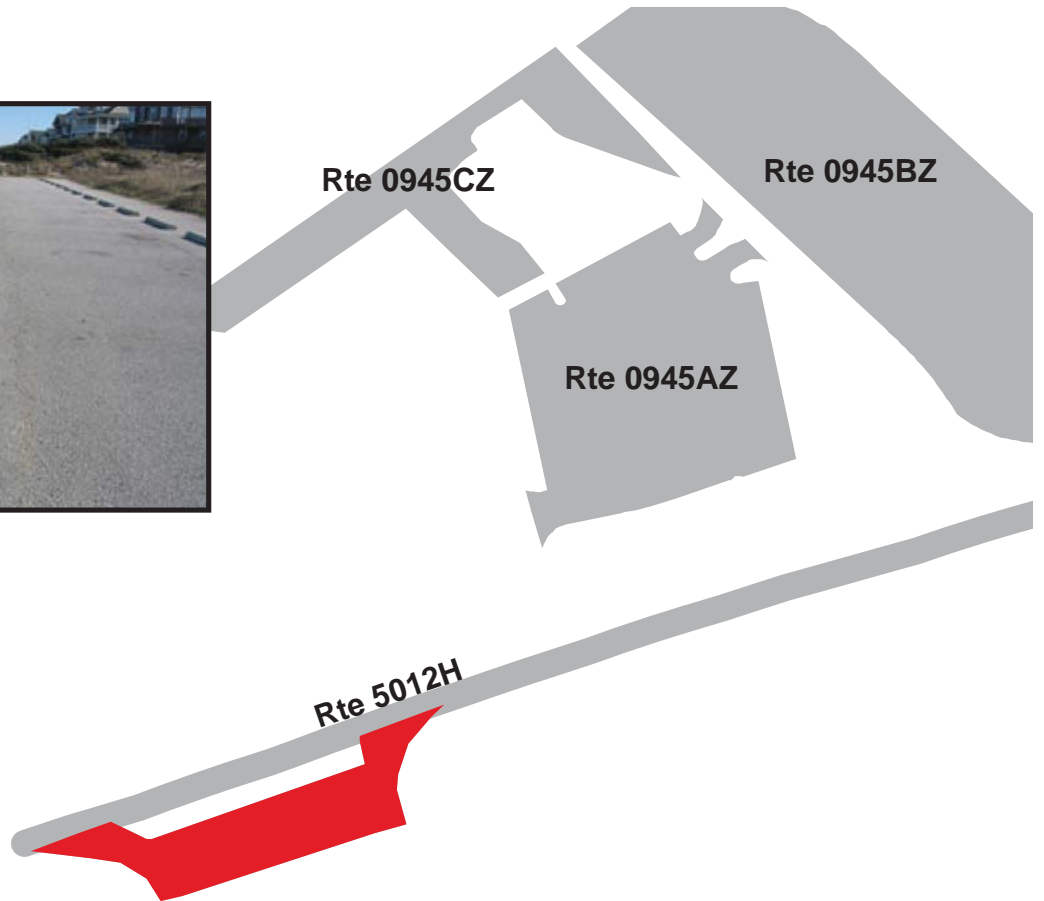
## Route 0943

Route Number	Public / NonPublic	Date Visited		Area (sq ft)	Lane Miles *	Surface Type
0943	PUBLIC	1/10/2007		15,171	0.26	AS
Culverts	Drop Inlets	Gates	Fire Hydrants	Curb & Gutter	Curb	PCR
0	0	0	0	NO CURB AND GUTTER	NO CURB	FAIR/73
