REPLACE JONES POINT TRAILER
JEAN LAFITTE NATIONAL HISTORICAL PARK & PRESERVE, NEW ORLEANS, LA

Hazardous Materials Assessment of Impacted Areas of Education Building, Administration Building, Maintenance Complex and Jones Point Trailer and Surrounding Site

August 15, 2024

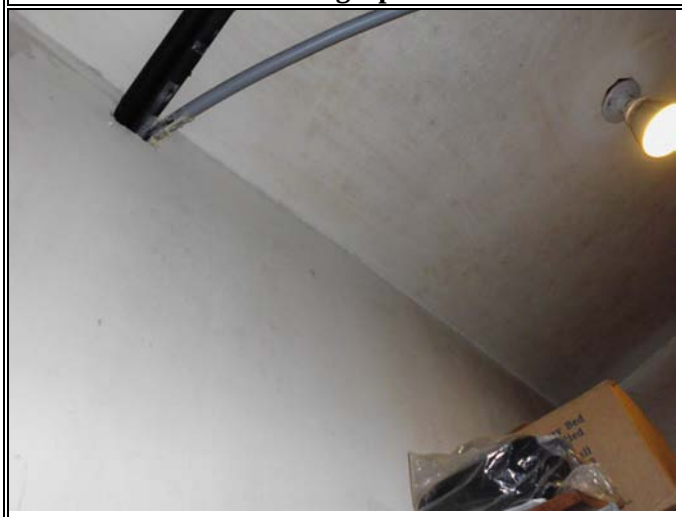
Photograph #3	**Photograph #4**

• Gypsum wallboard and joint compound- walls and ceilings. Samples of these materials were reported as “no asbestos detected” by the accredited laboratory. • Photo location was in exterior access Utility Closet.	• FT-3: Brown pebble pattern sheet vinyl flooring (SVF) and adhesive. Samples of these materials were reported as “no asbestos detected” by the accredited laboratory. • Photo location was in exterior access Utility Closet.

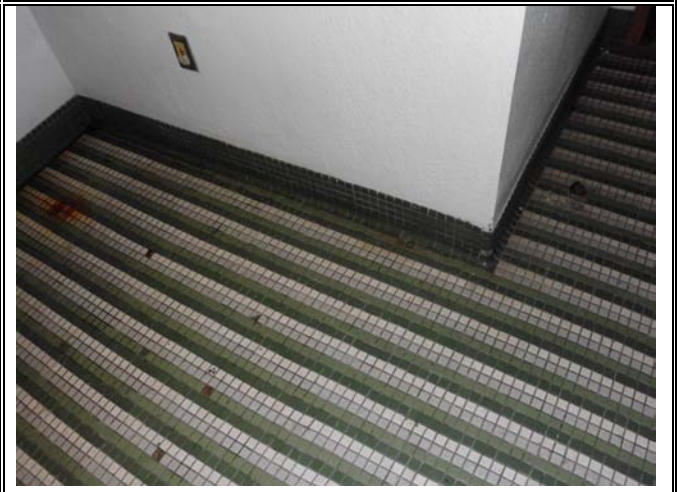
Photograph #3	**Photograph #4**

• Black coating on exterior metal door frame reported to contain lead above laboratory analytical method detection limit- 80 PPM. • Photo location was at Law Bldg at exterior entry doors to Bathrooms.	• Ceramic tile flooring in Bathrooms was assumed to contain lead above the laboratory analytical method detection limit in the glazing. • Photo location was in the Law Bldg in the Men's Bathroom.

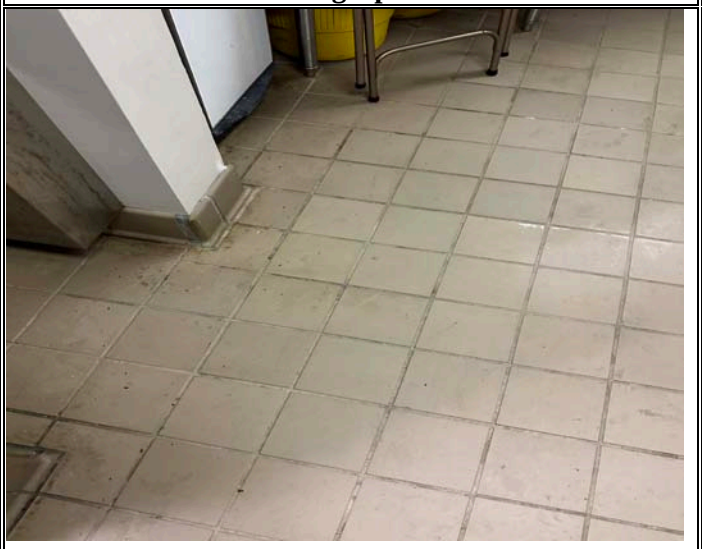
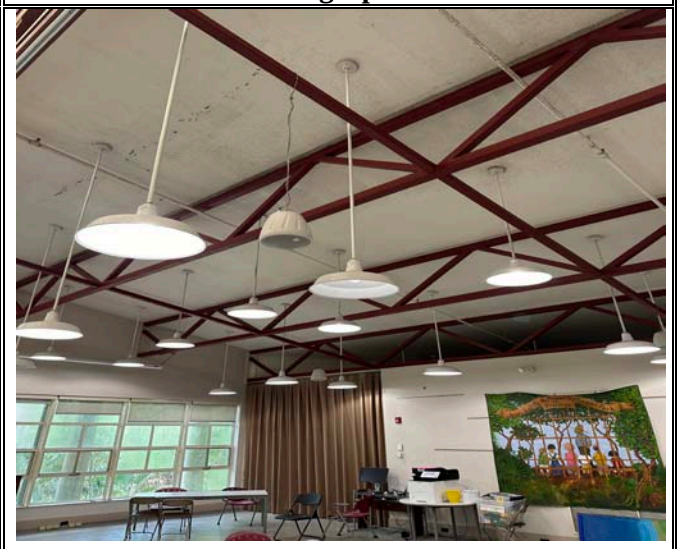
Photograph #5	**Photograph #6**

• Glazing on 8” Quarry Tile flooring was assumed to contain lead above laboratory analytical method detection limit. • Photo location was at Education Bldg in the Kitchen.	• Red coating on Structural Steel was assumed to contain lead above the laboratory analytical method detection limit. • Photo location was in the Education Bldg in the MultiPurpose area.

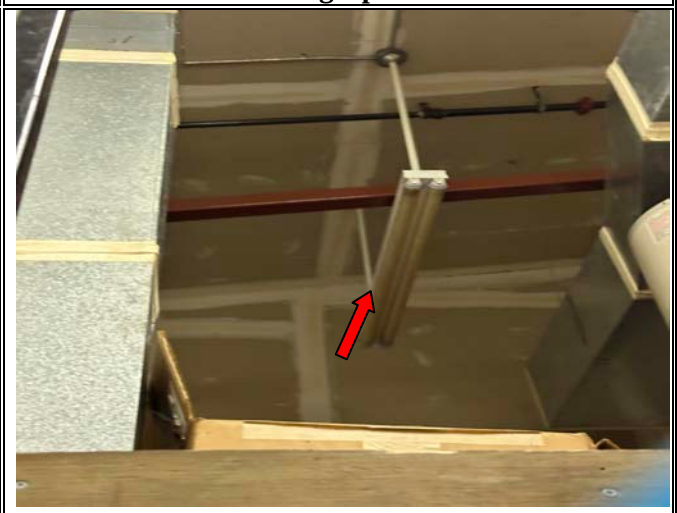
Photograph #3	Photograph #4

• MHM:- fluorescent light fixtures with mercury containing bulbs. Fluorescent Bulbs contain mercury and ballasts possibly contain PCBs. • Photo location was in Kitchen area.	• MHM:- fluorescent light fixtures with mercury containing bulbs. Fluorescent Bulbs contain mercury and ballasts possibly contain PCBs. • Photo location was in Mechanical space above Storage area.

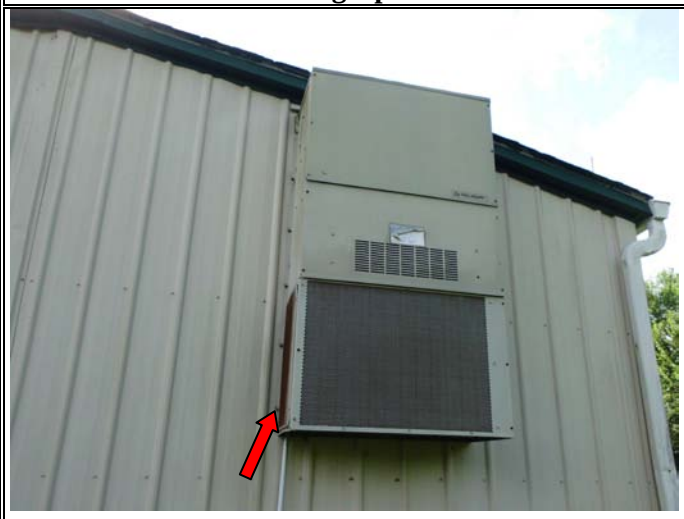
Photograph #1	**Photograph #2**

• Miscellaneous Hazardous Materials (MHM): Exterior wall mounted self-contained packaged AC and Heat unit with potential to contain Freon, an Ozone Depleting Substance (ODS). • Photo location was on exterior west elevation of Trailer.	• MHM- 2’ x 4’- 2 bulb fluorescent light fixture with mercury containing bulbs and possible PCB lighting ballasts. • Photo location was in interior room of Trailer.
