# LAWSON ARMY AIRFIELD STORMWATER ASSESSMENT AND CAPITAL IMPROVEMENT PLAN

Prepared for: **Columbus Water Works**

File: 3577421  
June 30, 2017

**BWSC** | BARGE  
WAGGONER  
SUMNER &  
CANNON, INC.®

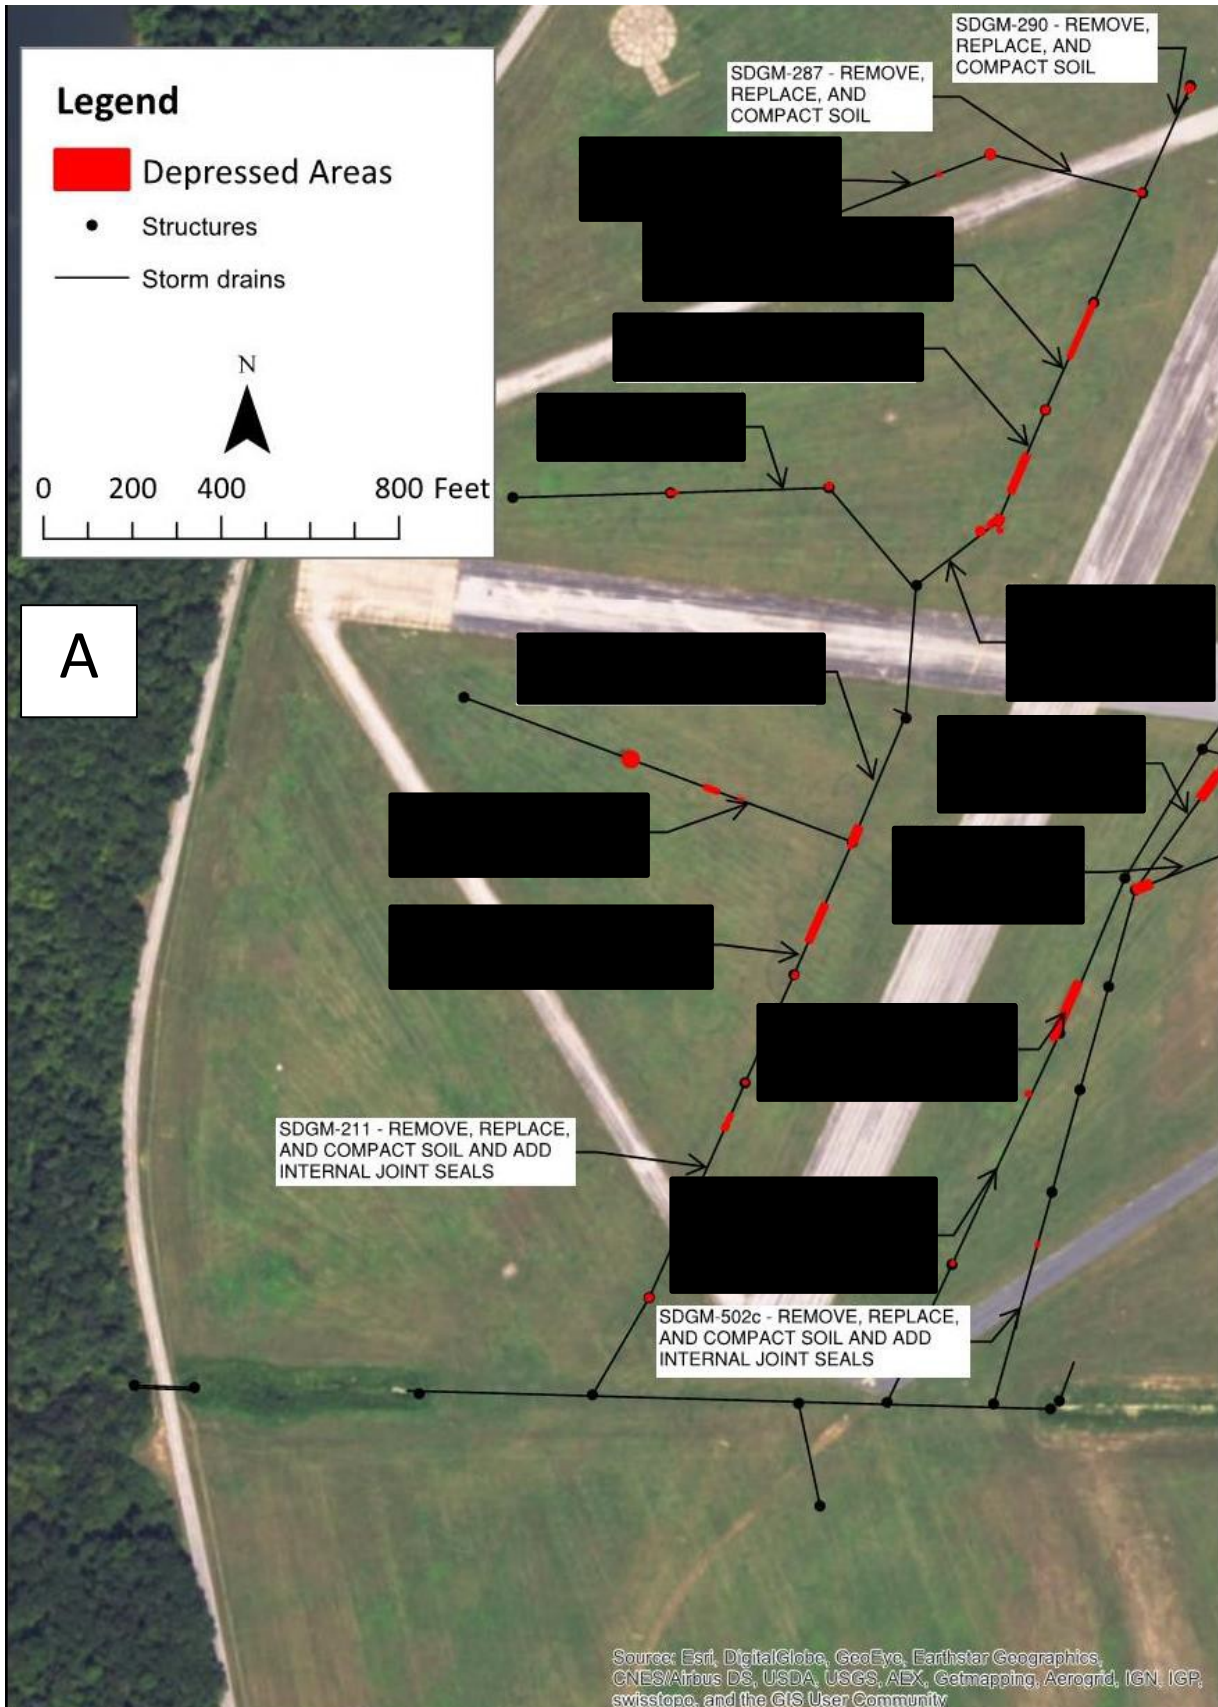
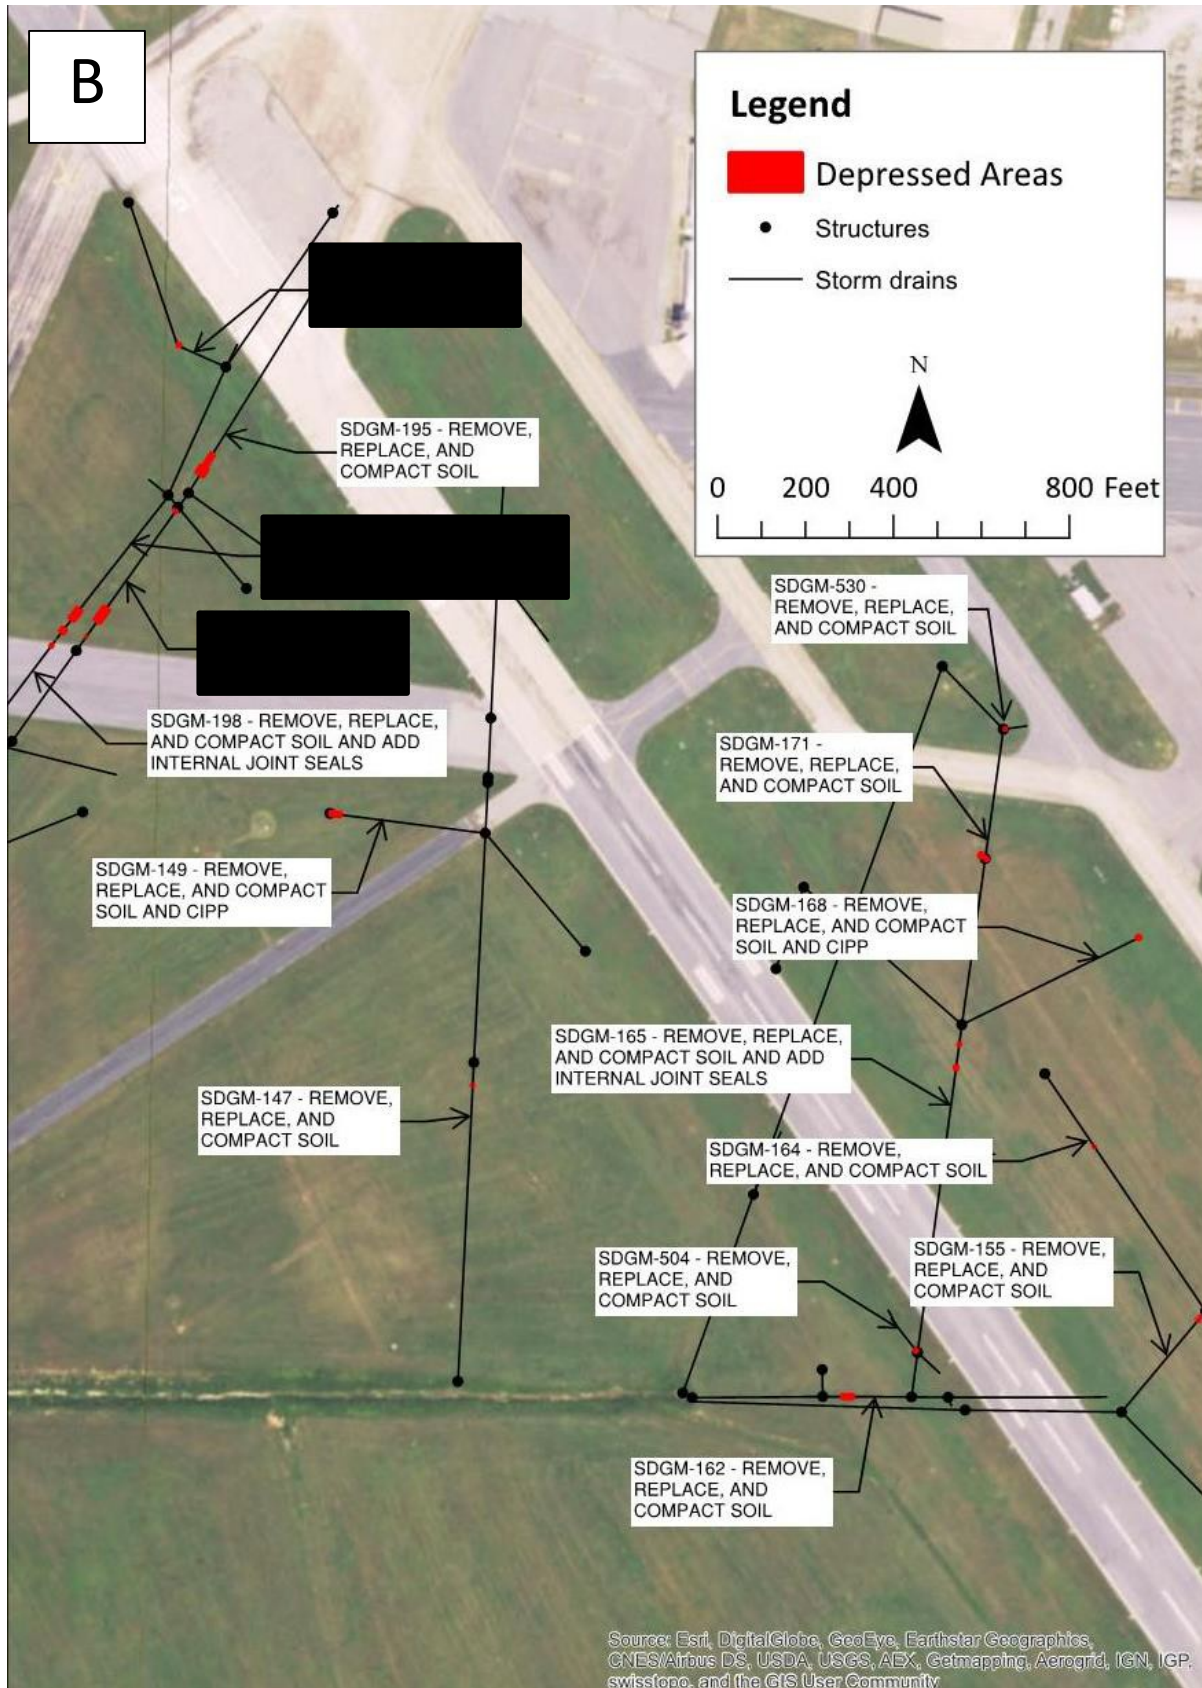
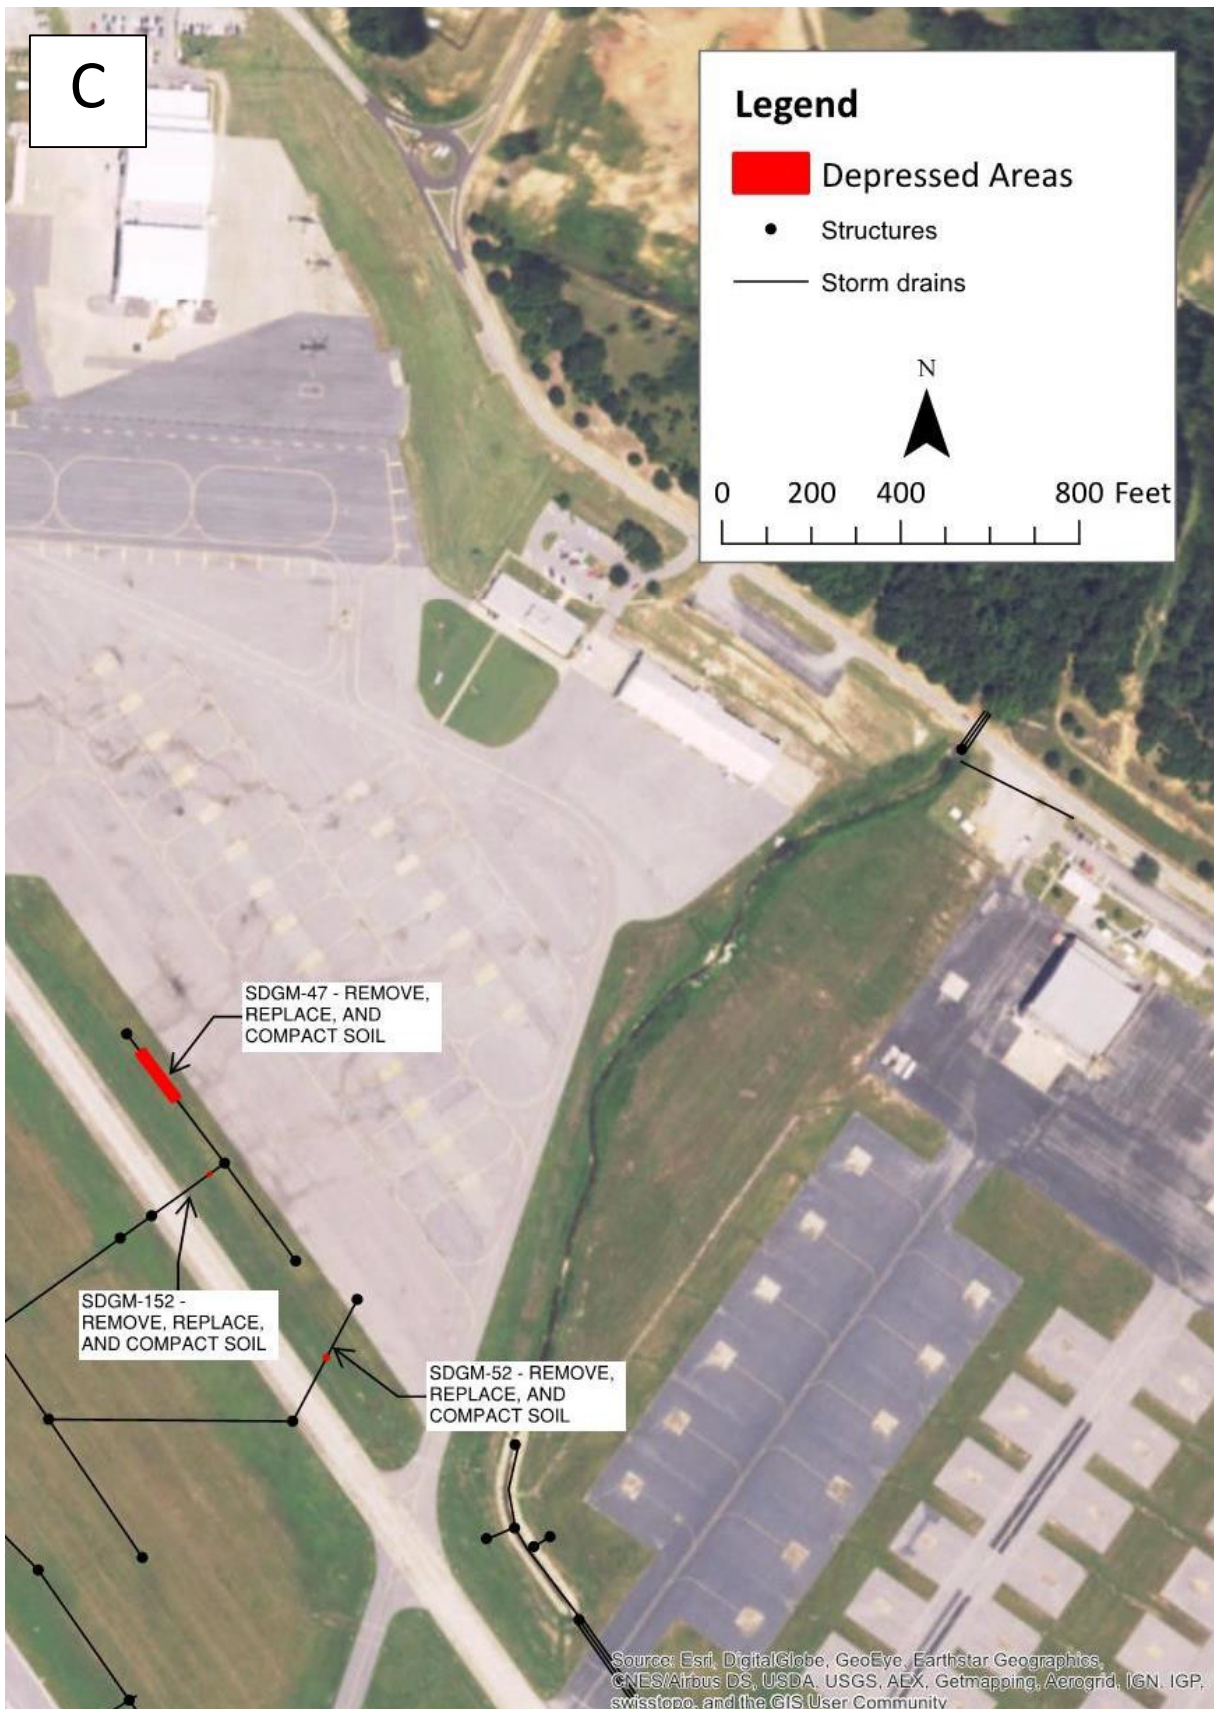
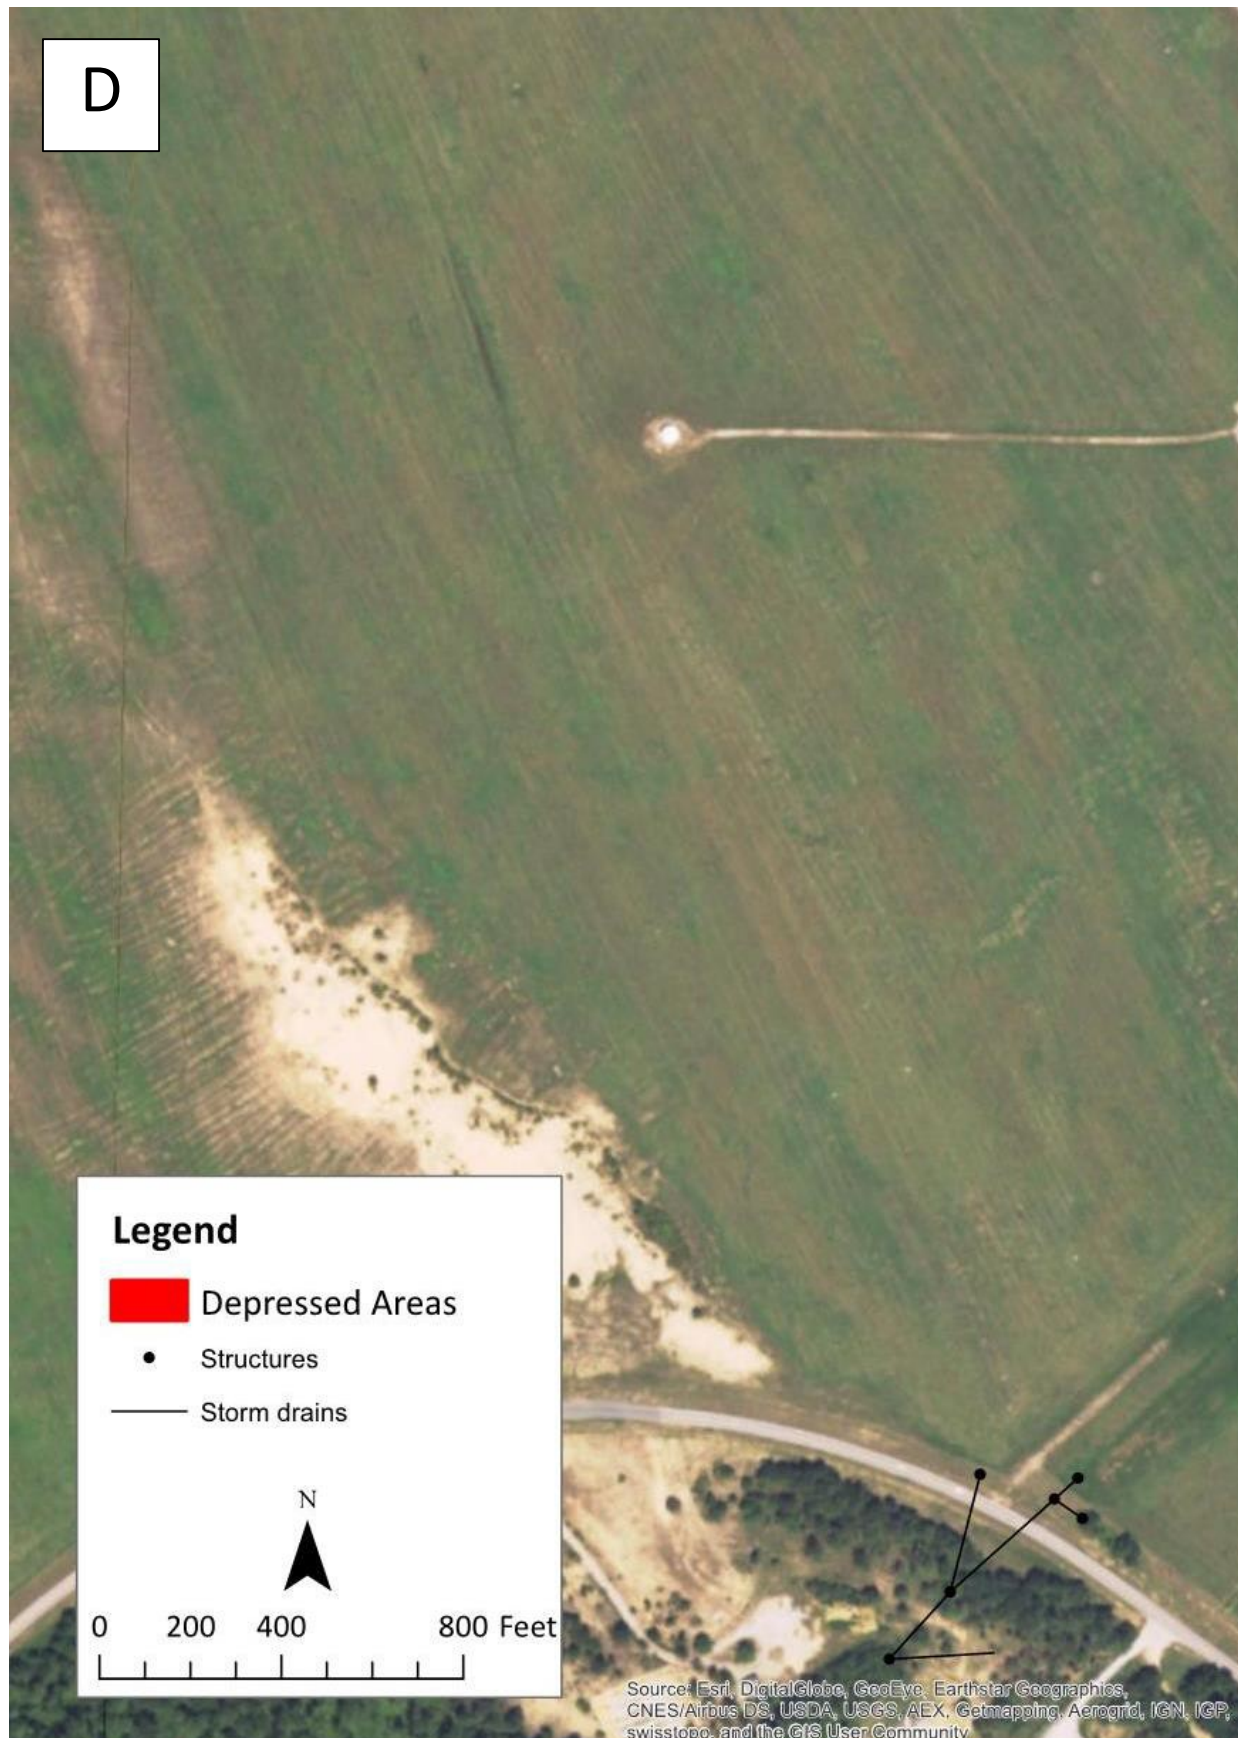
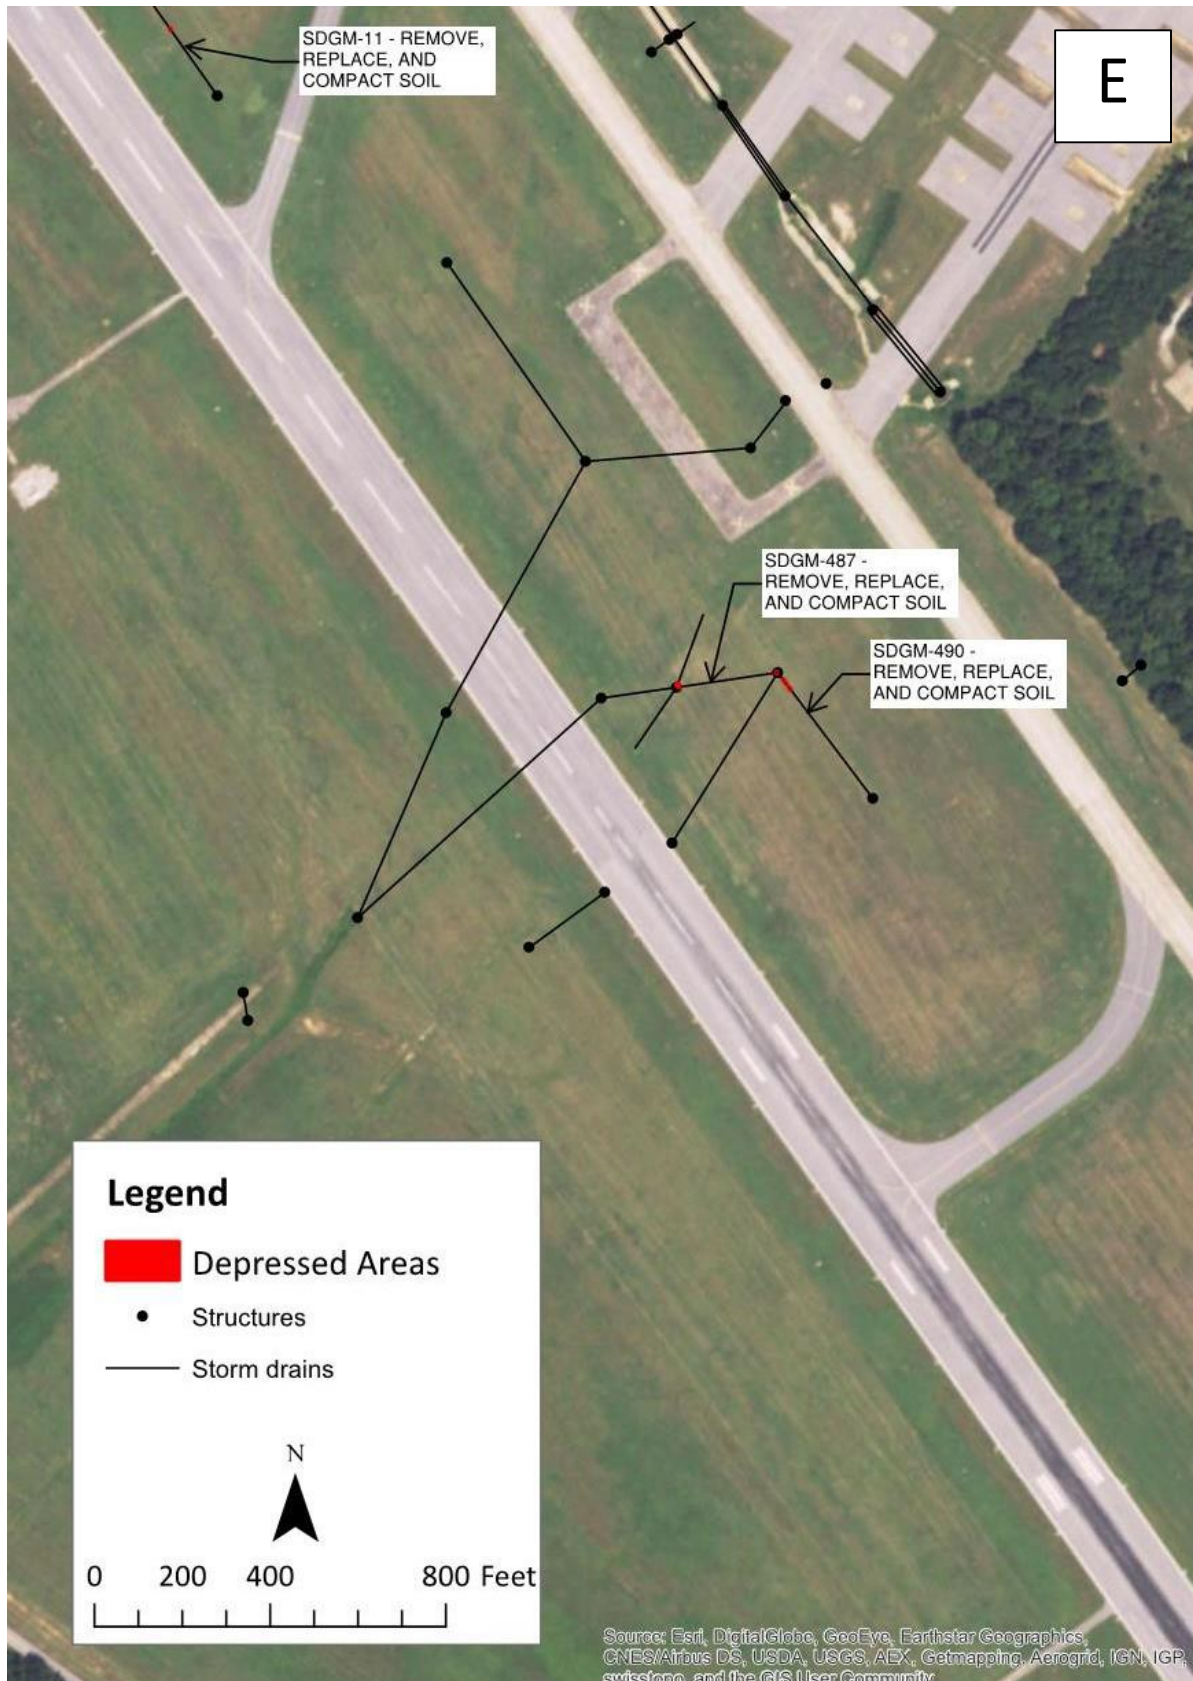
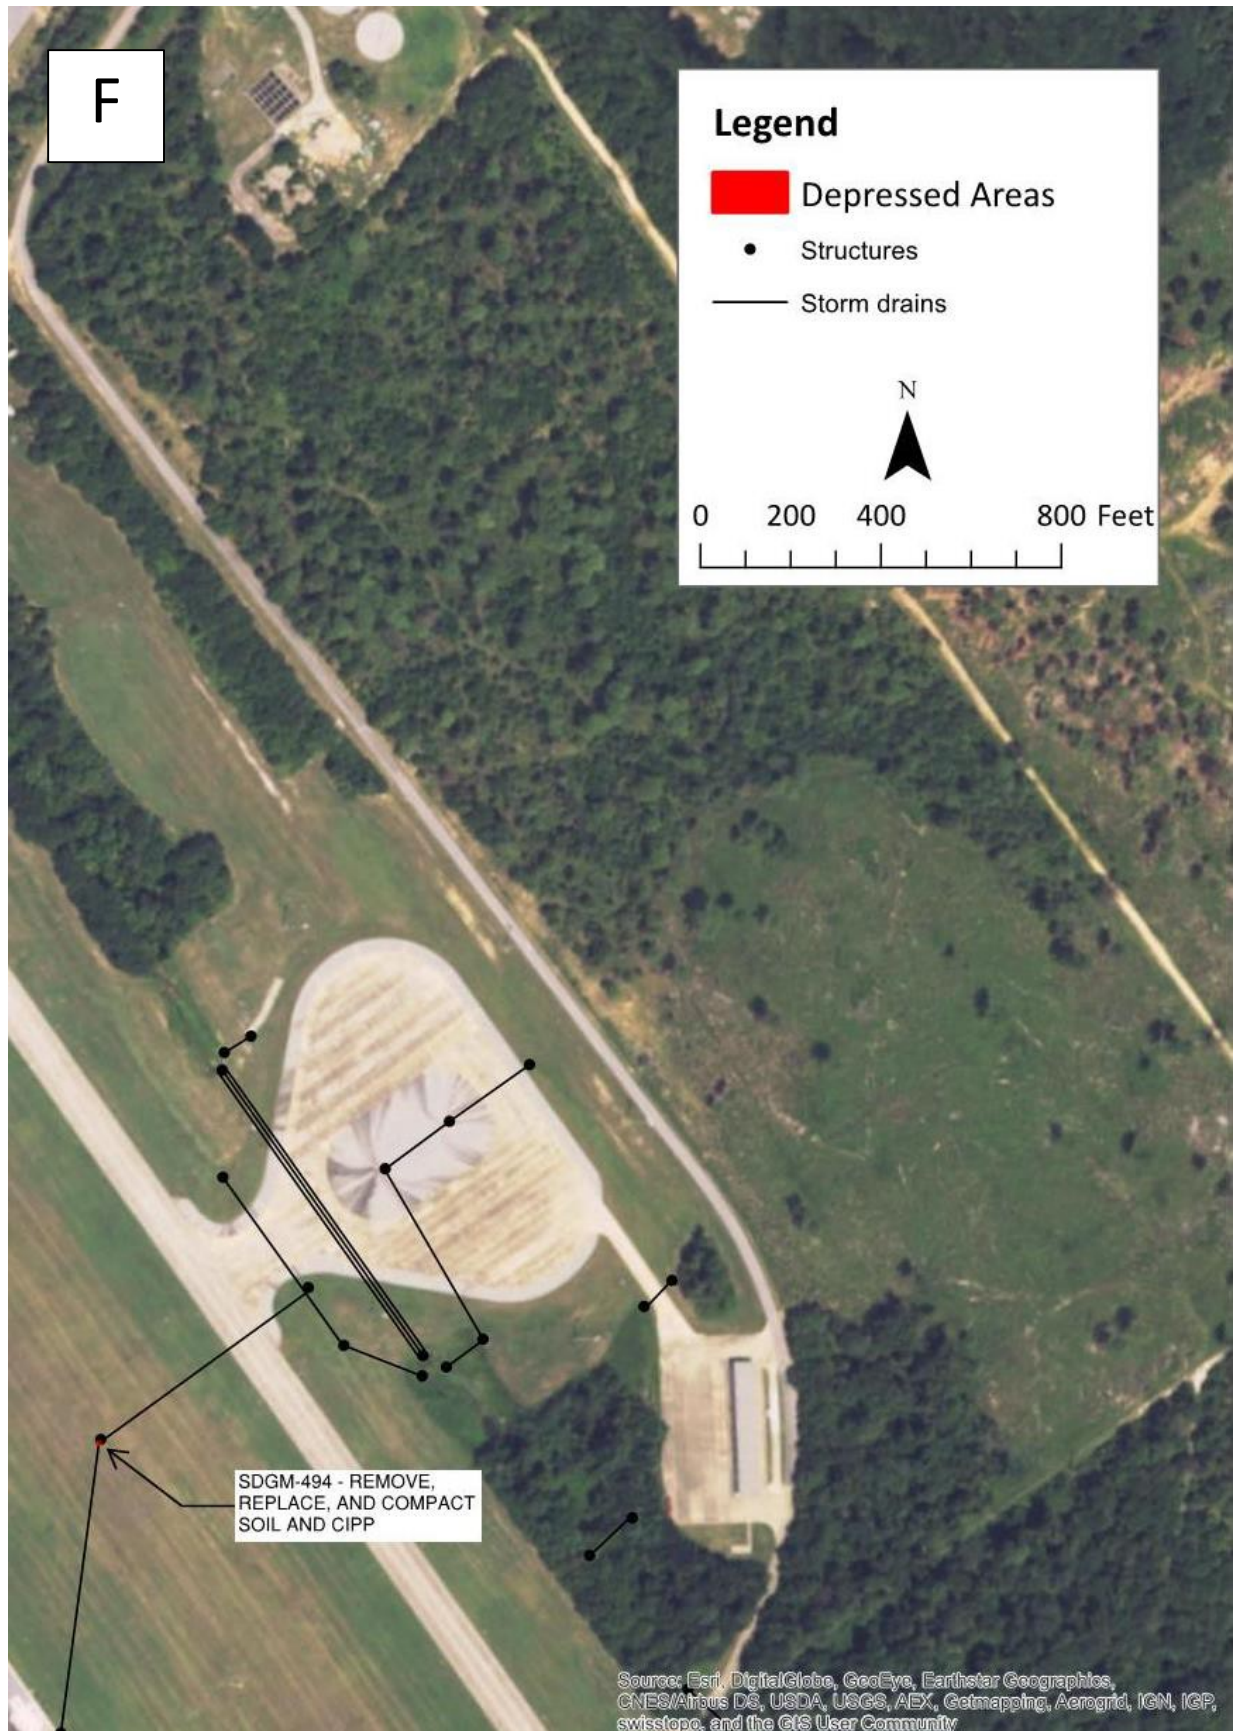
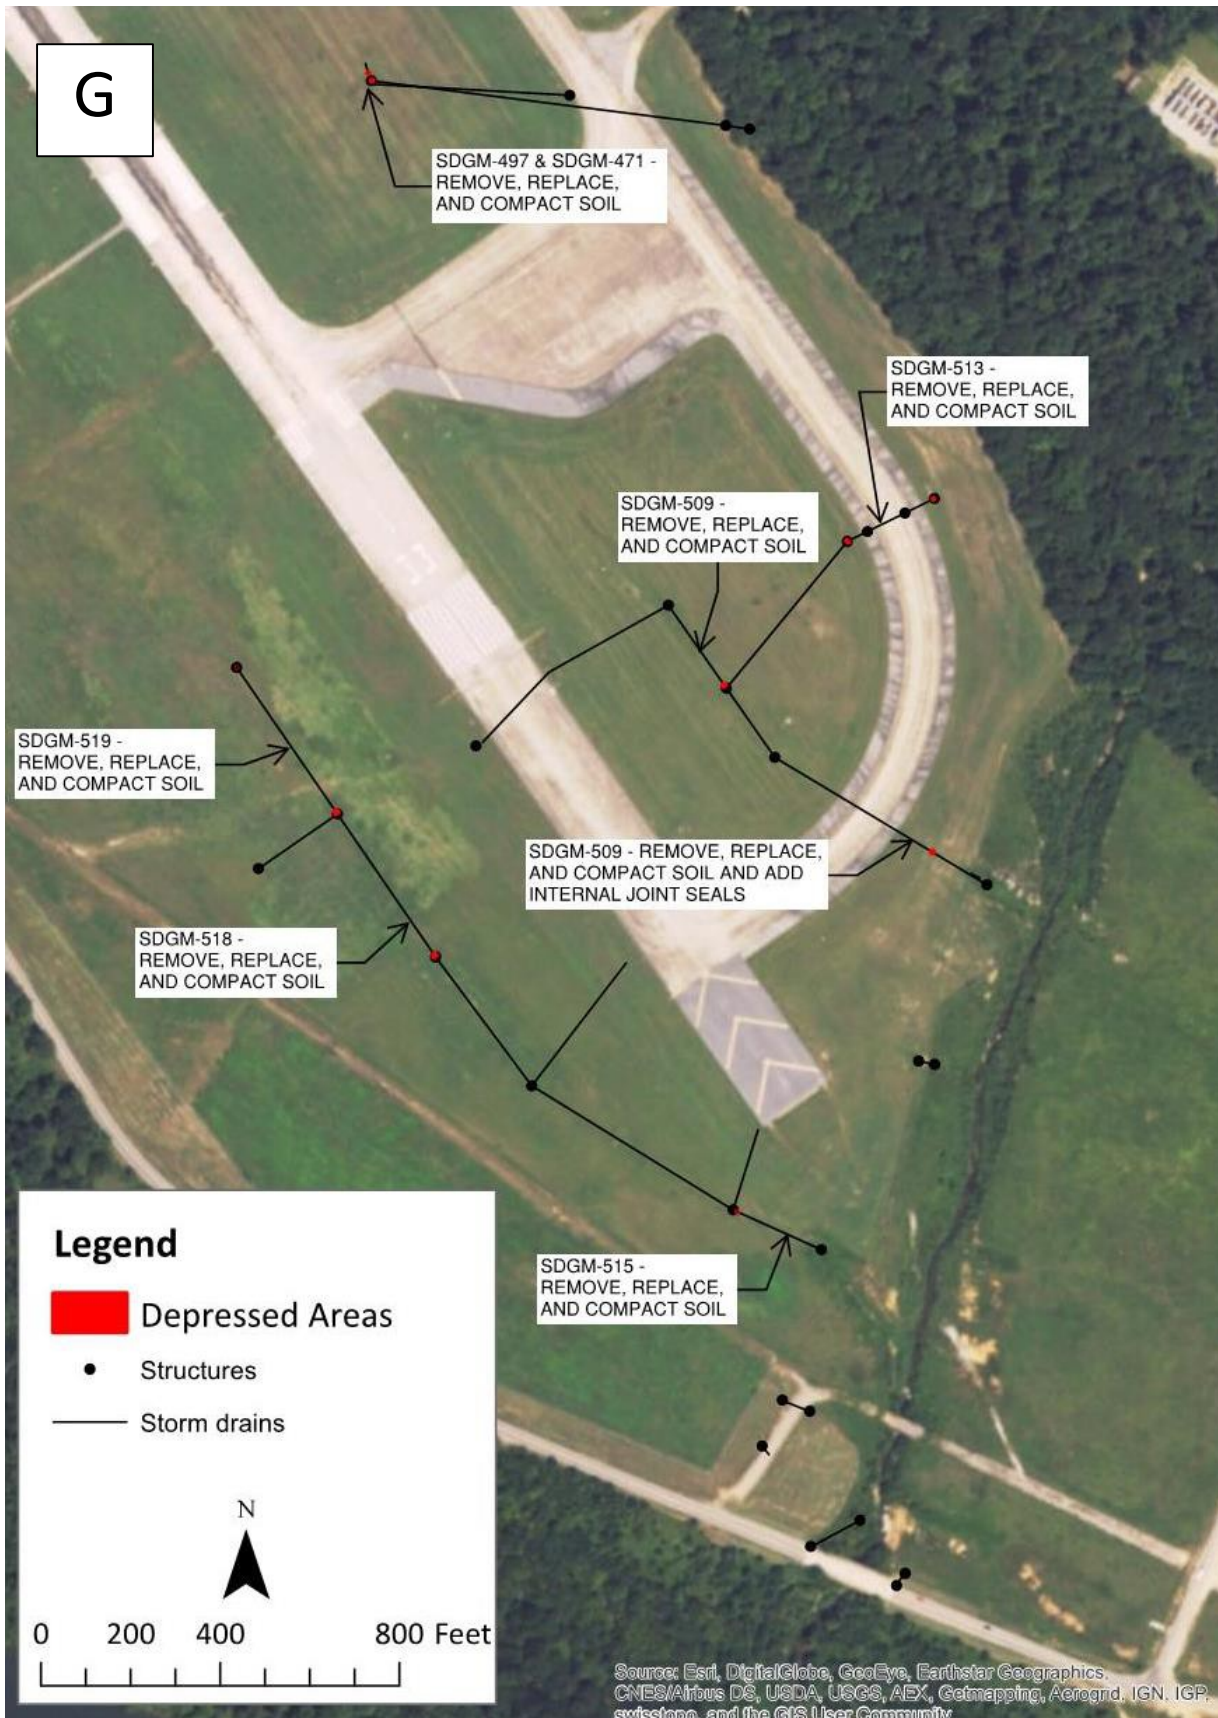
## **APPENDIX H: DETAILED MAPS OF DEPRESSED AREAS A-G**

Figure 23 illustrates the depressed areas identified during our field work within the study area. When compared with the condition assessment of the storm drain pipes, it was discovered that the depressed areas were not largely due to pipe collapses, but rather infiltration in pipe joints or poorly compacted soils which have consolidated over time. Due to these findings, depressed areas throughout LAAF are recommended to be addressed according to three different criteria:

1. In situations where there is a depressed area above a pipe with no detectable infiltration of sediment into the pipe, remove the soil above the pipe and replace the soil in compacted lifts (imported soil will be utilized to match adjacent grades as necessary).
2. In situations where there is a sinkhole present over pipes with significant infiltration of sediment into the pipe and for instances in which the pipe diameter is large enough for man entry, the recommended repair is to either wipe the joints with mortar, use internal mechanical joint sealants, or Spraycast. Then, remove the soil above the pipe and replace

- the soil in compacted lifts (imported soil will be utilized to match adjacent grades as necessary).
3. In situations where there is a sinkhole present over pipes with significant infiltration of sediment into the pipe and for instances in which the pipe diameter is **not** large enough for man entry and Spraycast is not possible, the recommended repair is CIPP. Then, remove the soil above the pipe and replace the soil in compacted lifts (imported soil will be utilized to match adjacent grades as necessary).
