# LAWSON ARMY AIRFIELD PHASE II/MAIN POST PHASE I STORMWATER ASSESSMENT AND CAPITAL IMPROVEMENT PLAN

Prepared  
For: Columbus Water Works

September 2018

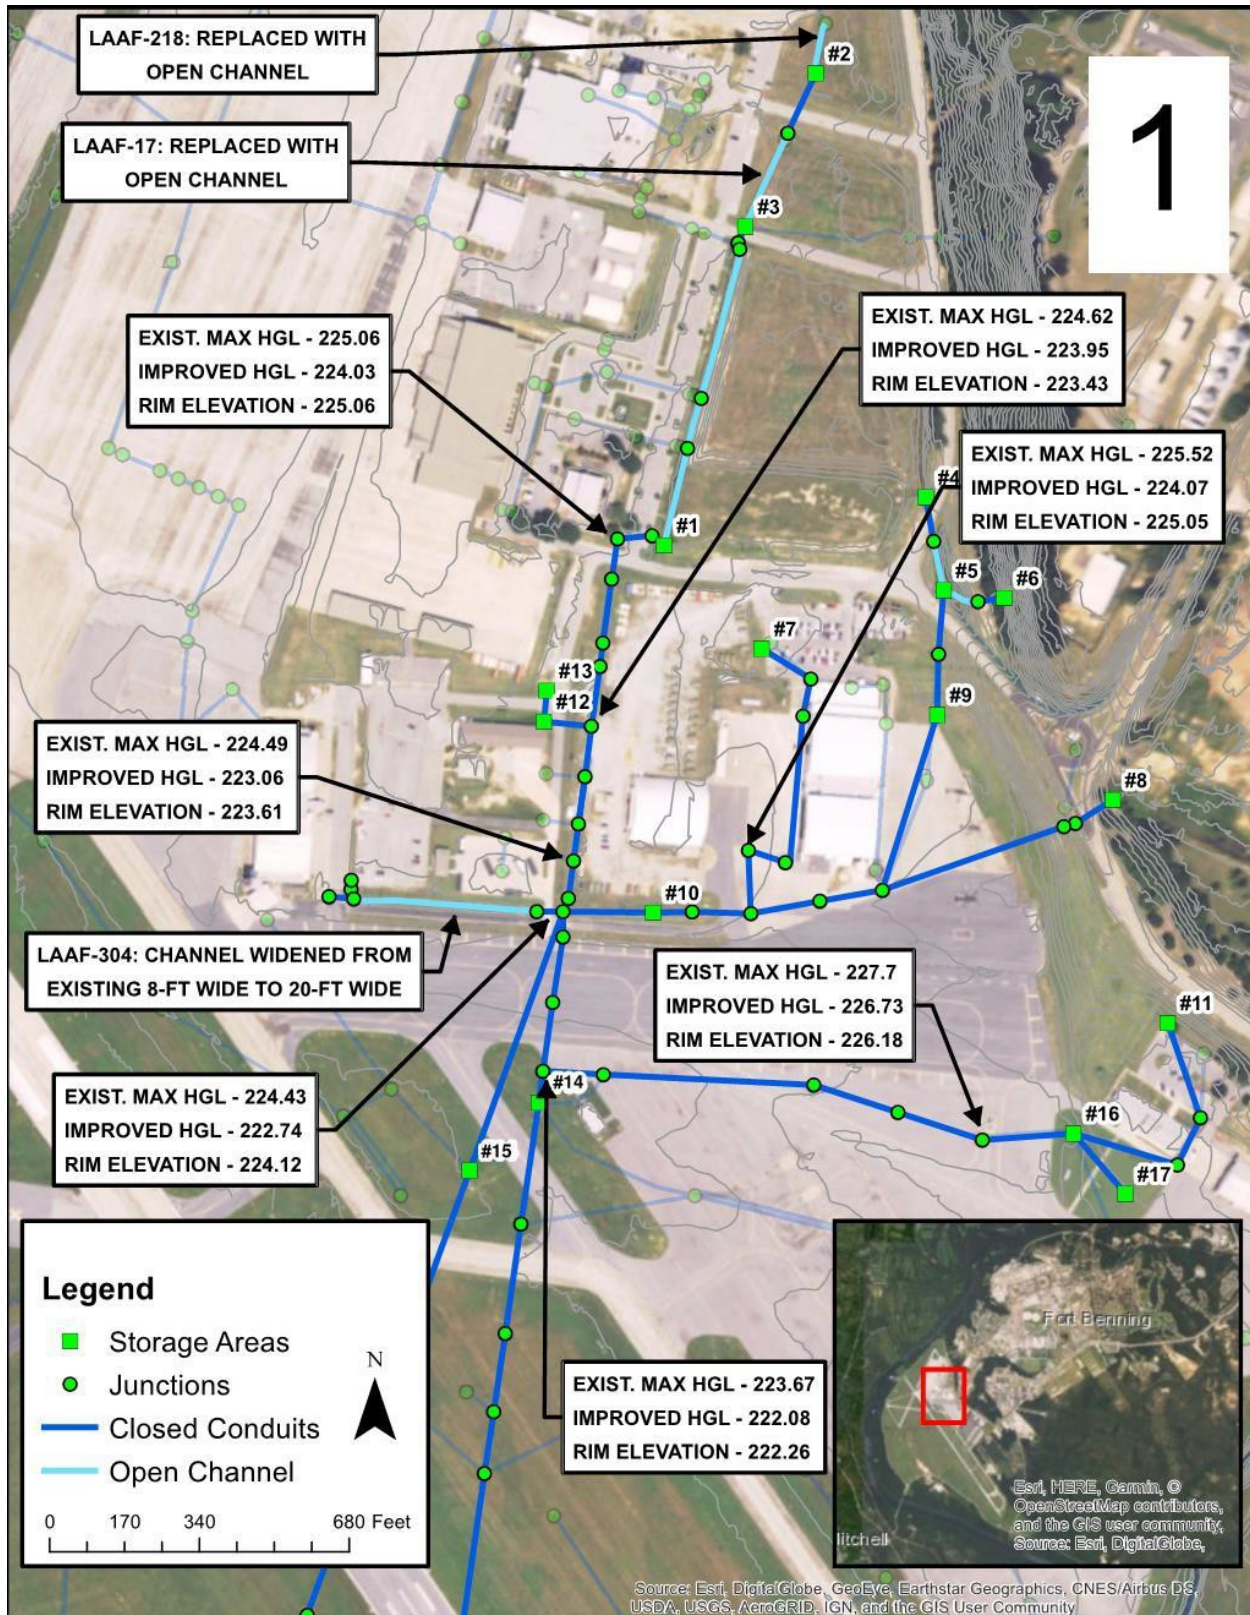
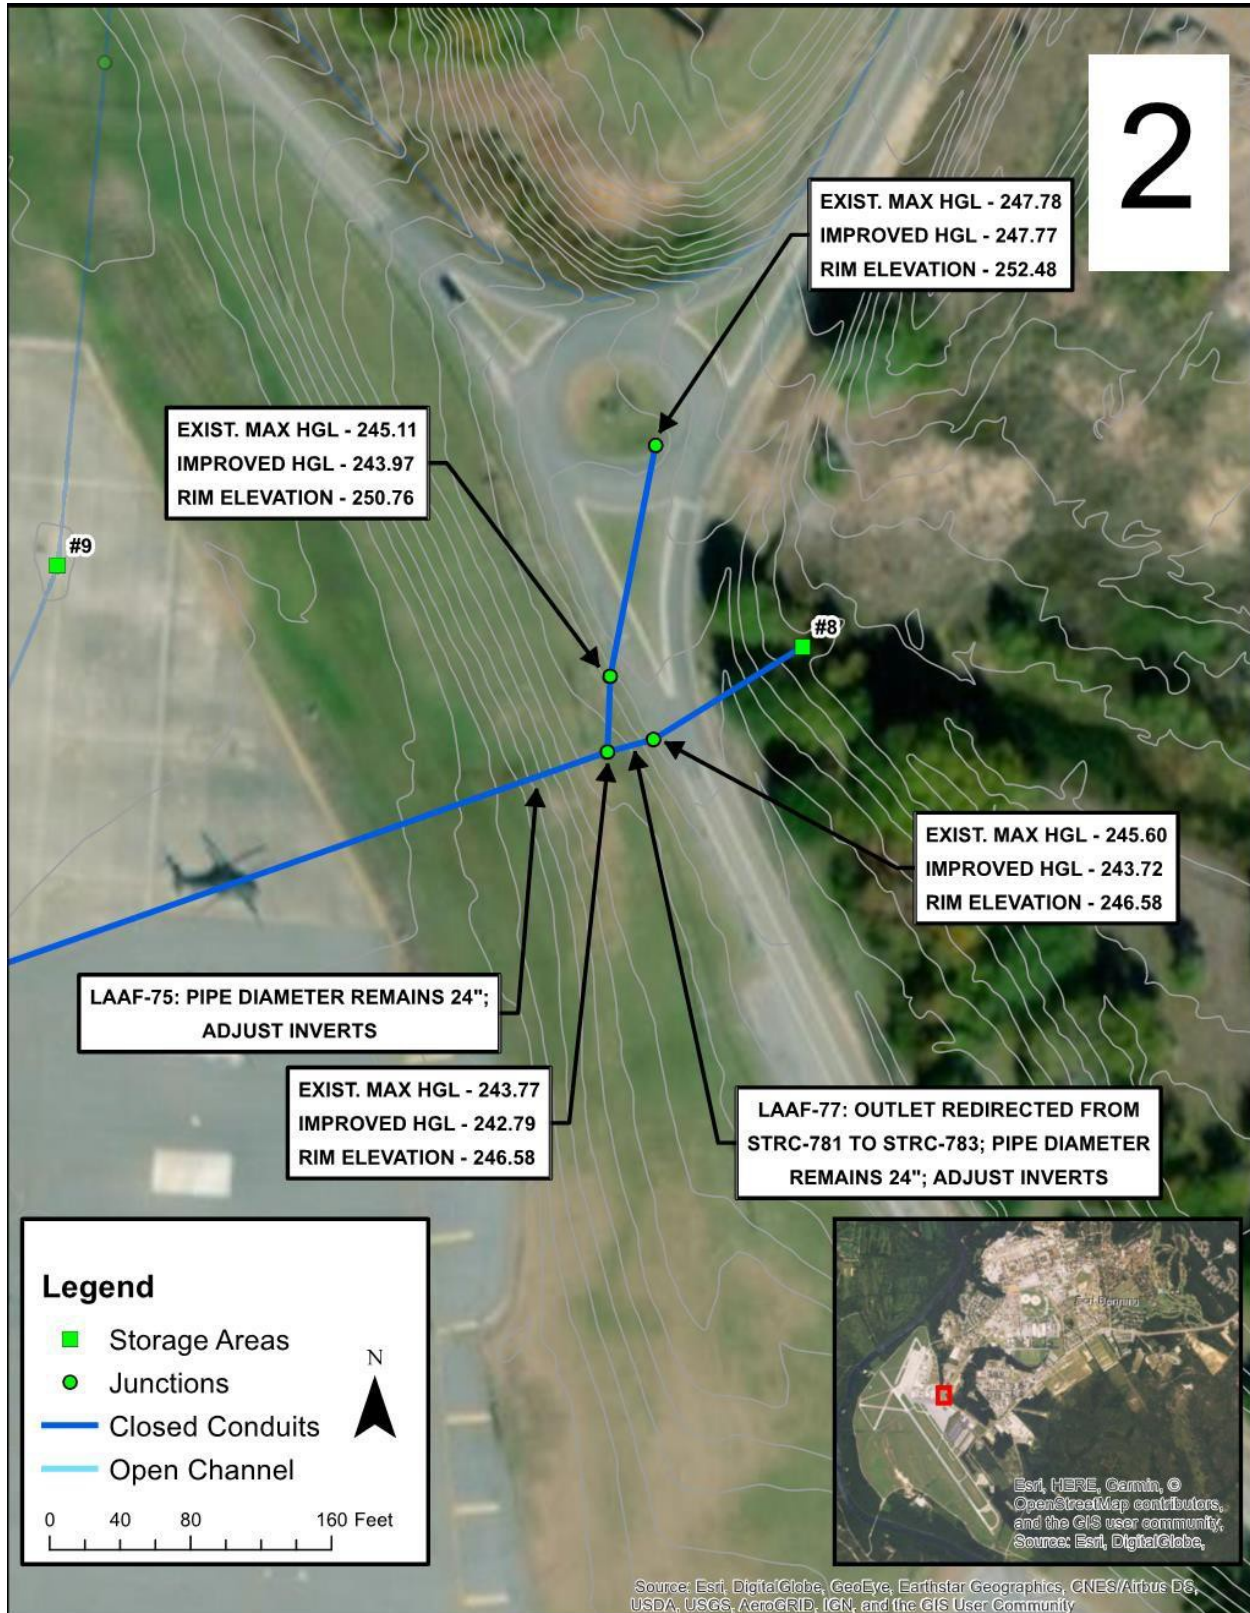
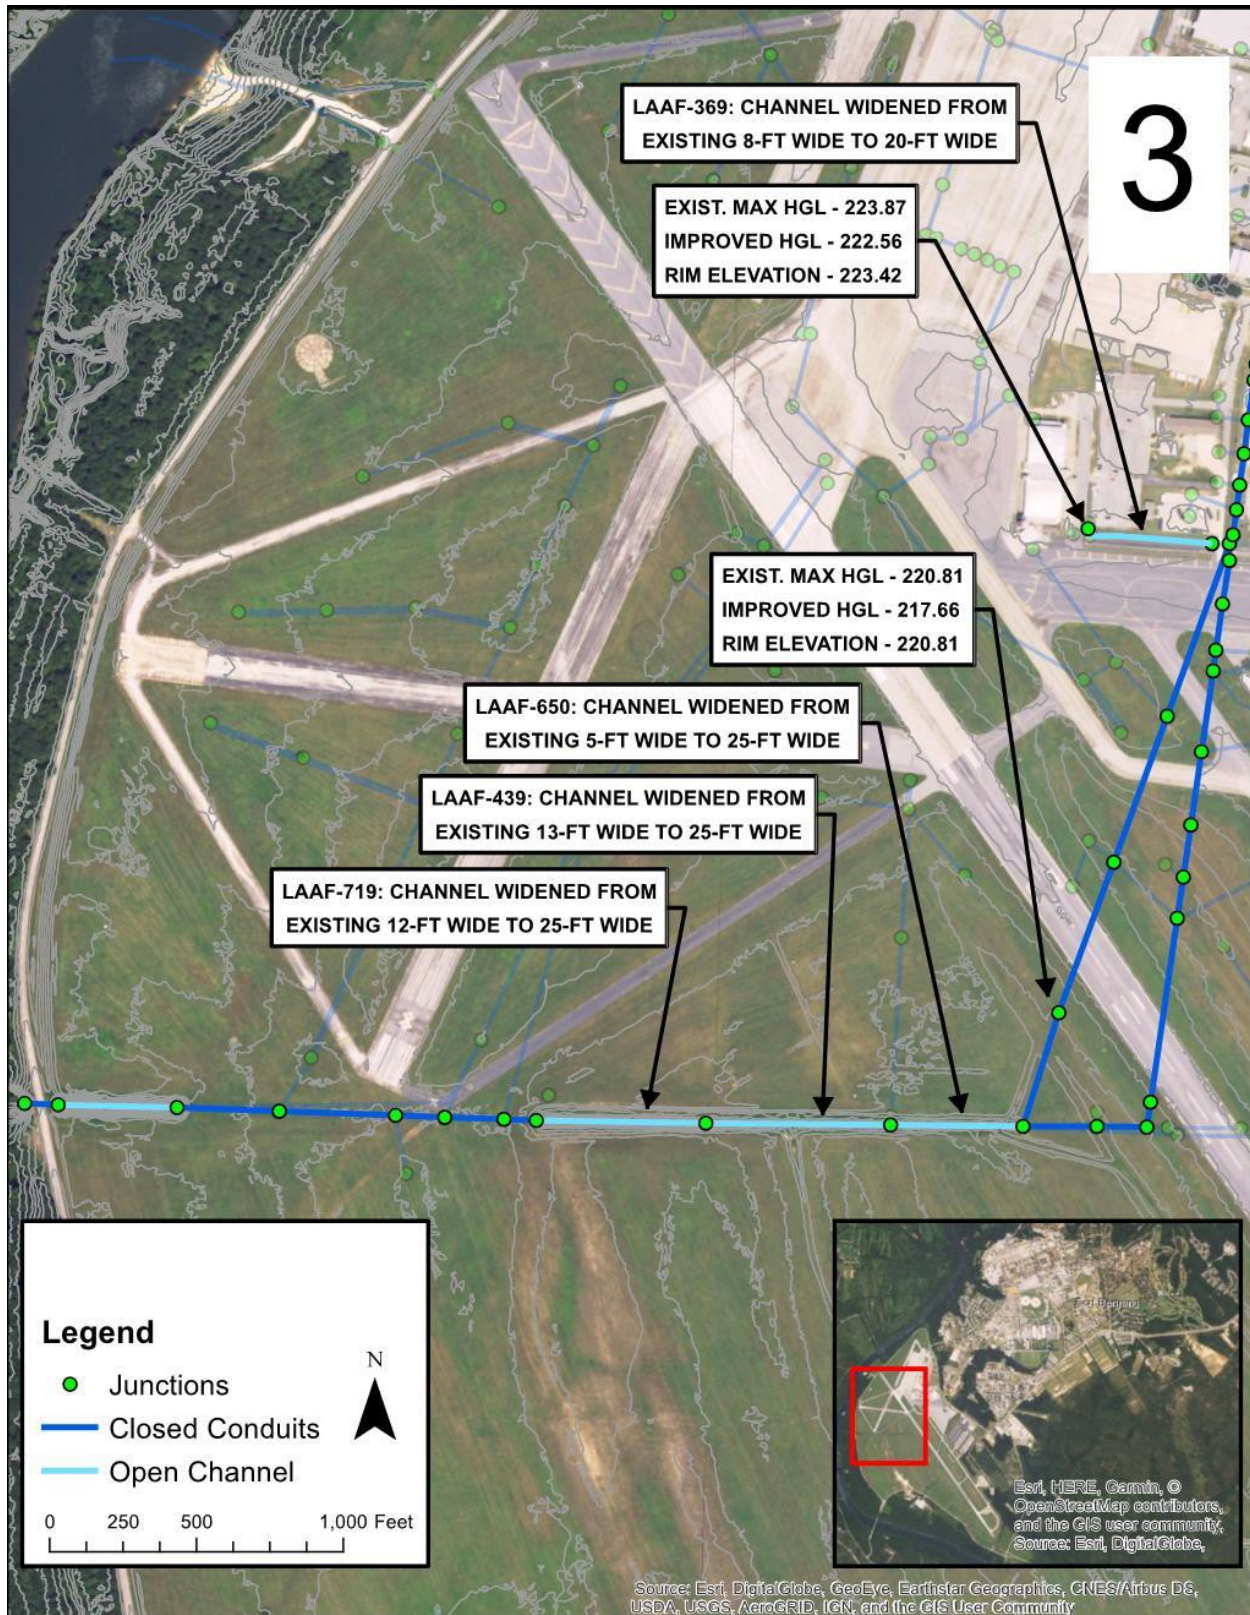
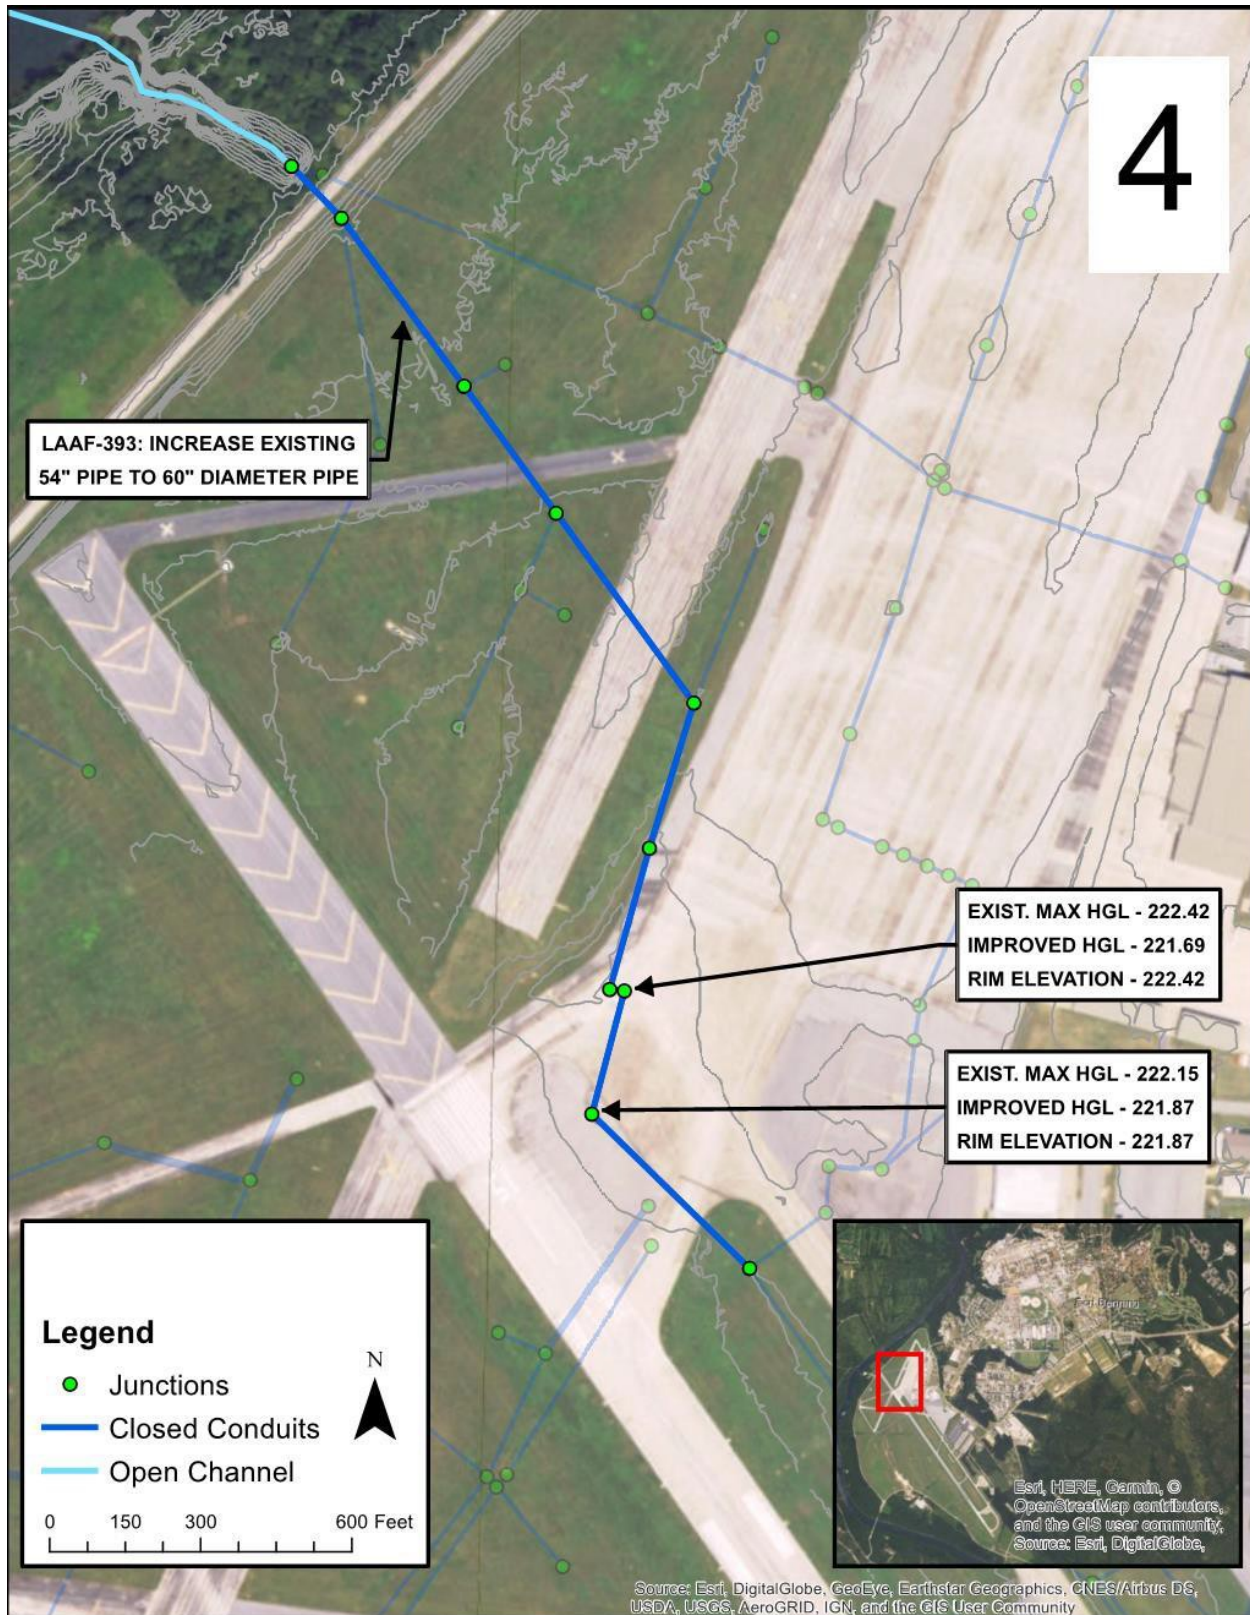
## **APPENDIX H: MAPS OF RECOMMENDED REPAIRS BASED ON HYDRAULIC CAPACITY ANALYSIS**

Table 2 through Table 6 outline the recommended modifications to improve stormwater system performance, and Appendix H provides figures that display the recommended stormwater system modifications and improved system performance. The recommended modifications either eliminated or minimized overflows for the 25-year, 24-hour design storm considered in this analysis.
