# LAWSON ARMY AIRFIELD PHASE II/MAIN POST PHASE I STORMWATER ASSESSMENT AND CAPITAL IMPROVEMENT PLAN

Prepared  
For: Columbus Water Works

September 2018

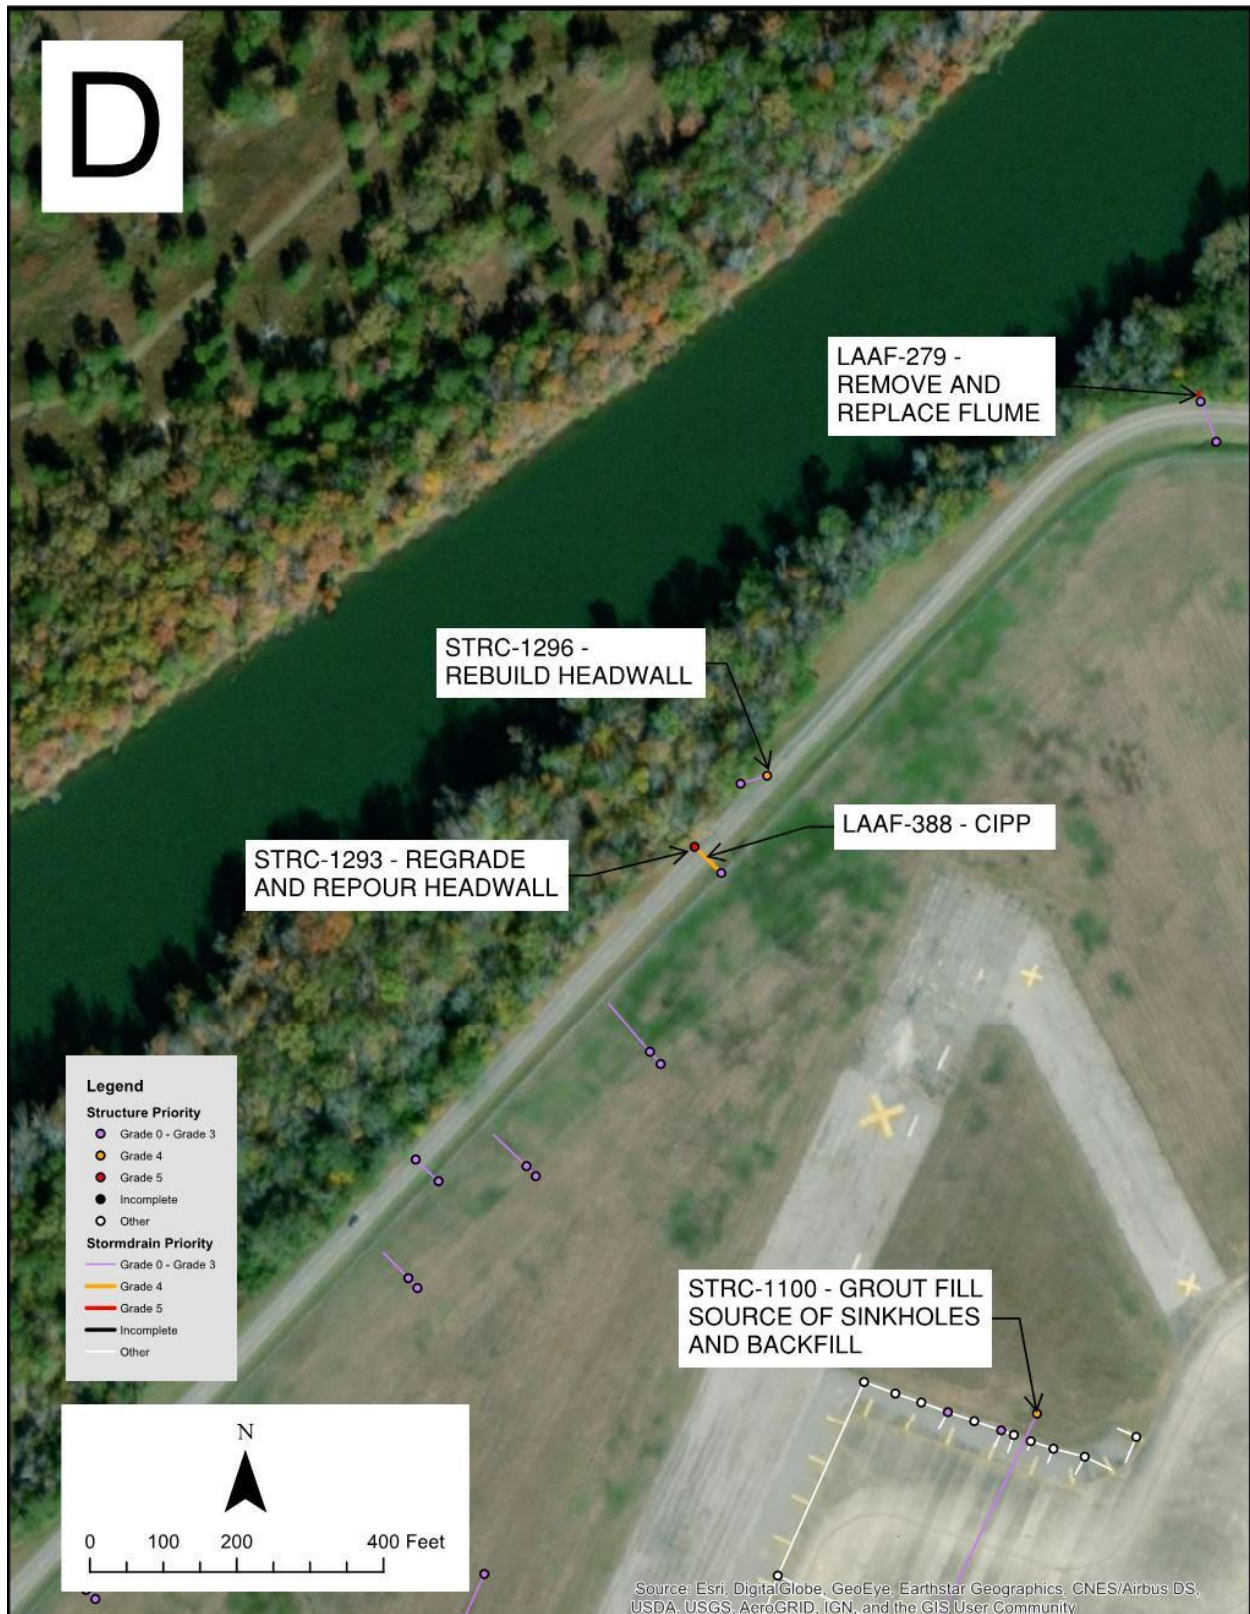
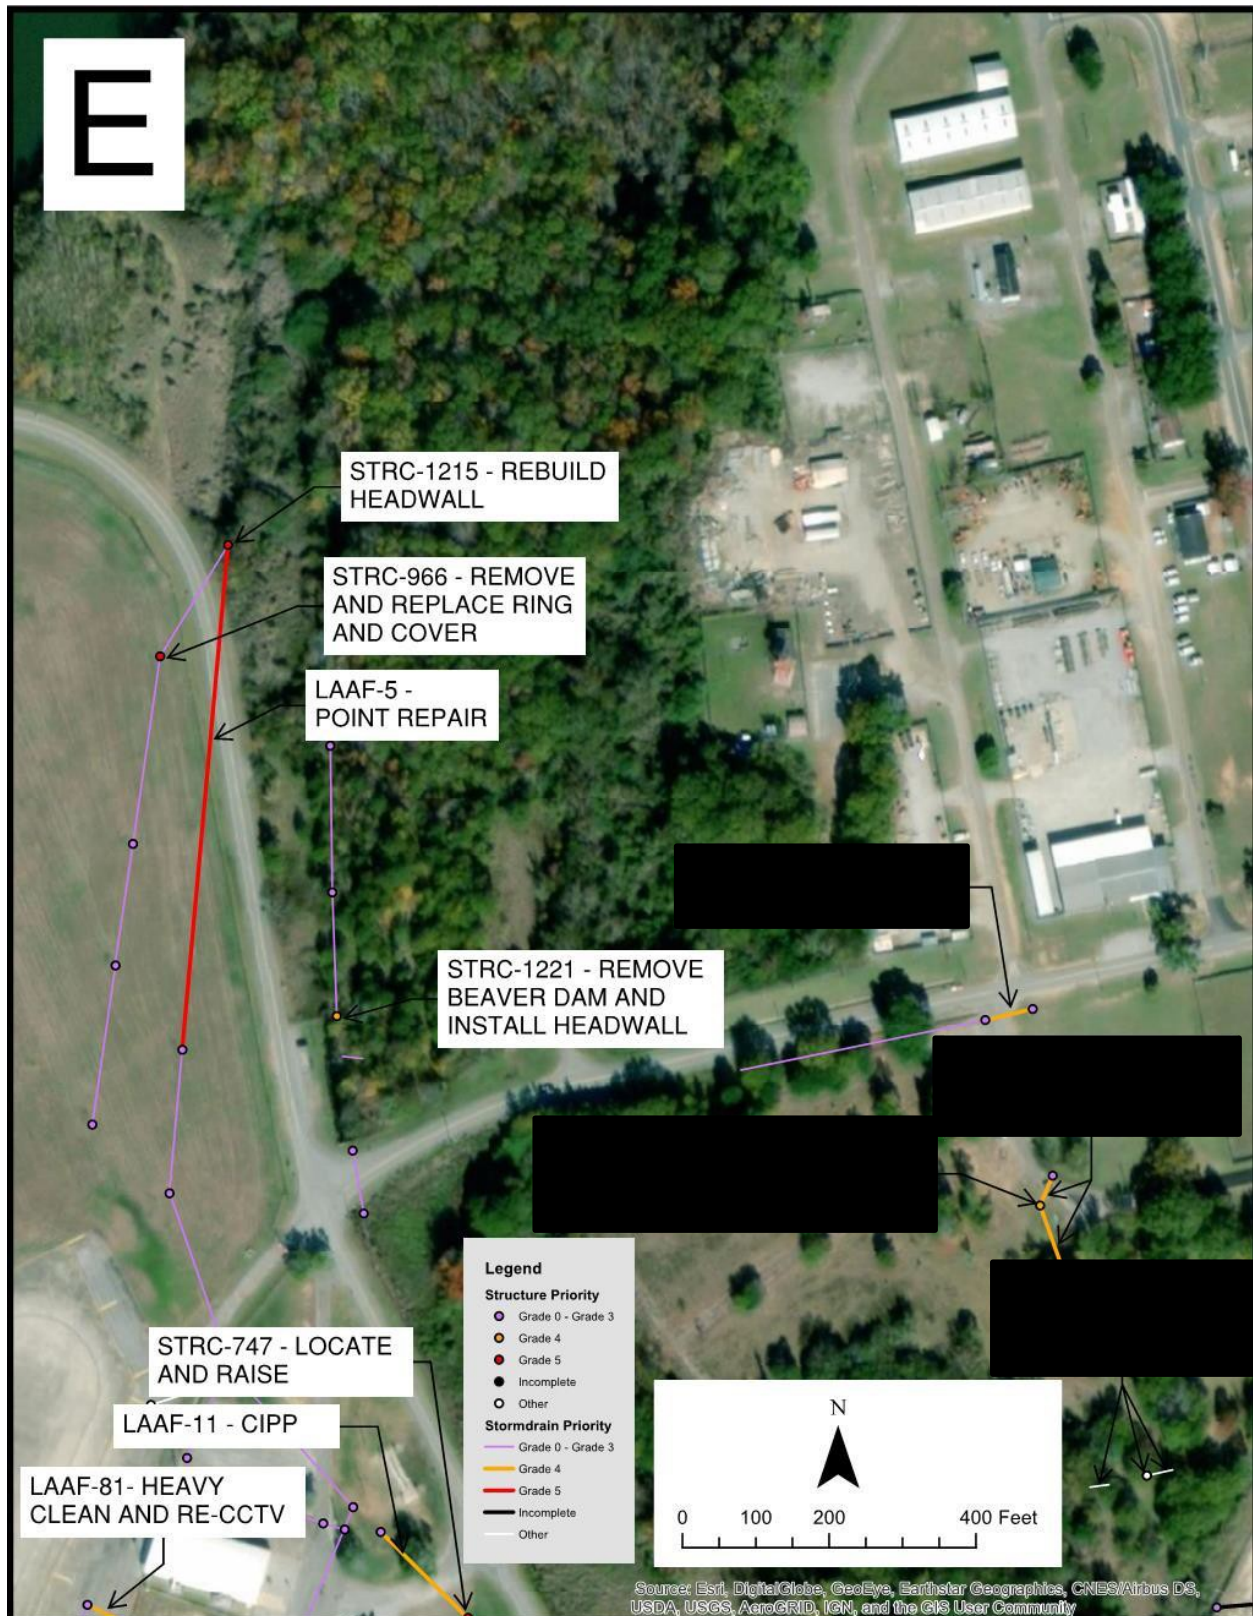
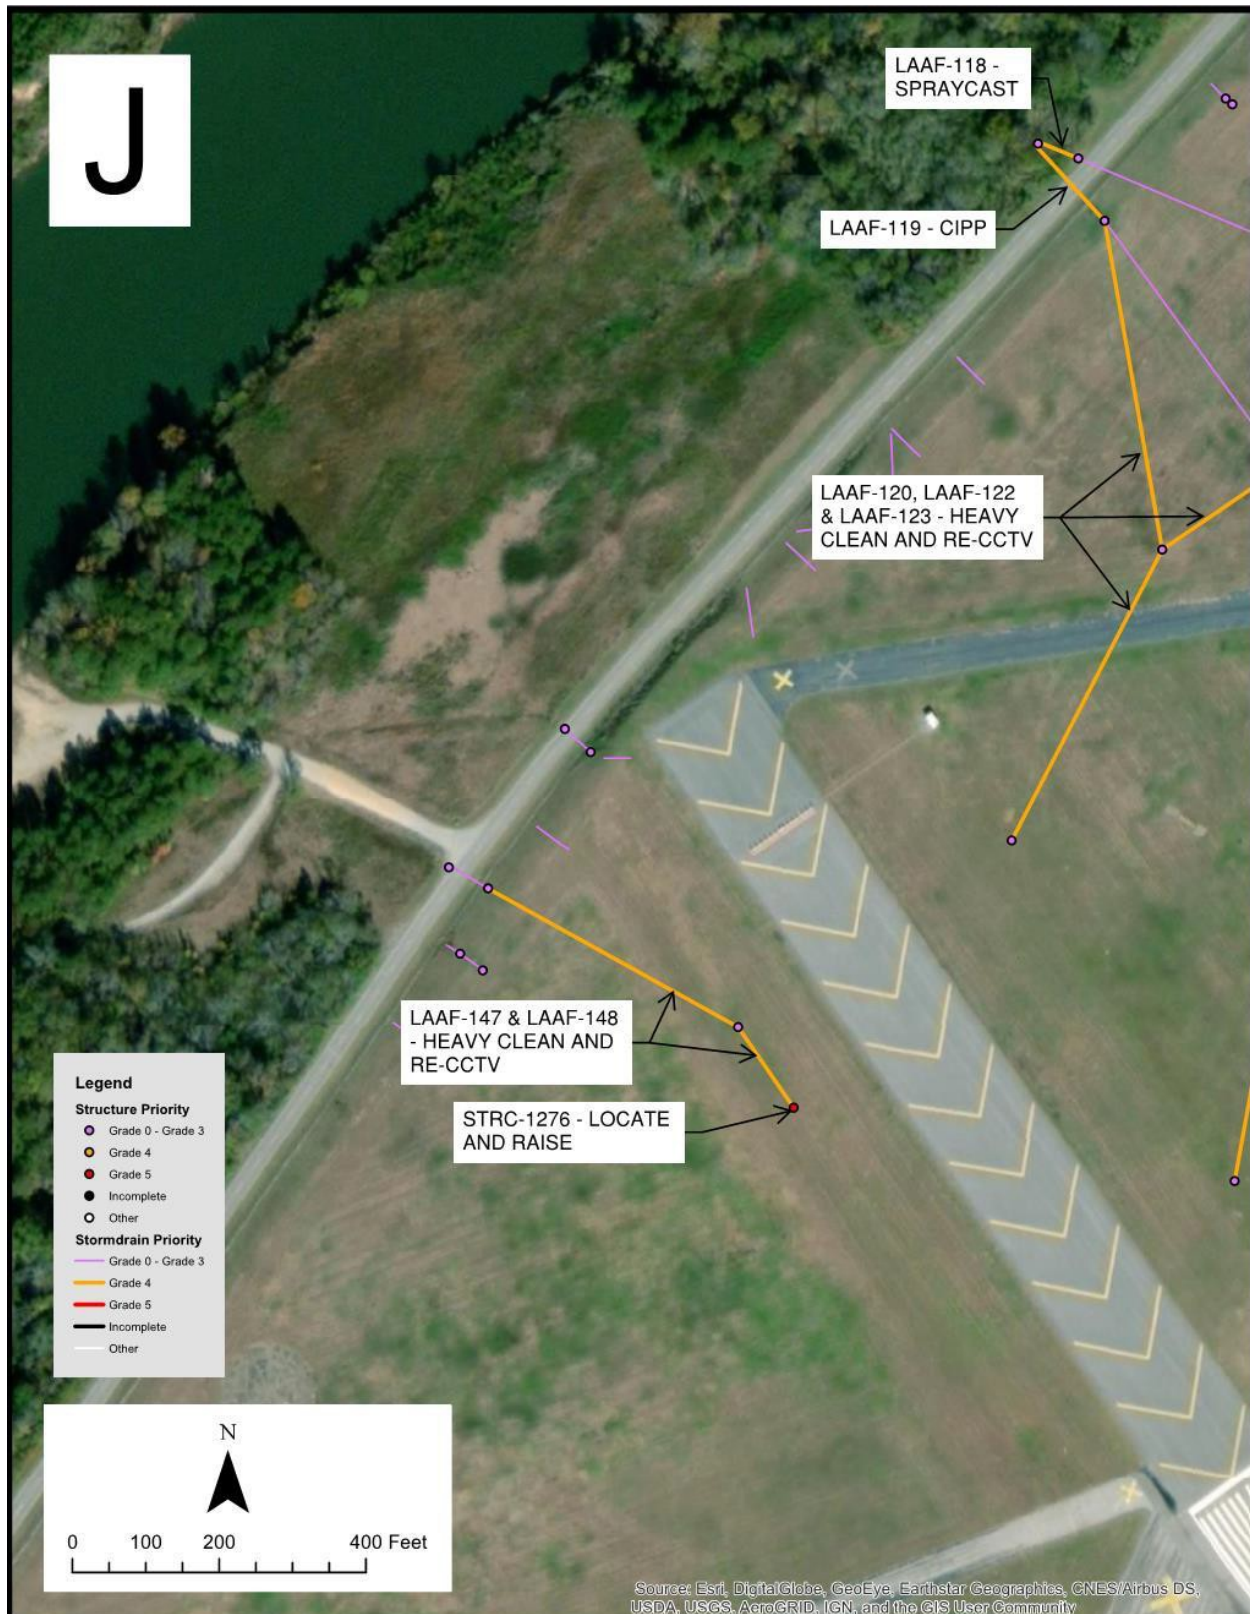
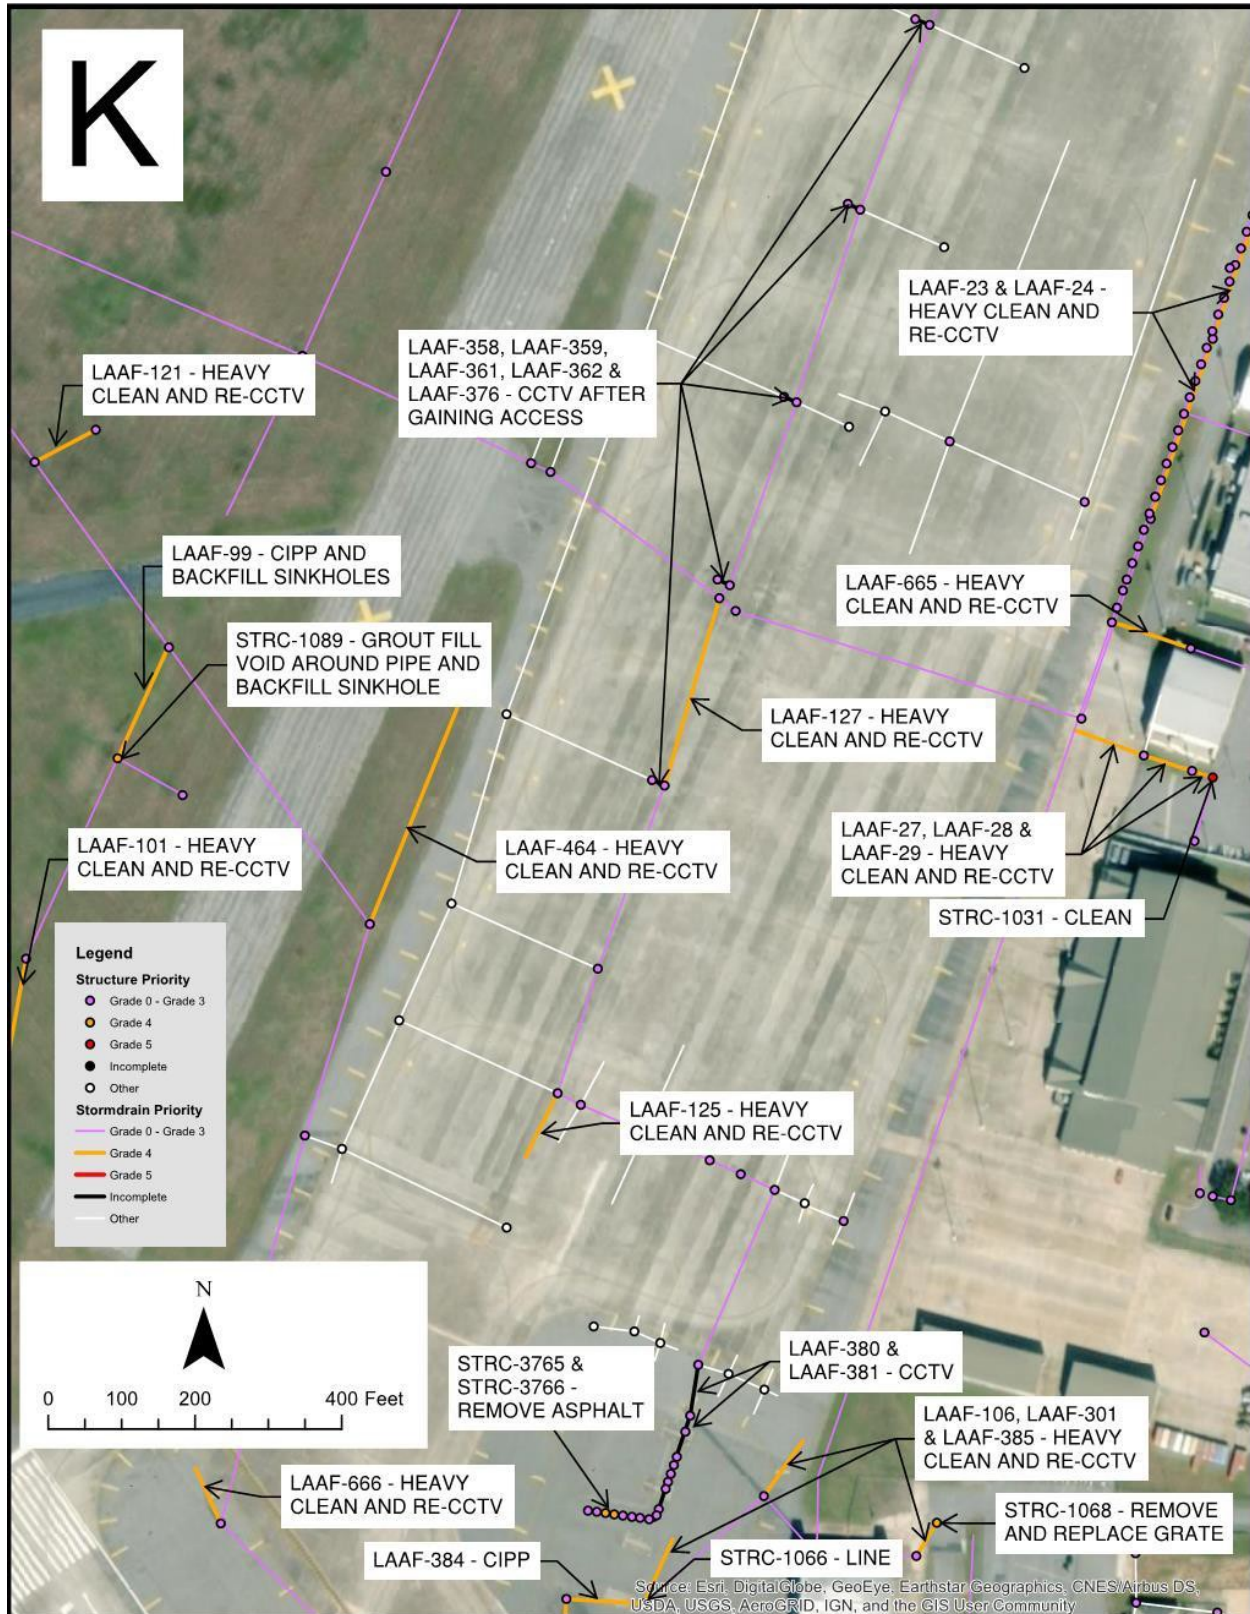
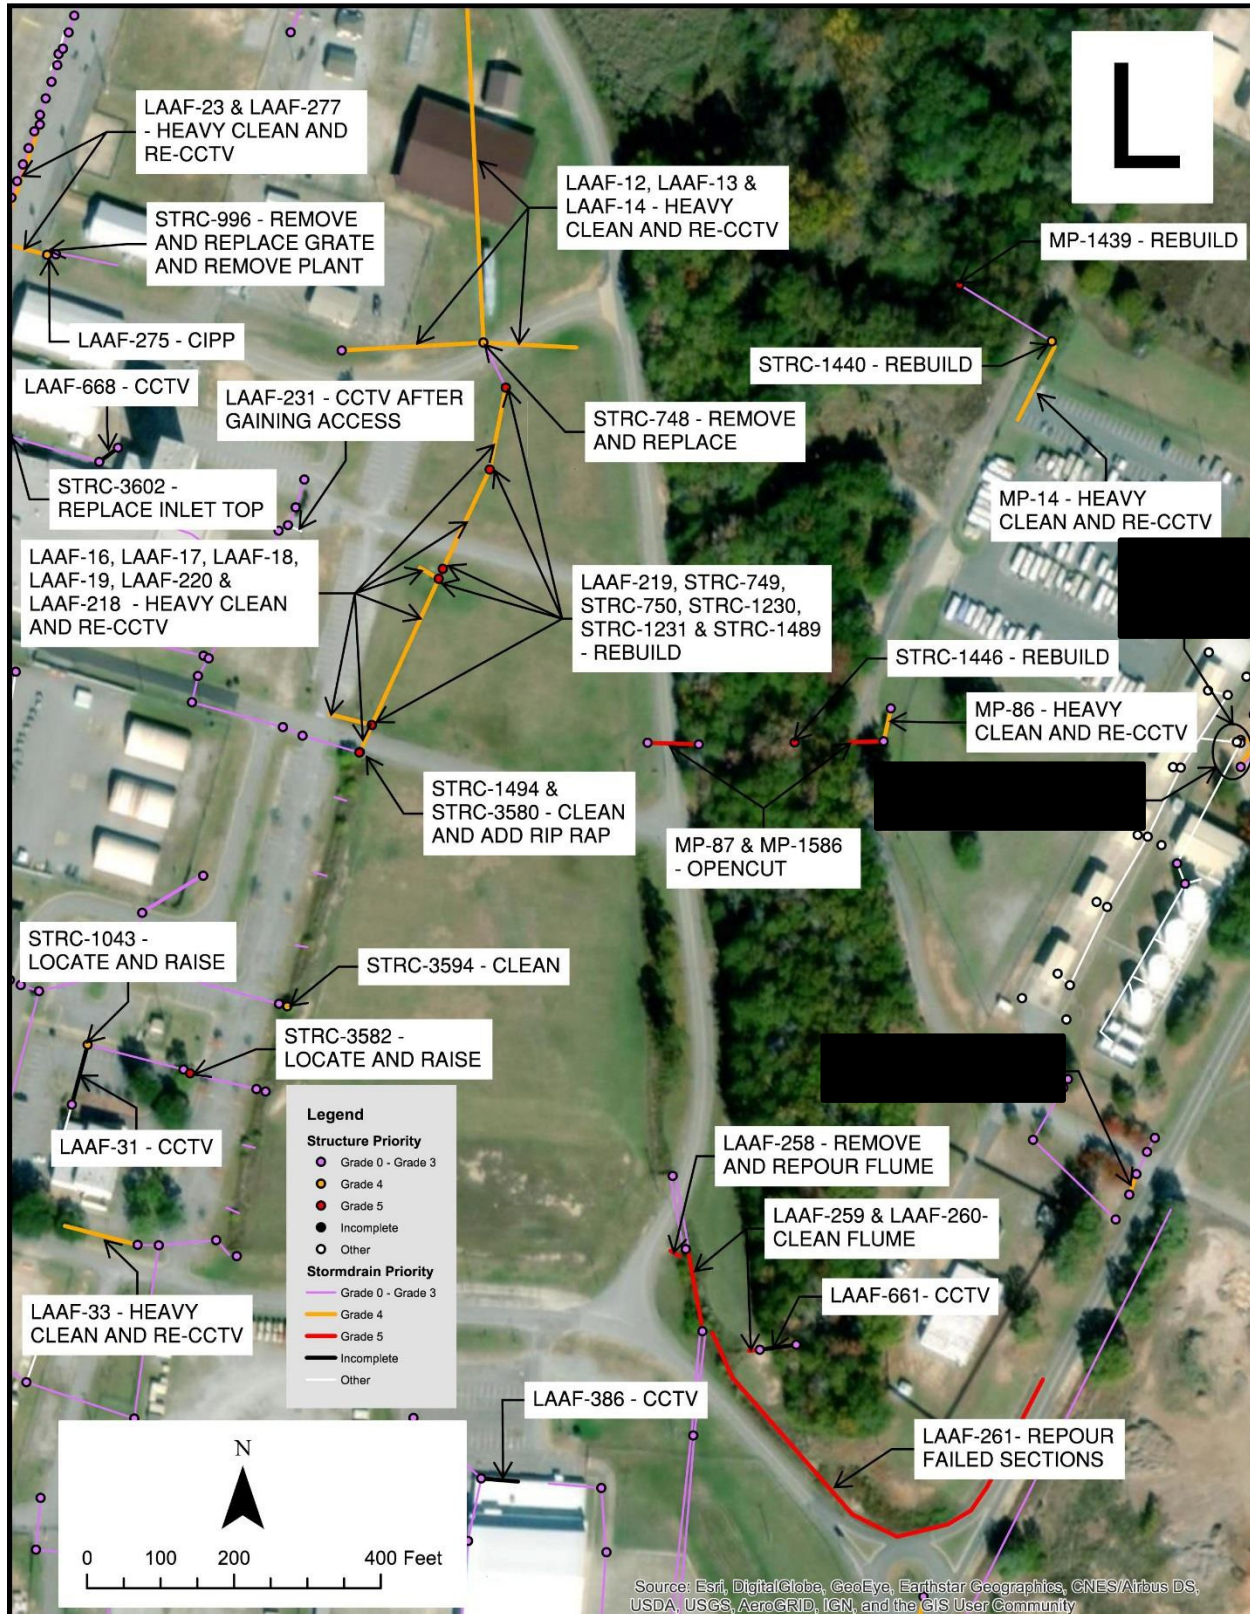
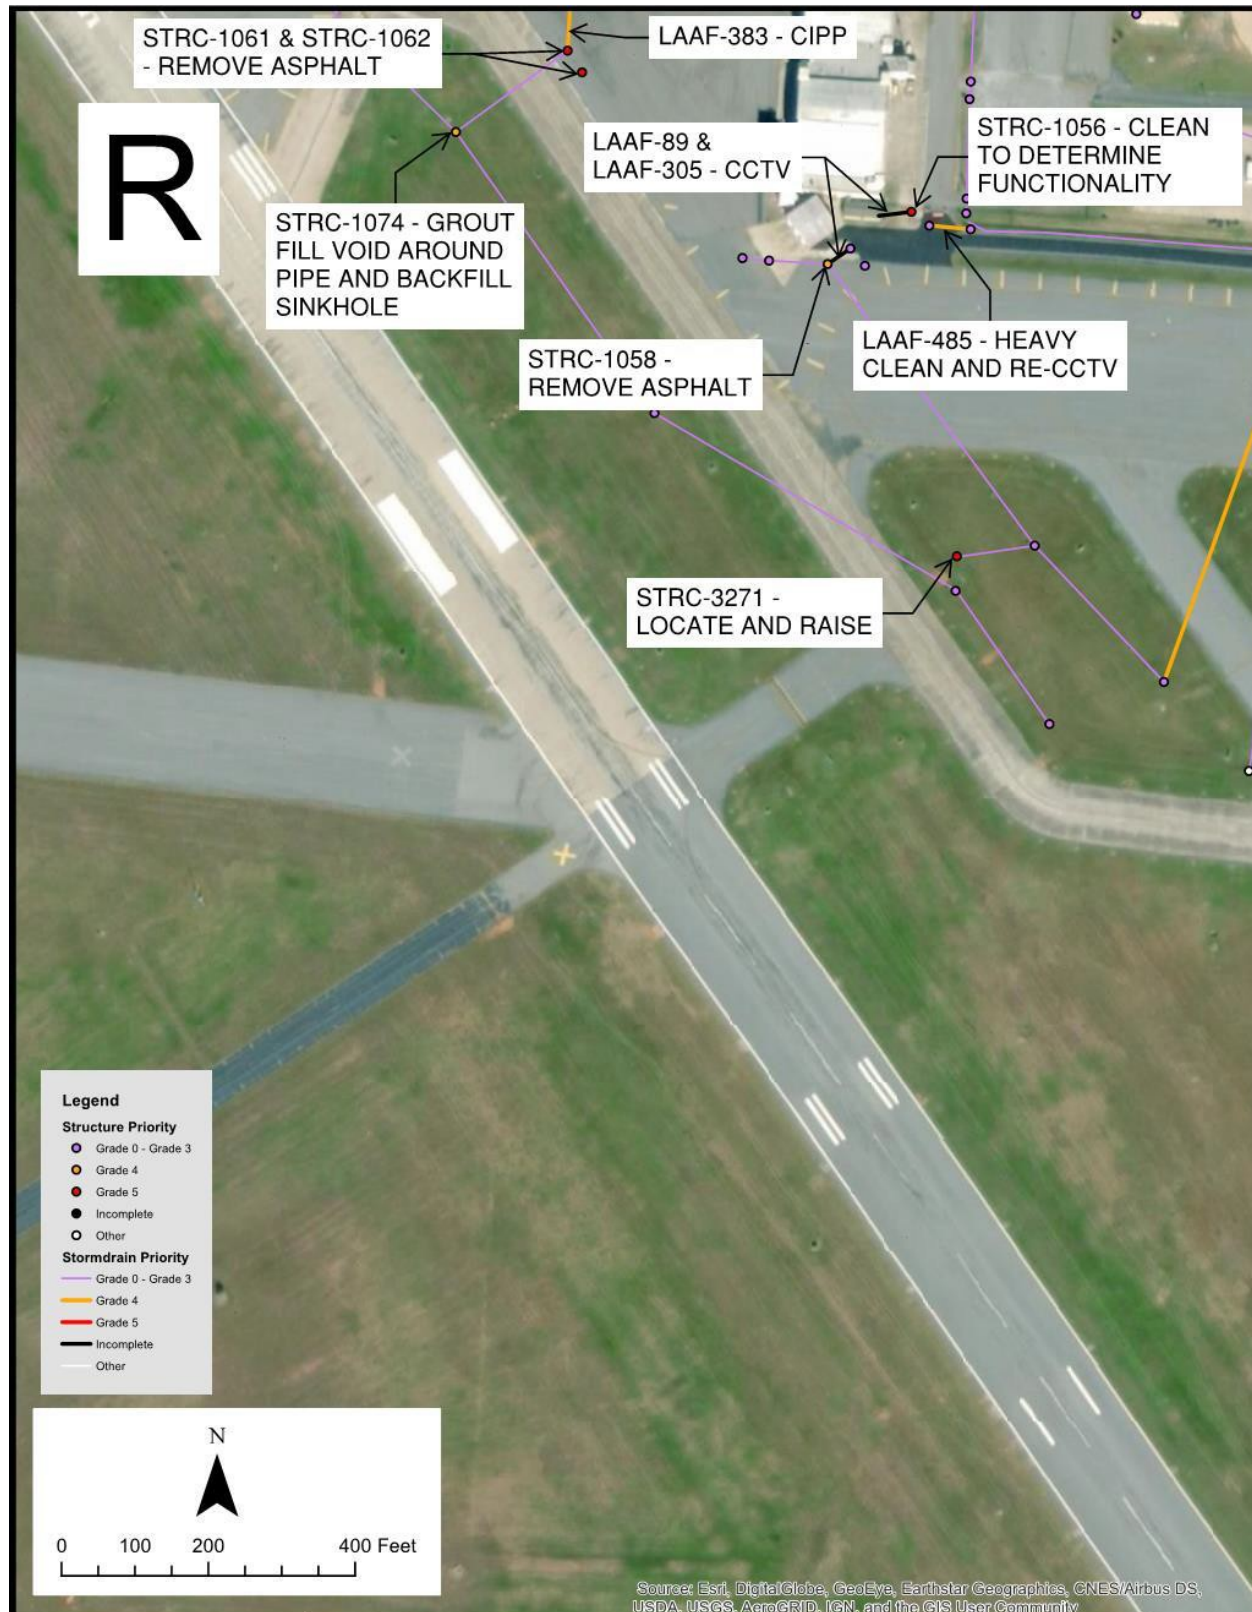
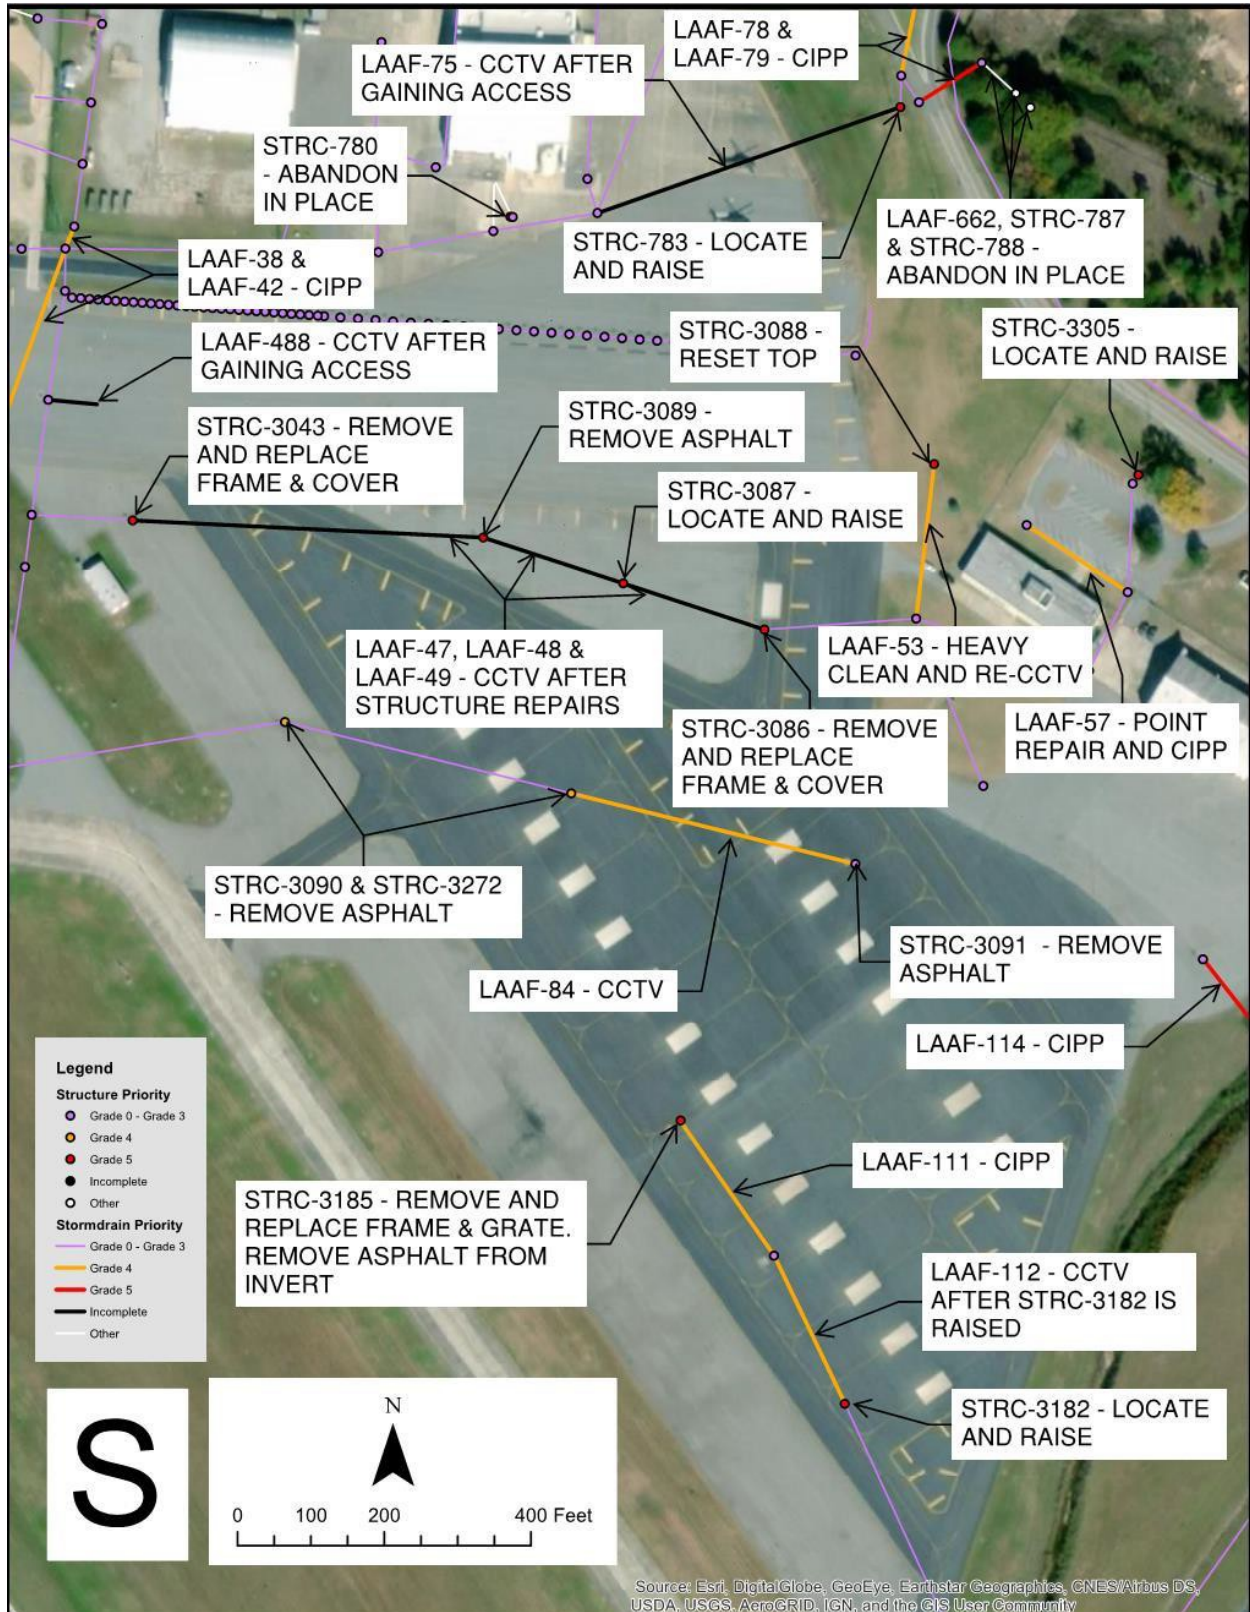
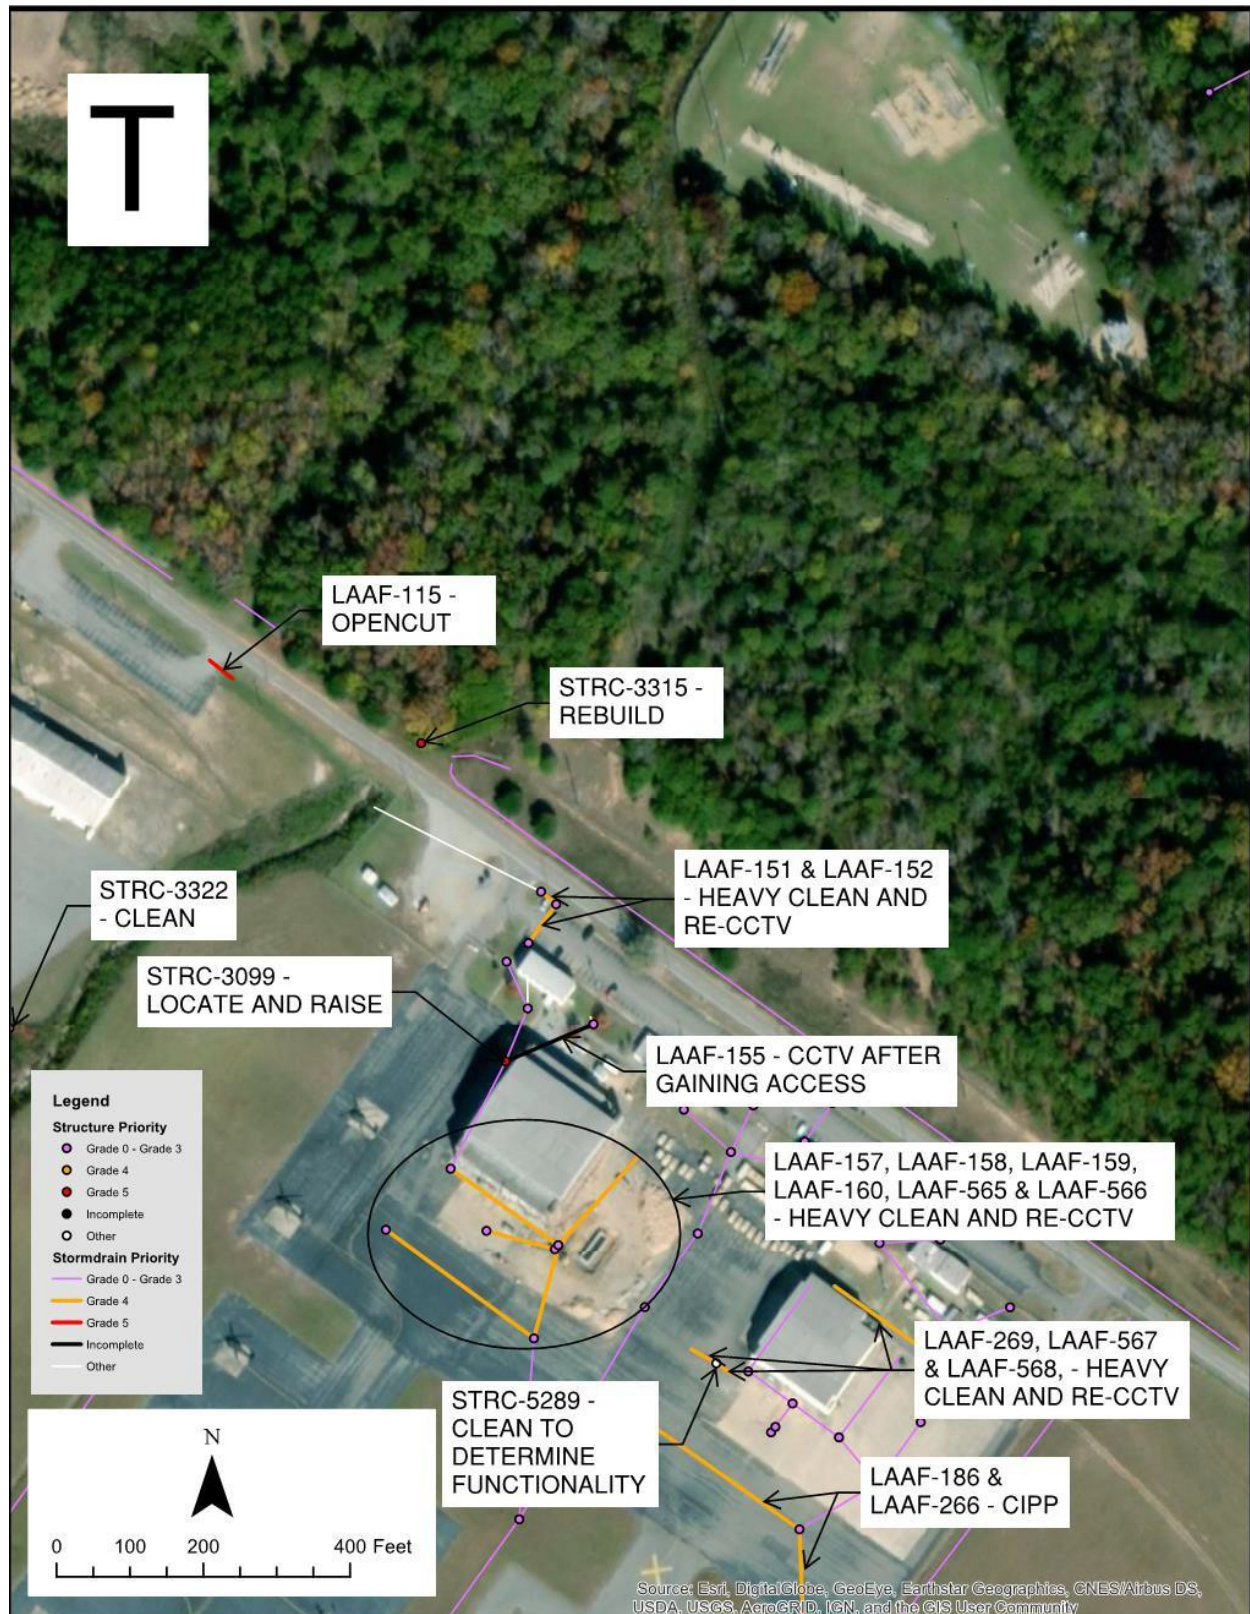
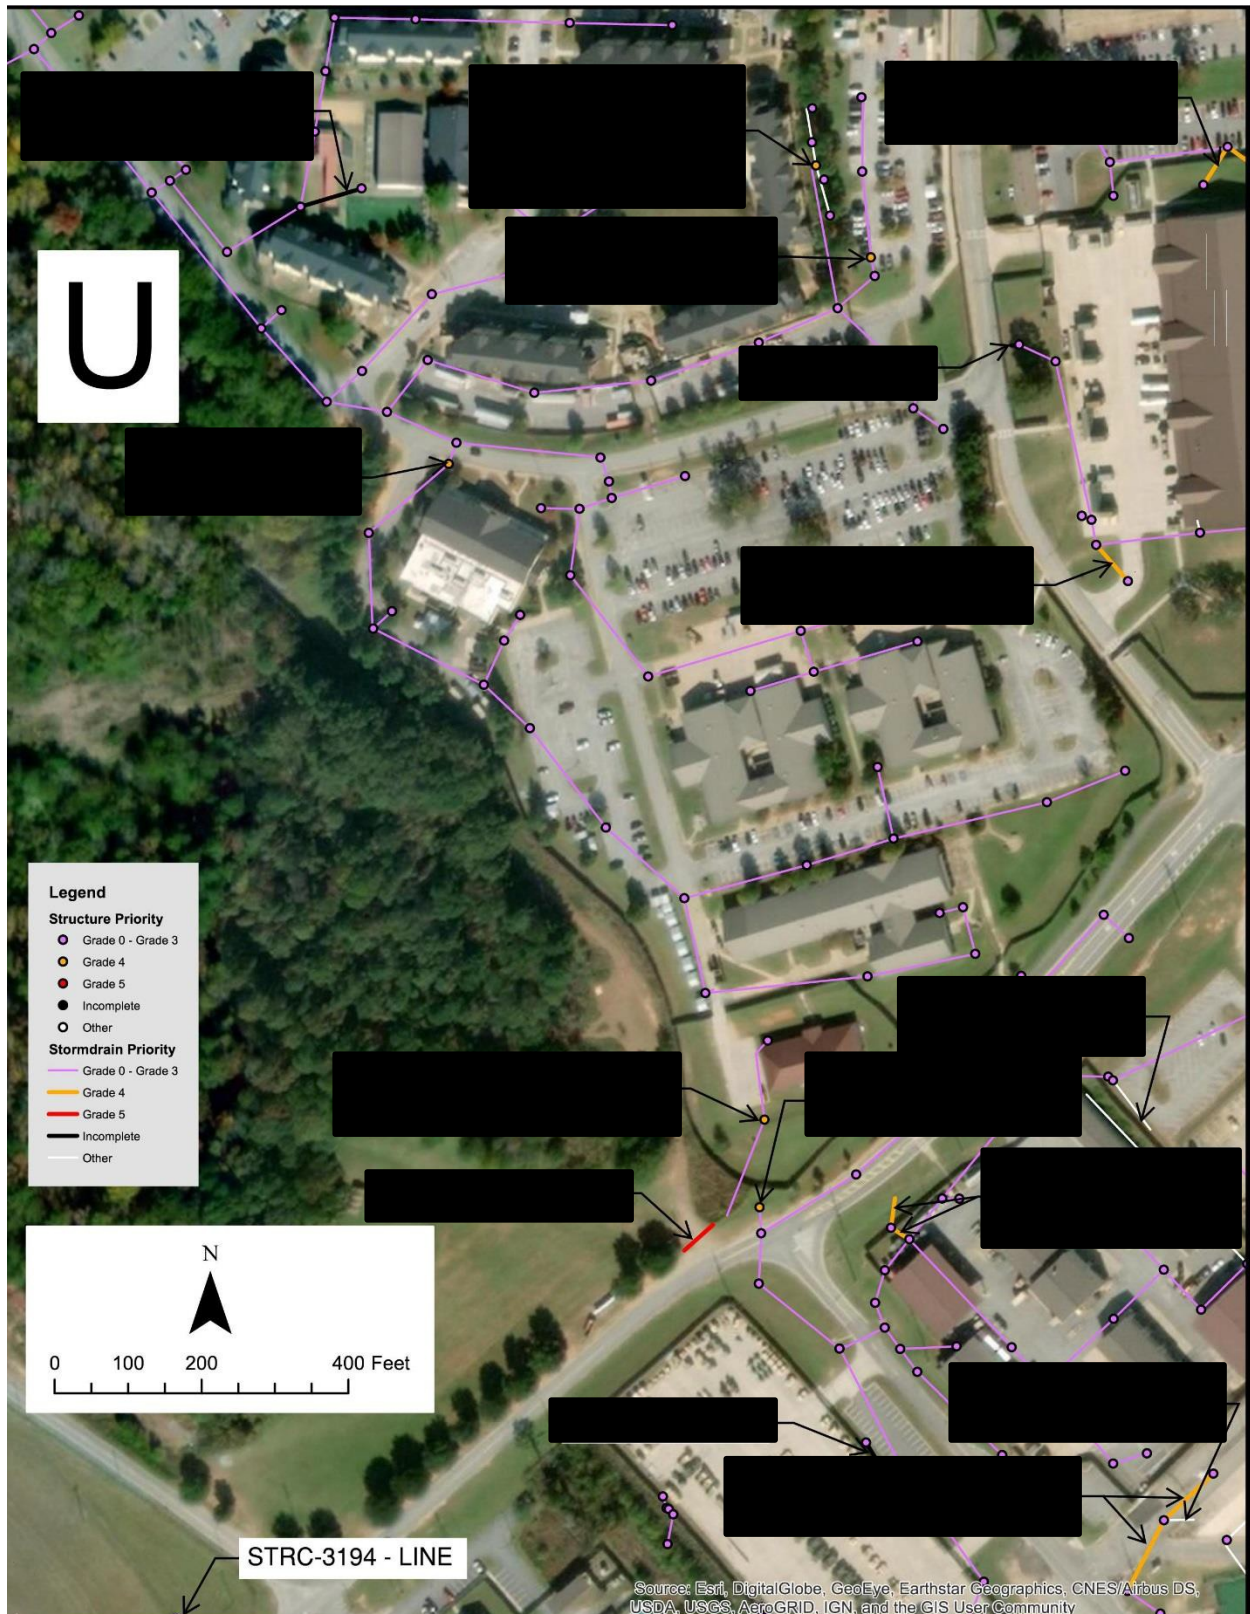
## **APPENDIX I: MAPS OF RECOMMENDED REPAIRS BASED ON CONDITION ASSESSMENT**

Storm structures and storm drains which received a Grade 4 or 5 in the condition assessment (see Figure 36), and pipes which need to be upsized as indicated by the hydraulic capacity analysis are recommended for repair. Detailed maps of the hydraulic capacity recommended repairs can be found in Appendix H and condition assessment recommended repairs maps can be found in Appendix I. Further details of the recommended repairs can be found in the supplied geodatabase. The recommended repairs have been broken down into three recommended projects based on the type of work required:
