# LAWSON ARMY AIRFIELD STORMWATER ASSESSMENT AND CAPITAL IMPROVEMENT PLAN

Prepared for: **Columbus Water Works**

File: 3577421  
June 30, 2017

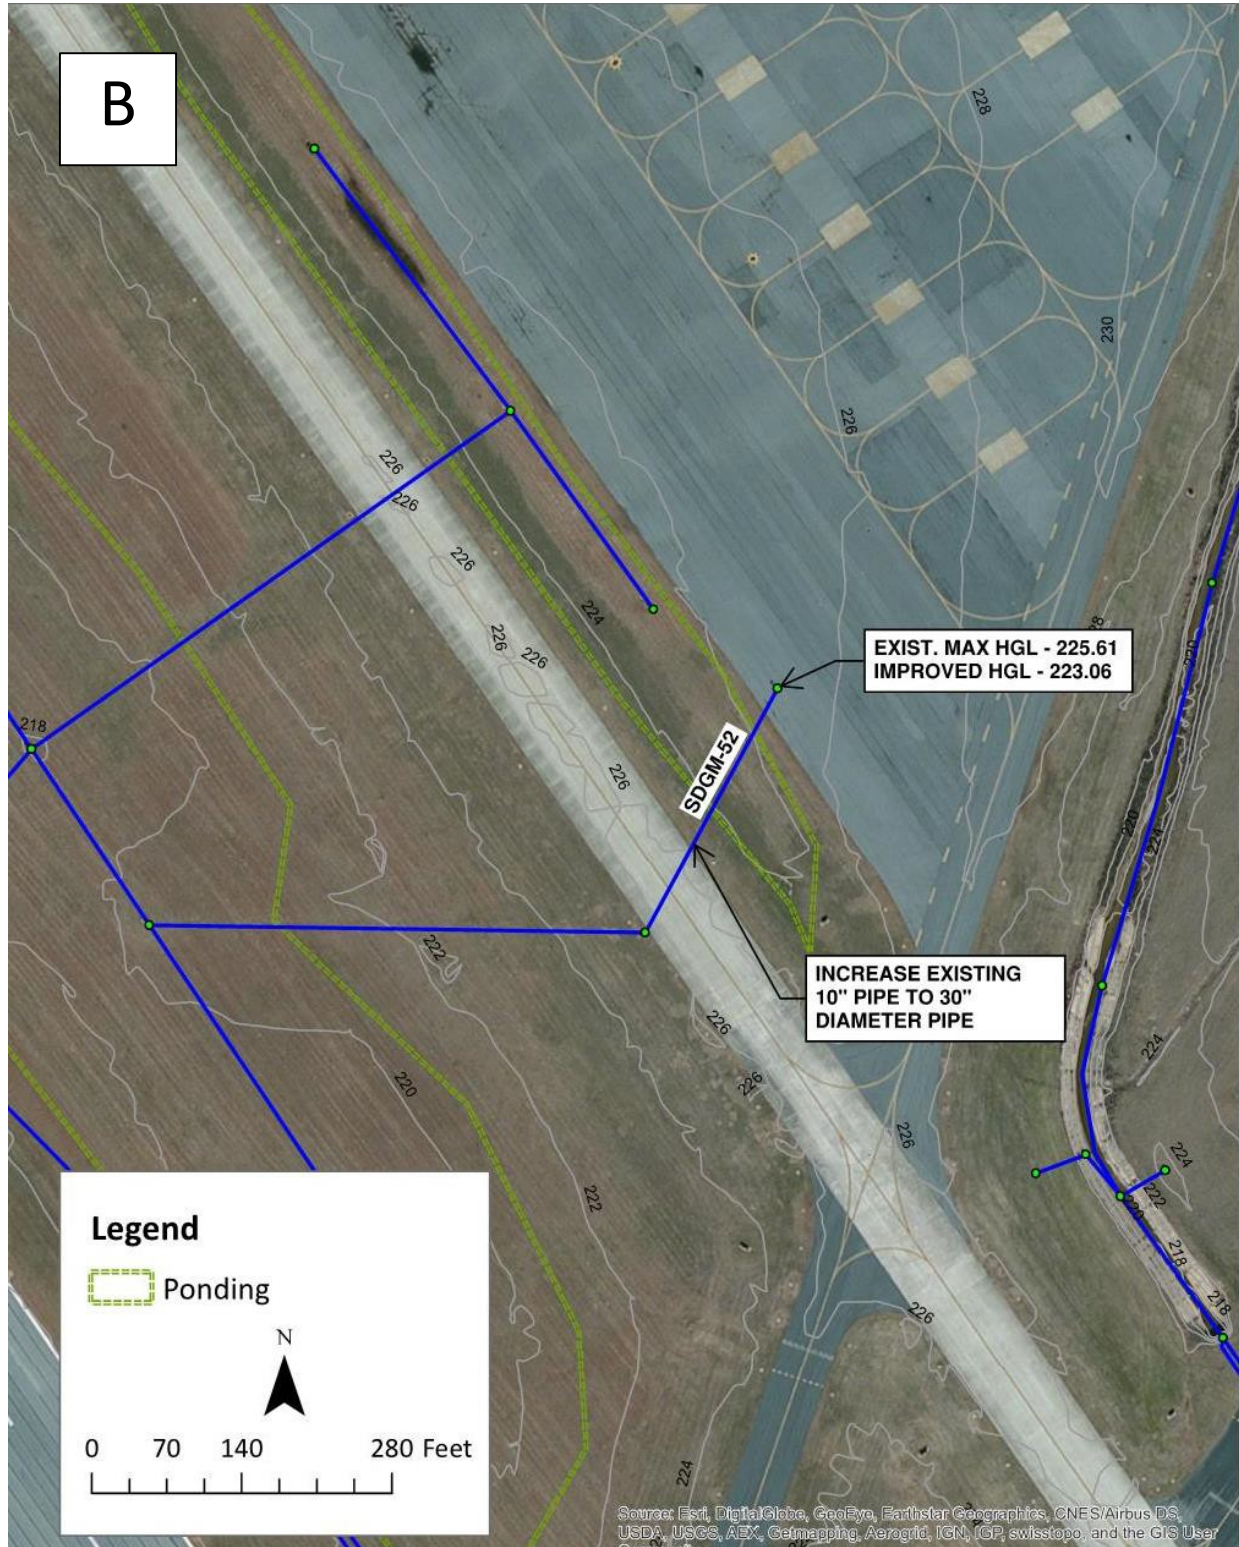
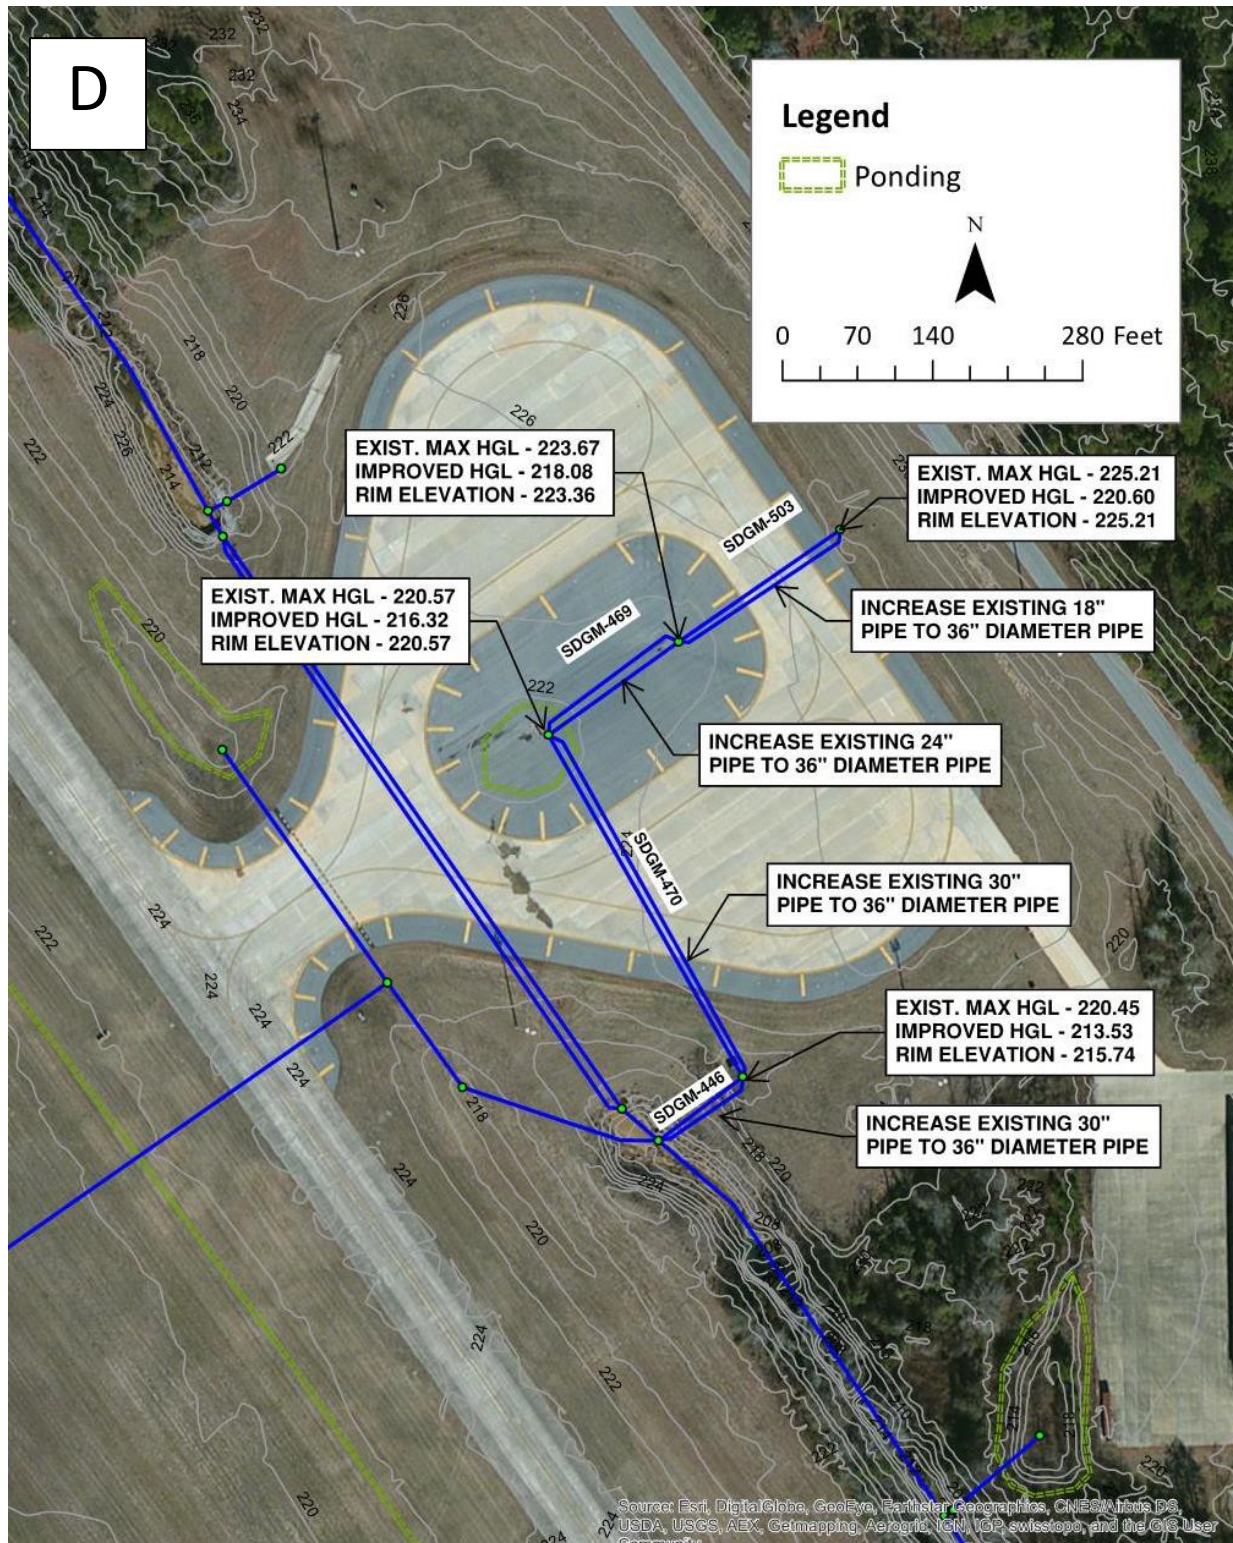
## **APPENDIX E: HYDRAULIC CAPACITY IMPROVEMENTS A-E**

replaced with a larger pipe. 10 pipes met this criteria and it is therefore recommended that these pipes be replaced with larger diameter pipes as proposed in Table 2. Attached in Appendix E, Figures A-E show the improvements when the pipe was upsized based on sizes in the table. The recommended improvements either eliminated or minimized overflows to appropriate ponding elevations in suitable areas for the 25-year, 24-hour design storm considered in this analysis.

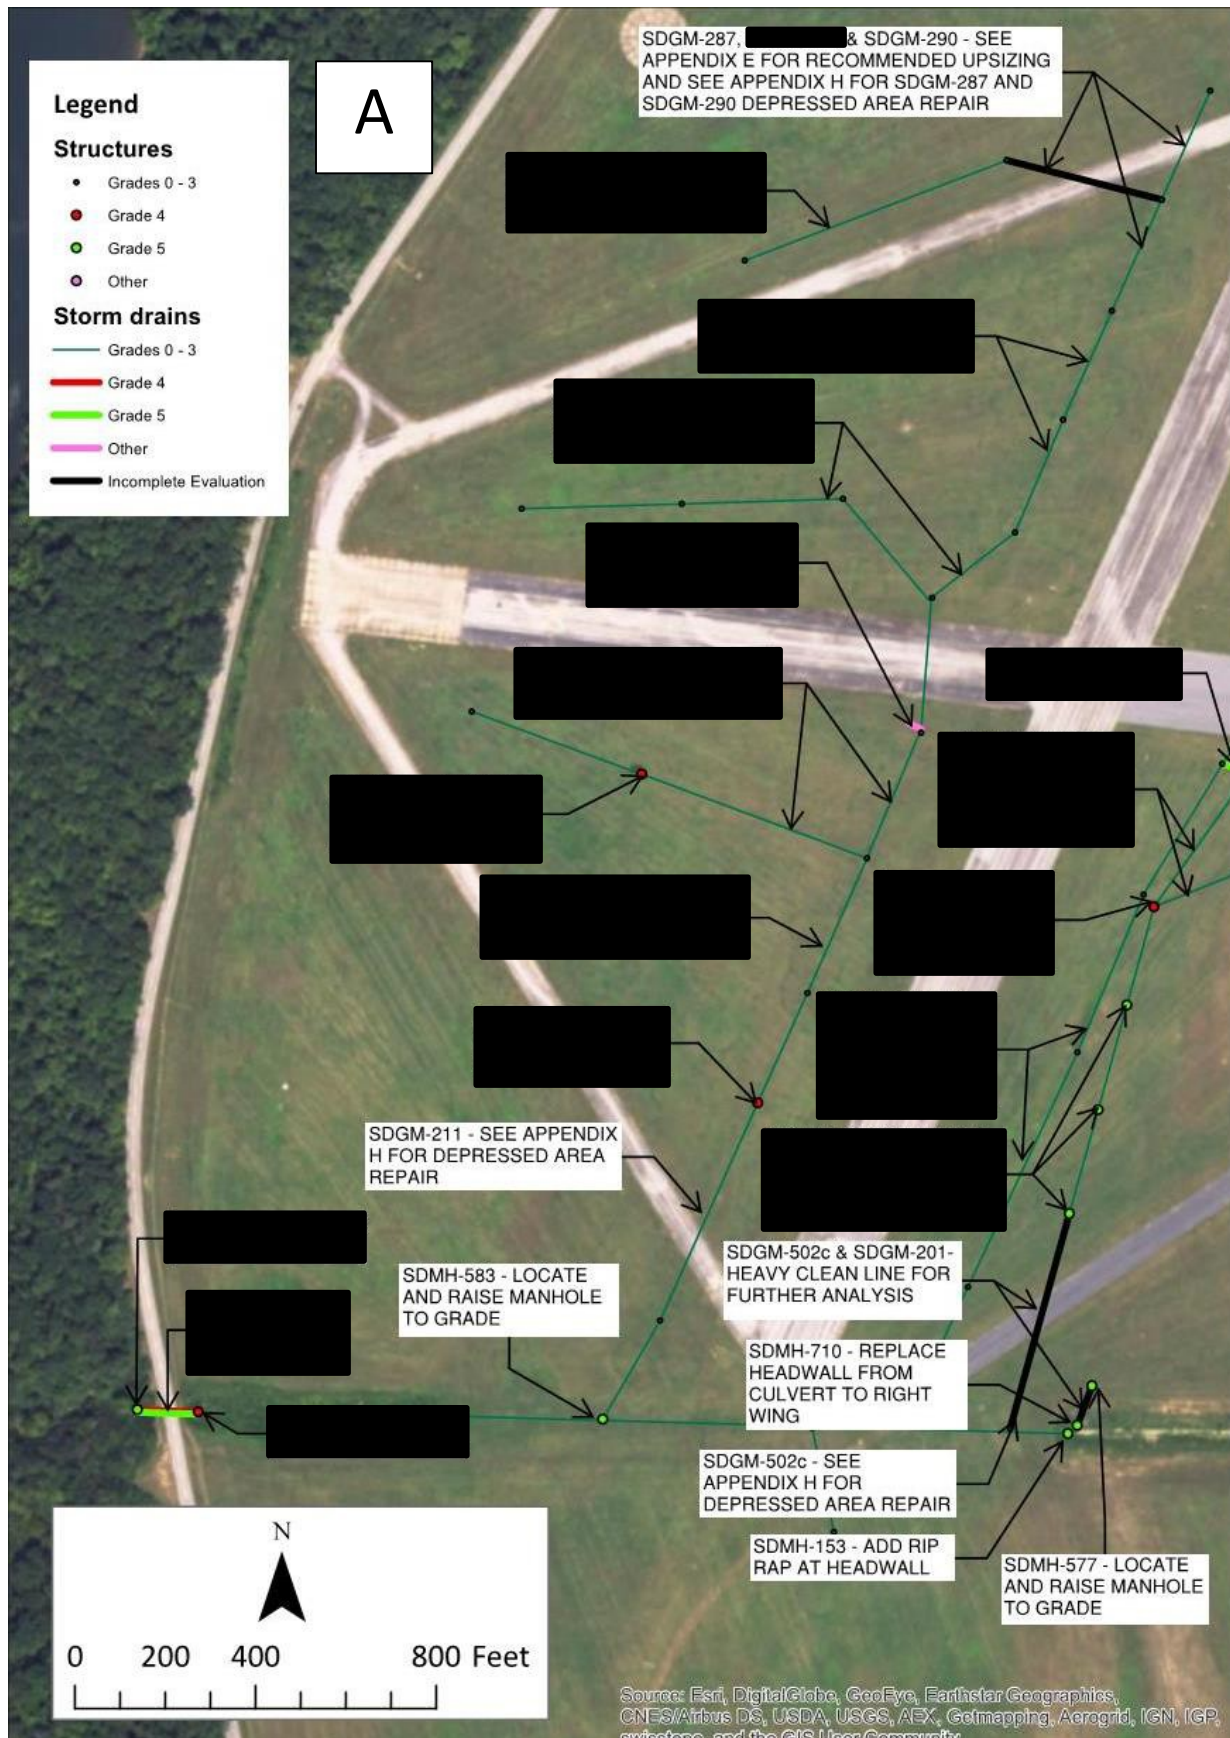
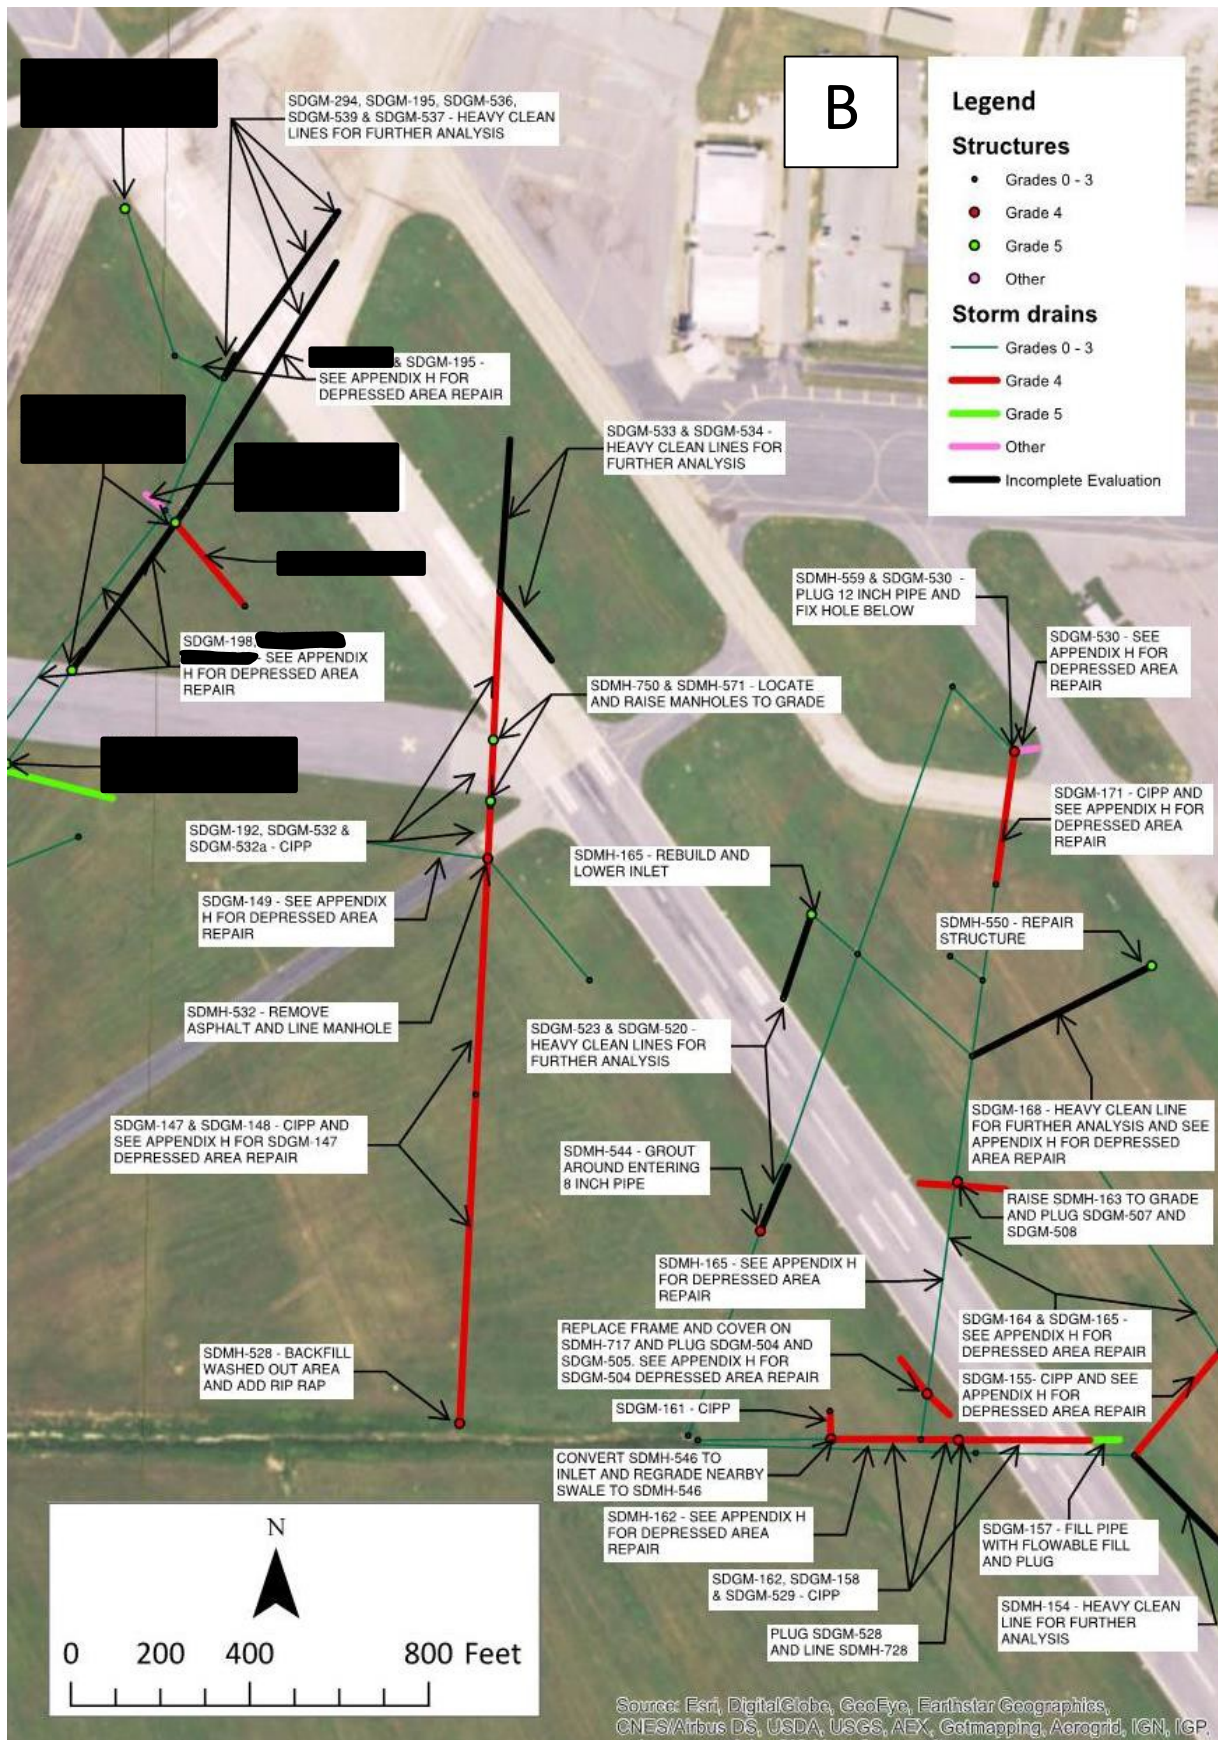
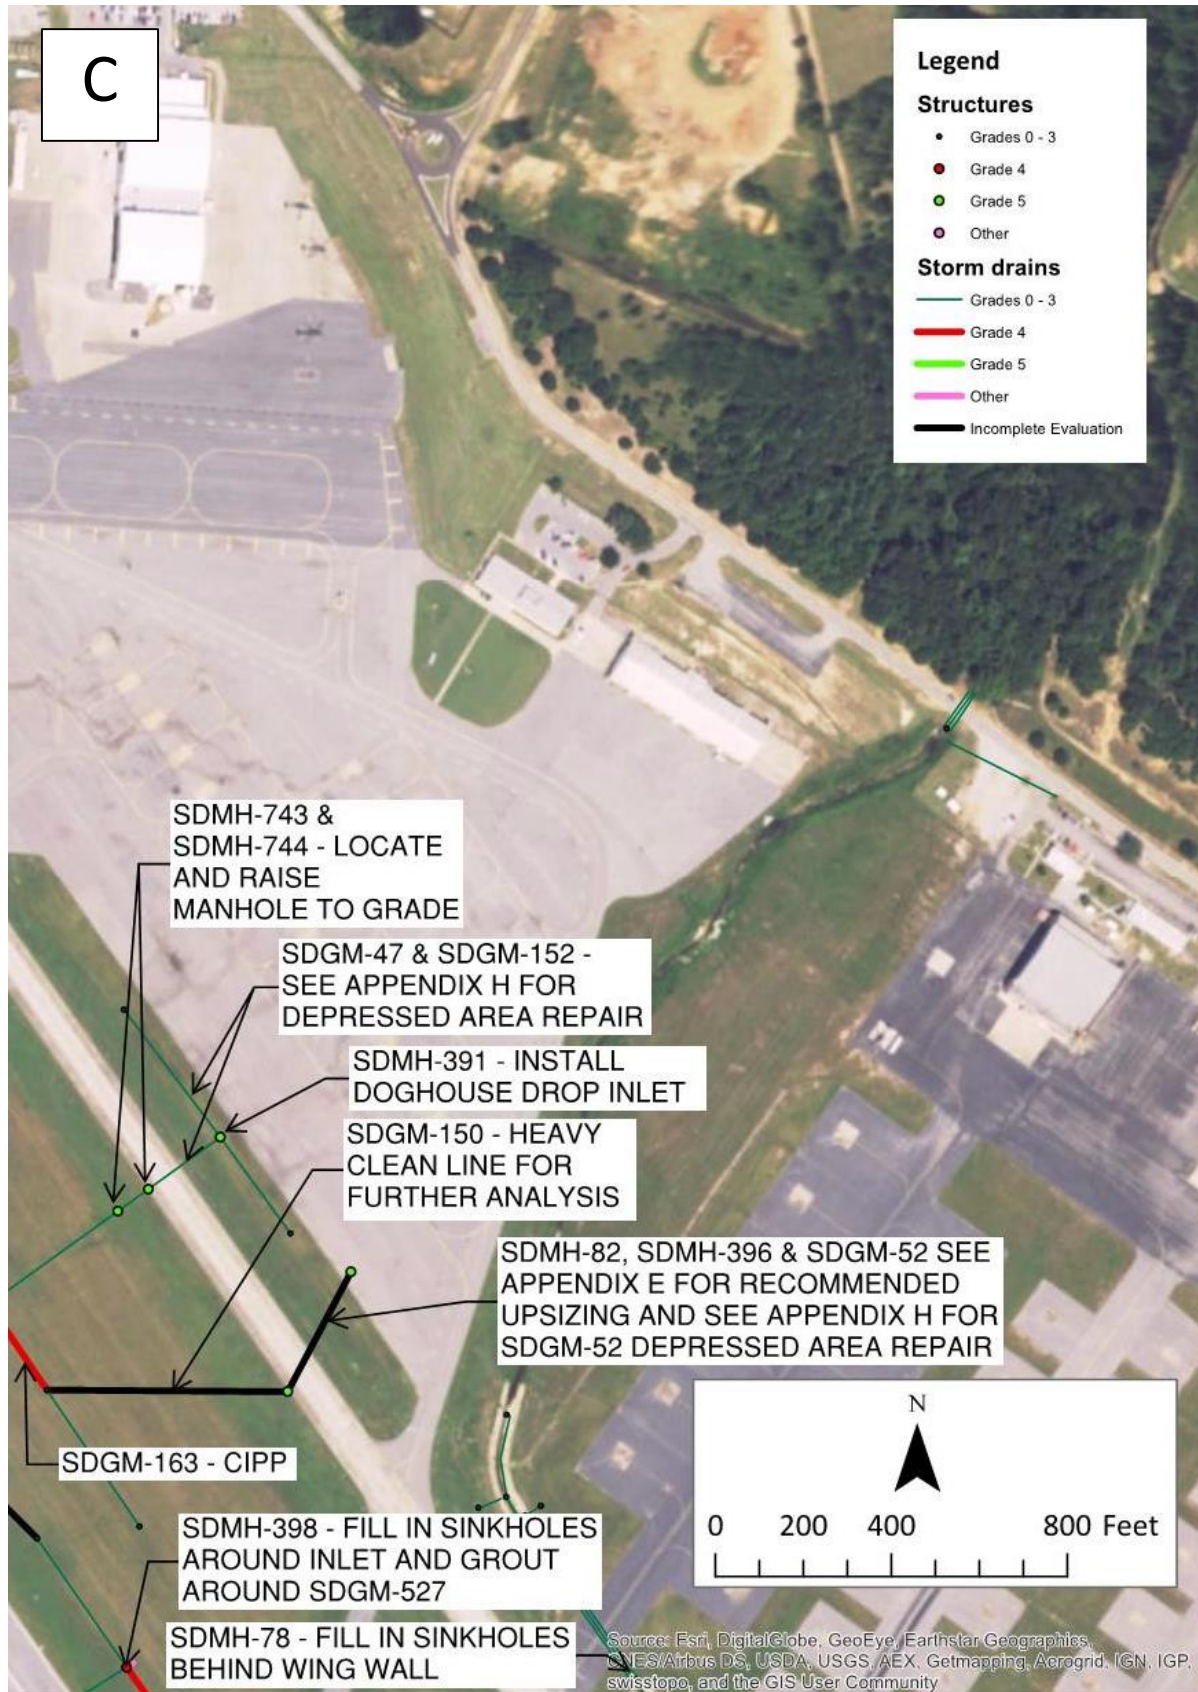
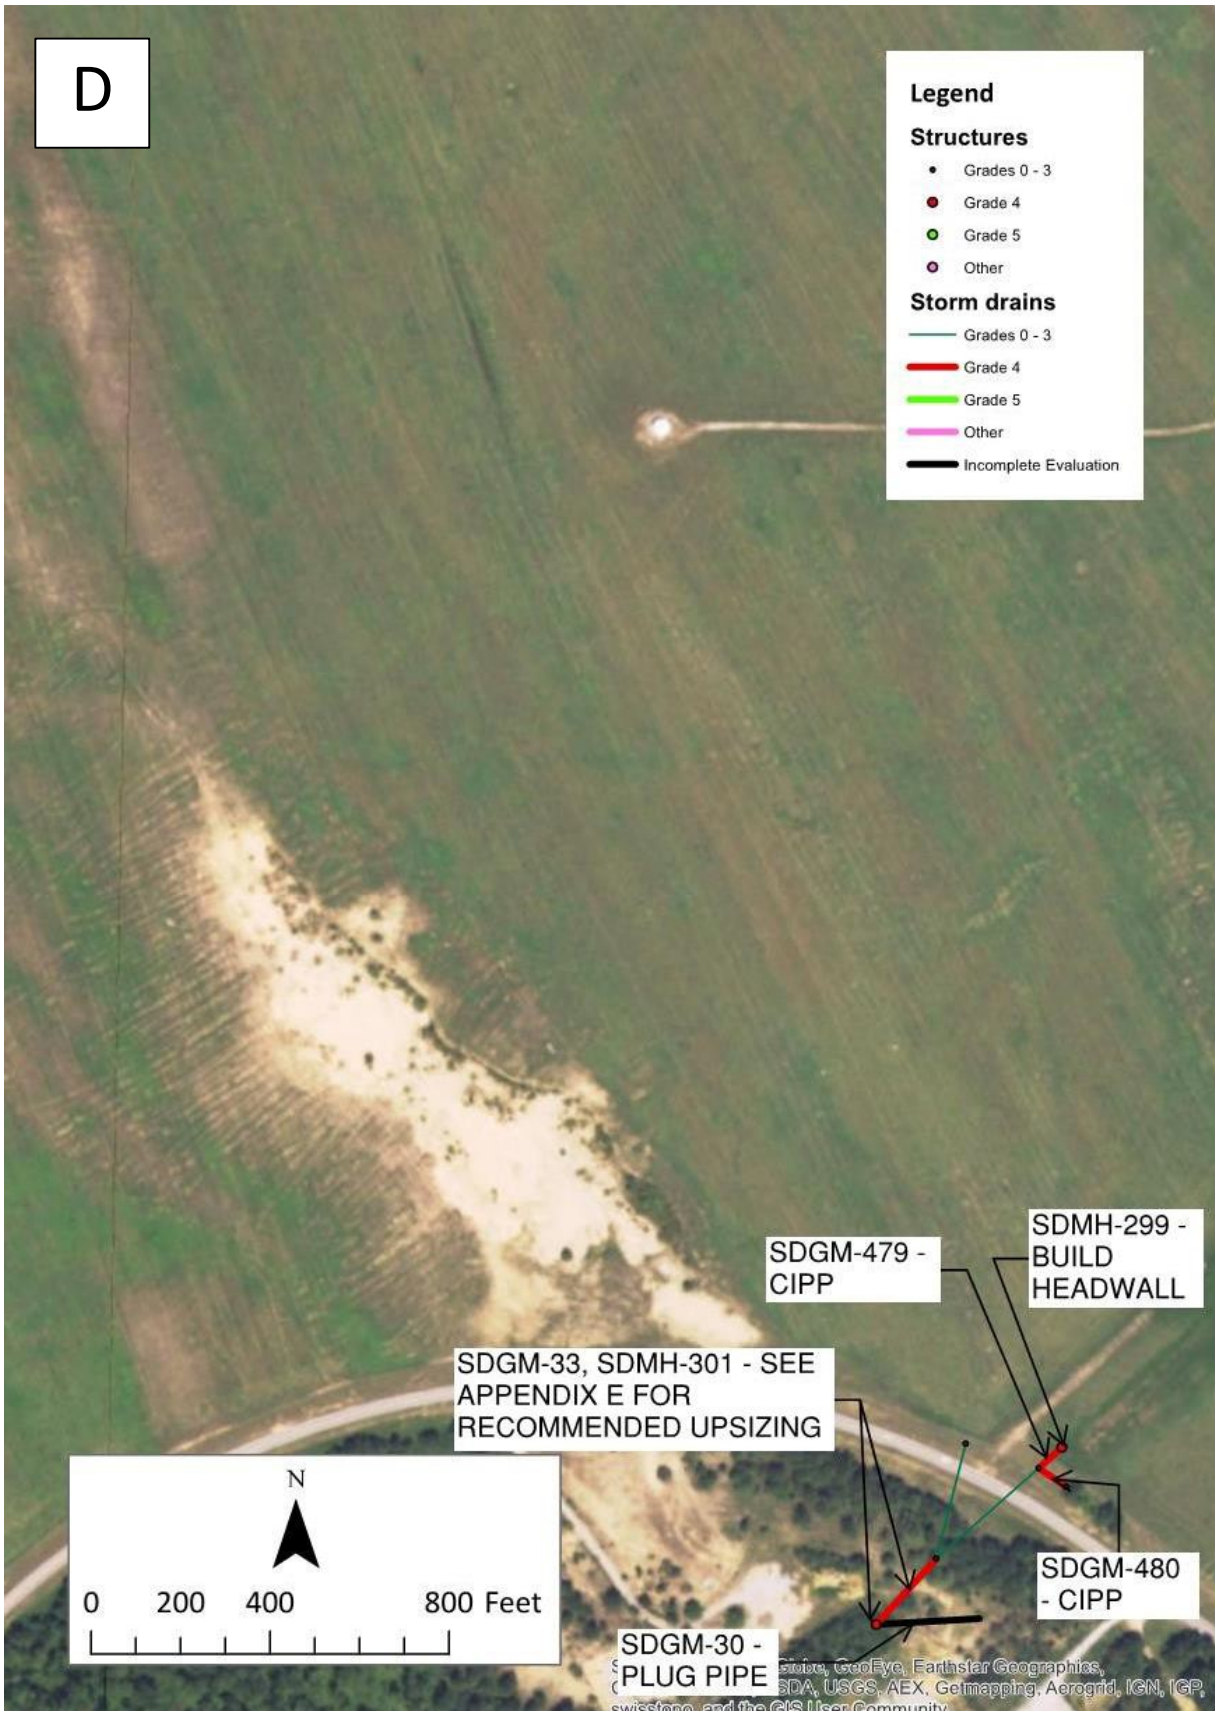
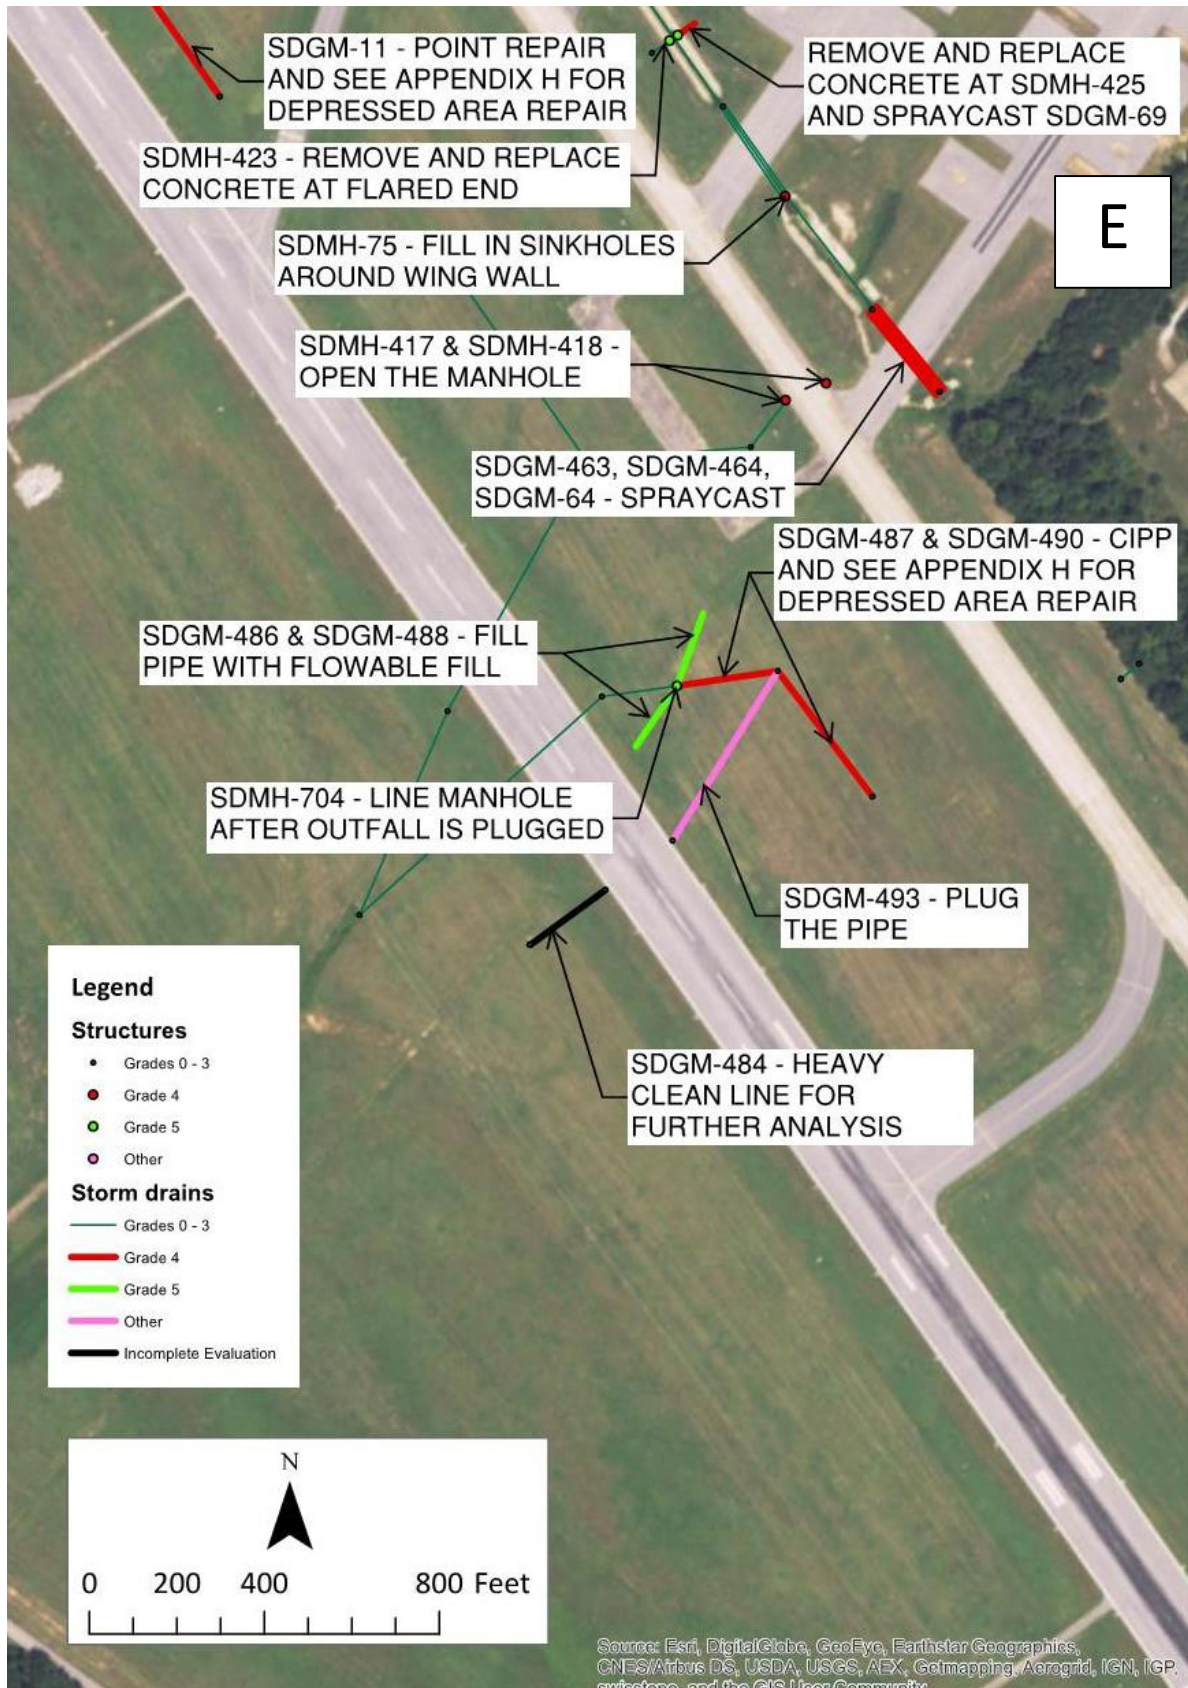
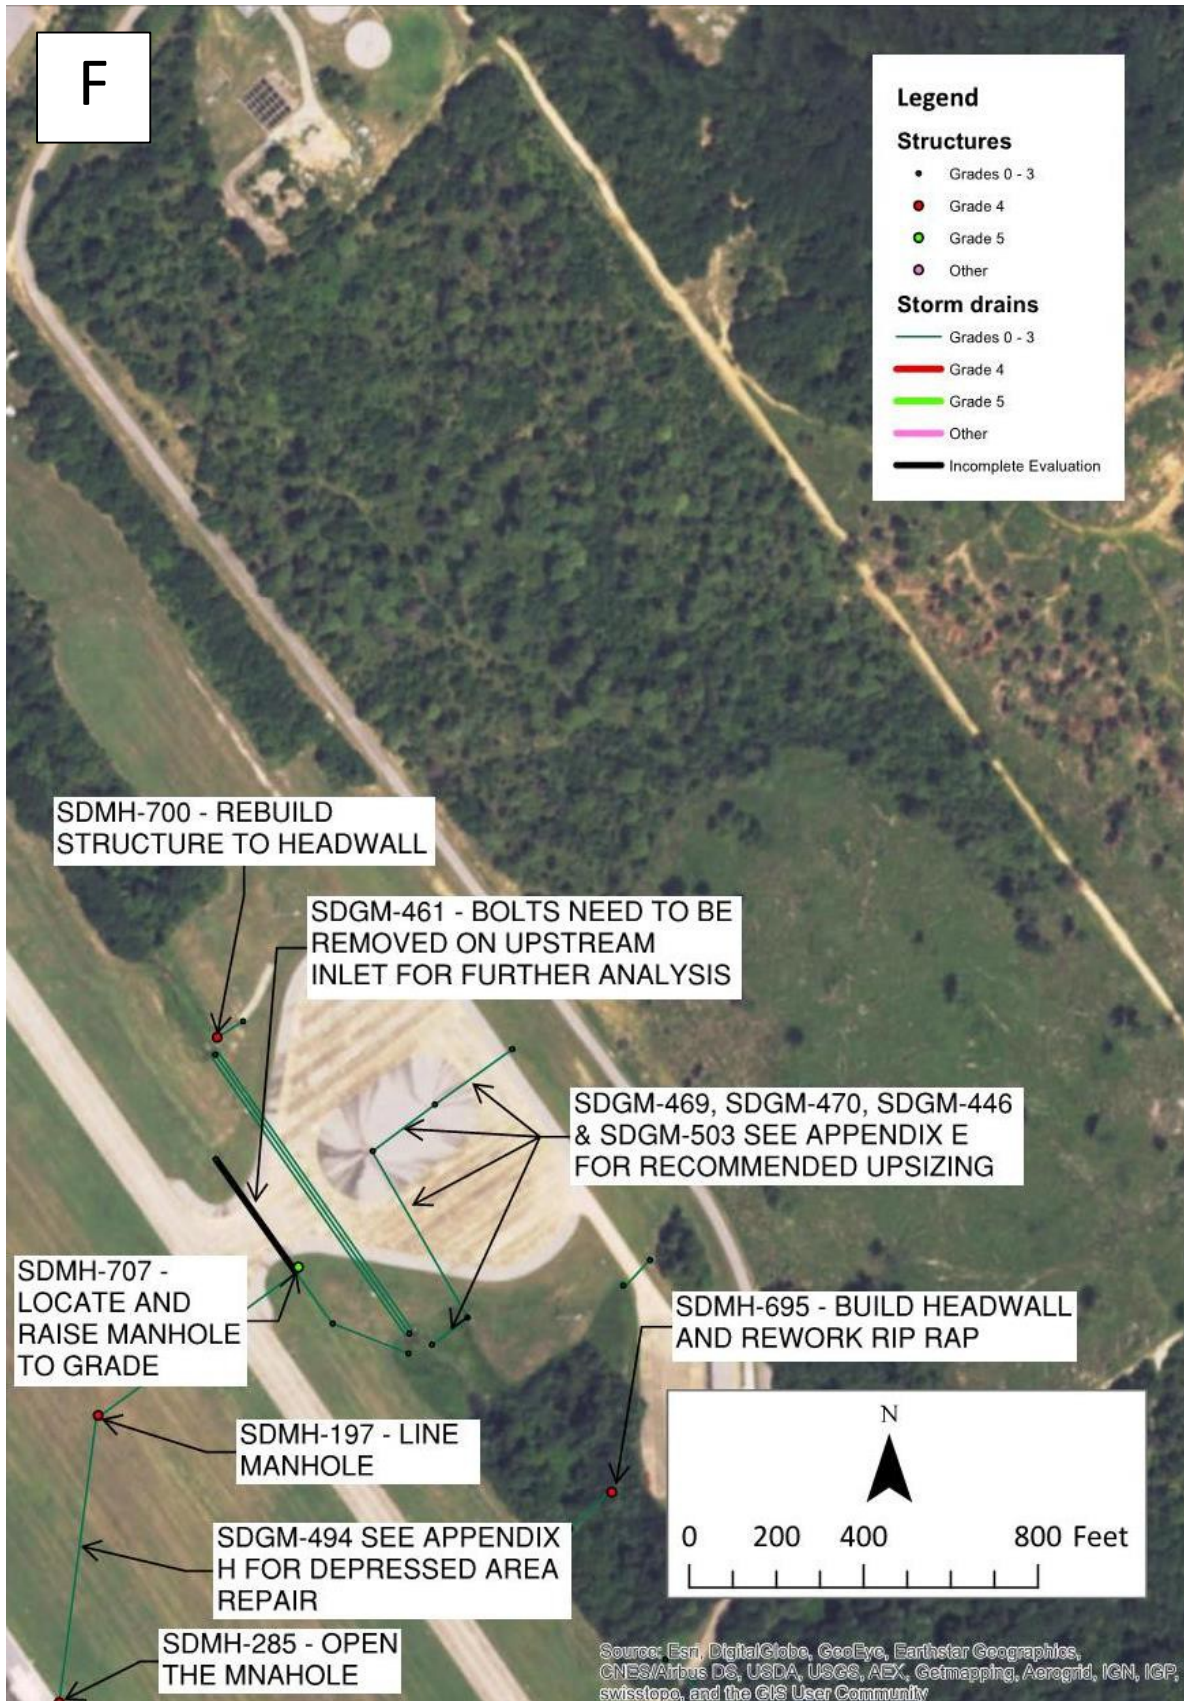
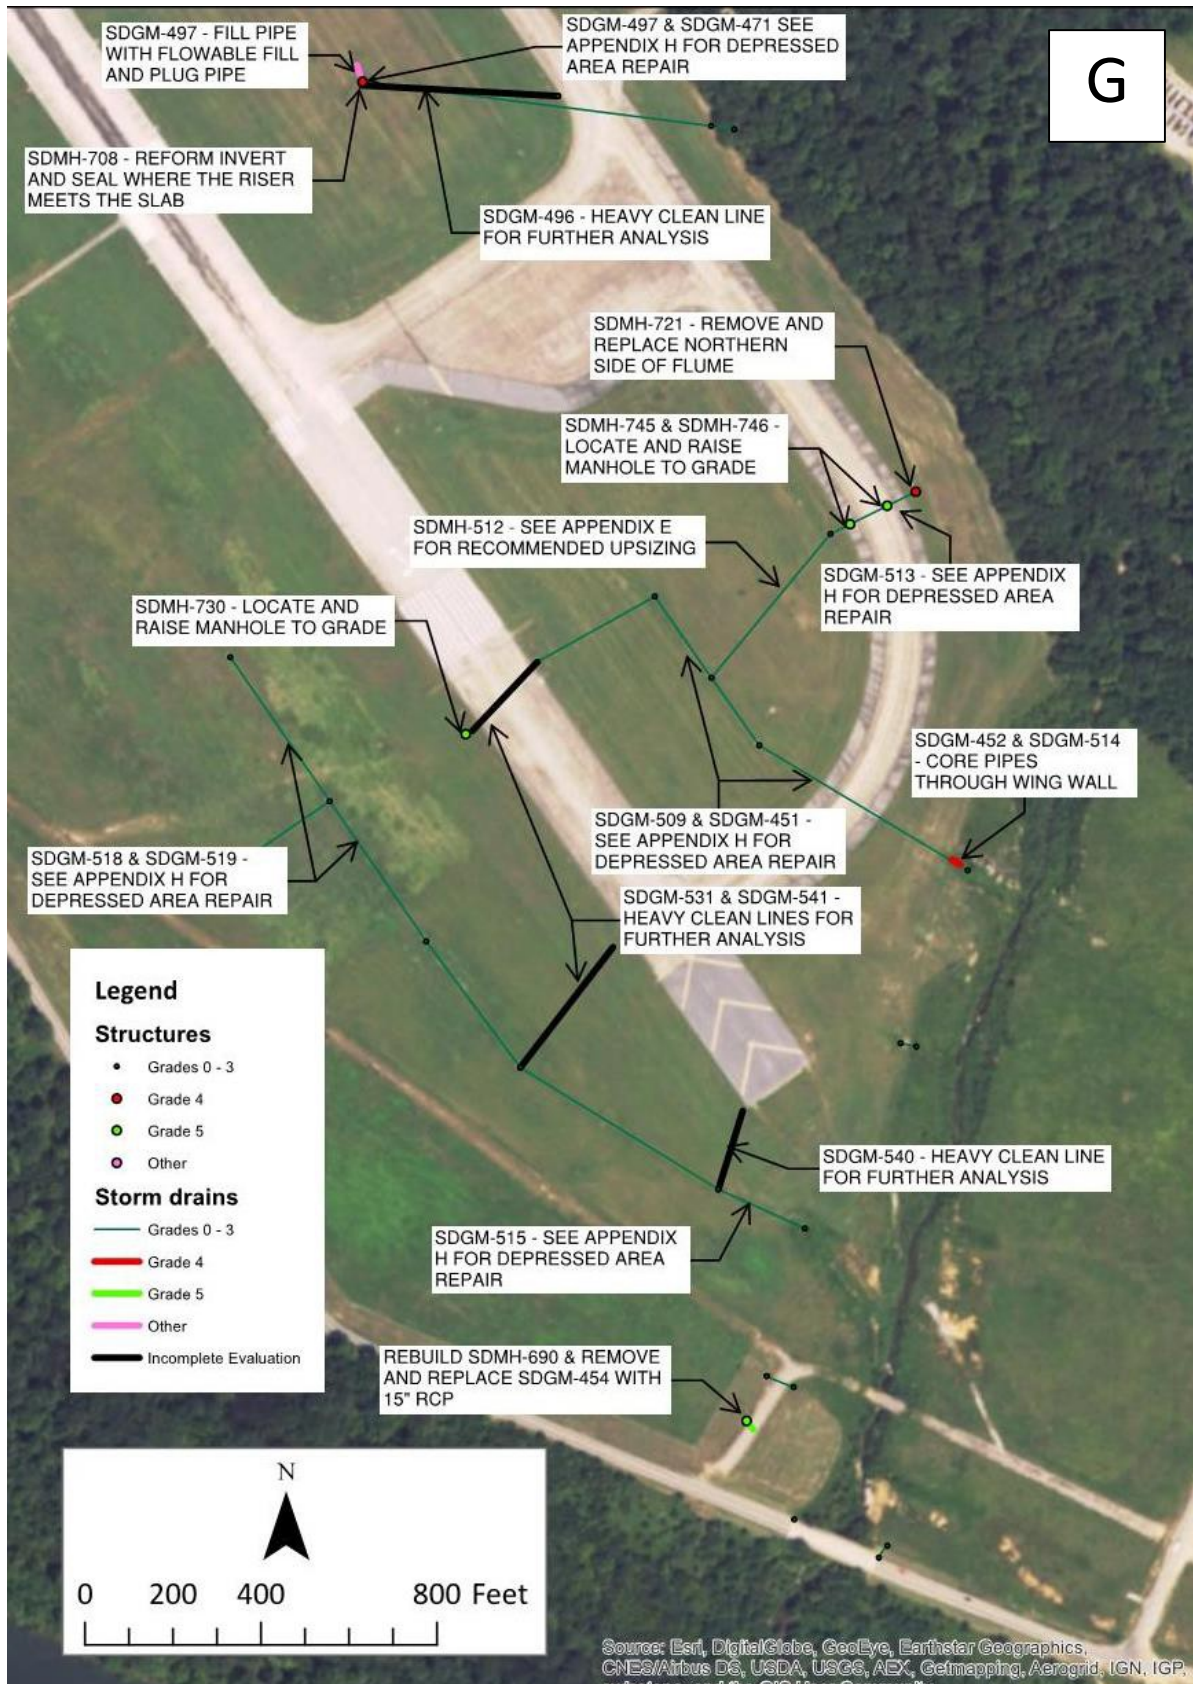
## **APPENDIX G: DETAILED MAPS OF RECOMMENDED REPAIRS A-G**

Storm structures and storm drains which received a Grade 4 or 5 in the condition assessment (see Figure 24), pipes which need to be upsized as indicated by the hydraulic capacity analysis, and the identified depressed areas are recommended for repair. The recommended repairs have been broken down into two recommended projects based on the type of work required:

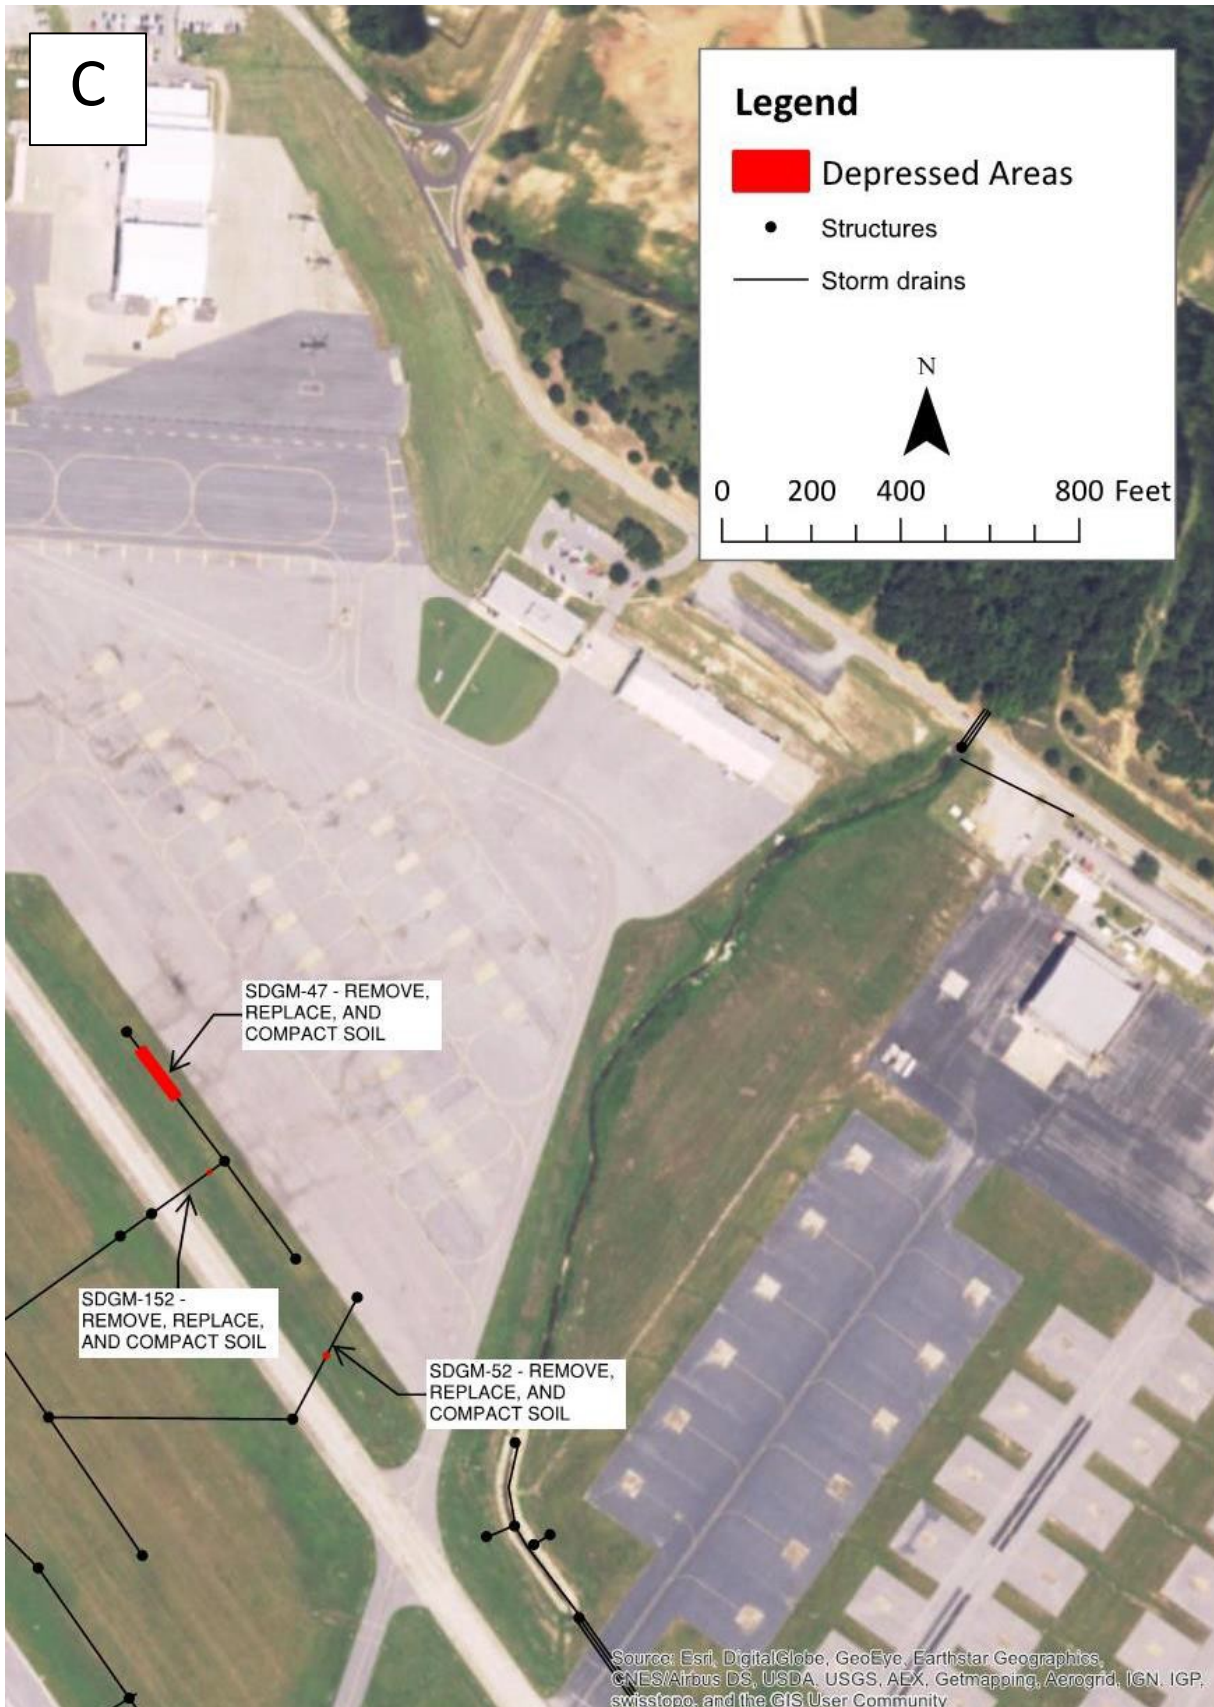
## **APPENDIX H: DETAILED MAPS OF DEPRESSED AREAS A-G**

Figure 23 illustrates the depressed areas identified during our field work within the study area. When compared with the condition assessment of the storm drain pipes, it was discovered that the depressed areas were not largely due to pipe collapses, but rather infiltration in pipe joints or poorly compacted soils which have consolidated over time. Due to these findings, depressed areas throughout LAAF are recommended to be addressed according to three different criteria:

1. In situations where there is a depressed area above a pipe with no detectable infiltration of sediment into the pipe, remove the soil above the pipe and replace the soil in compacted lifts (imported soil will be utilized to match adjacent grades as necessary).
2. In situations where there is a sinkhole present over pipes with significant infiltration of sediment into the pipe and for instances in which the pipe diameter is large enough for man entry, the recommended repair is to either wipe the joints with mortar, use internal mechanical joint sealants, or Spraycast. Then, remove the soil above the pipe and replace

- the soil in compacted lifts (imported soil will be utilized to match adjacent grades as necessary).
3. In situations where there is a sinkhole present over pipes with significant infiltration of sediment into the pipe and for instances in which the pipe diameter is **not** large enough for man entry and Spraycast is not possible, the recommended repair is CIPP. Then, remove the soil above the pipe and replace the soil in compacted lifts (imported soil will be utilized to match adjacent grades as necessary).
