Federal Lands Highway Road Inventory Program

Road Inventory and Condition Assessment

Wright Brothers National Memorial WRBR

Cycle 5 Report

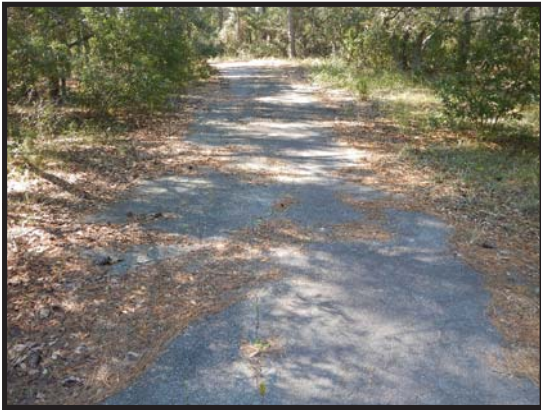
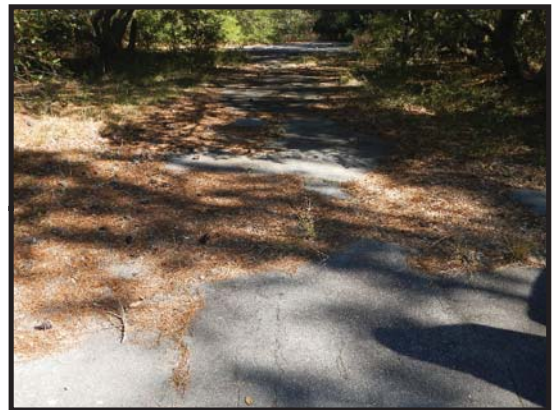
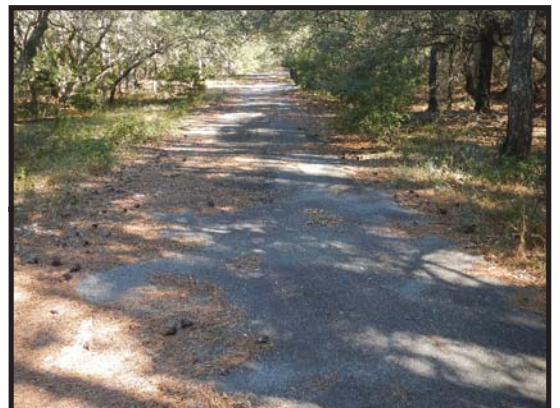
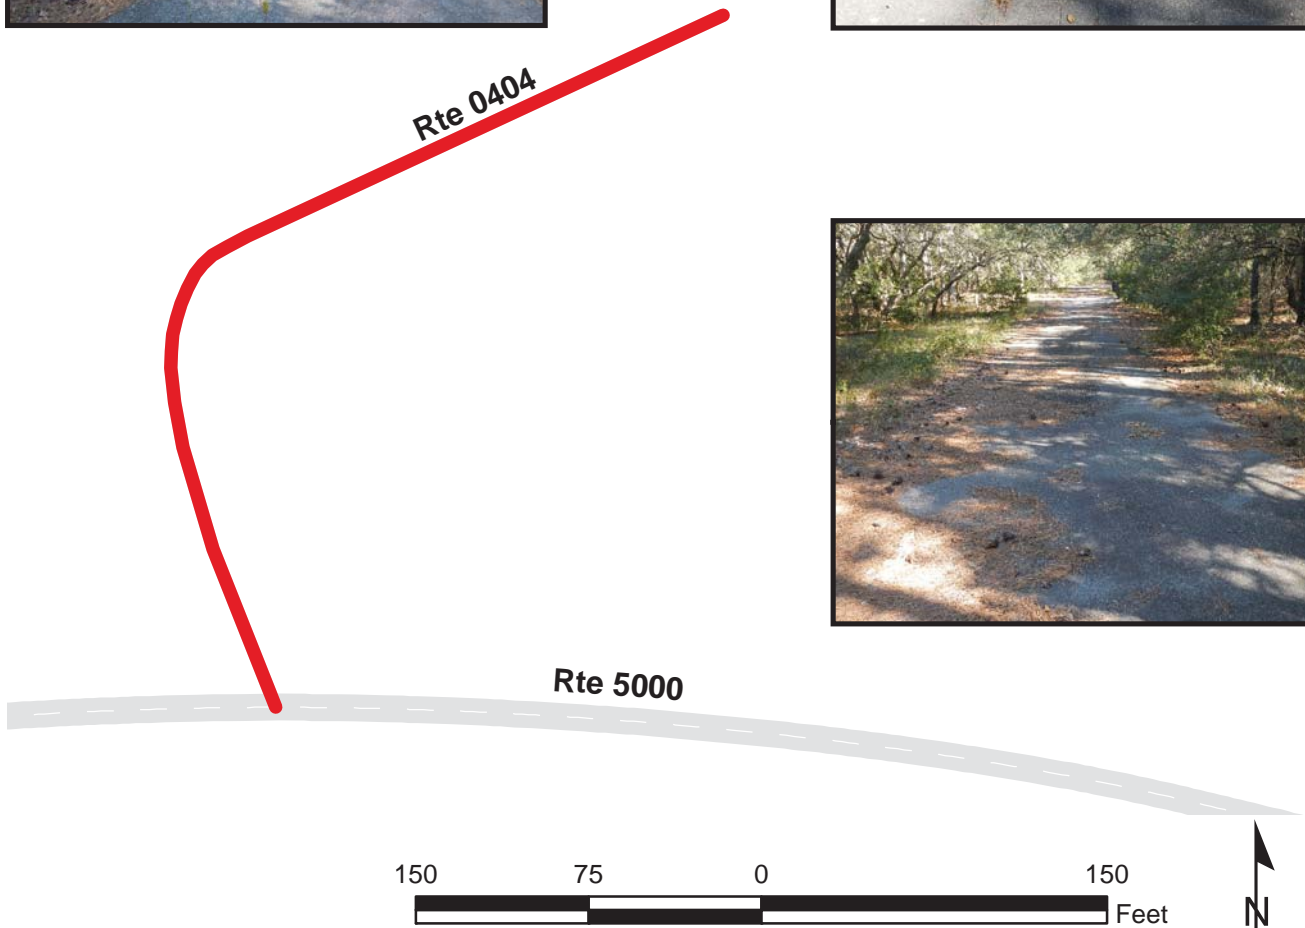
Route Number	Public / NonPublic	Date Visited	Area (sq ft)	Lane Miles *	Paved Length (mi)	Paved Width (ft)
0404	NONPUBLIC	2/6/2013	4,942	0.09	0.07	13
Culverts	Drop Inlets	Gates	Curb & Gutter	Curb	PCR	Surface Type
0	0	1	NO CURB AND GUTTER	NO CURB	POOR/45	AS

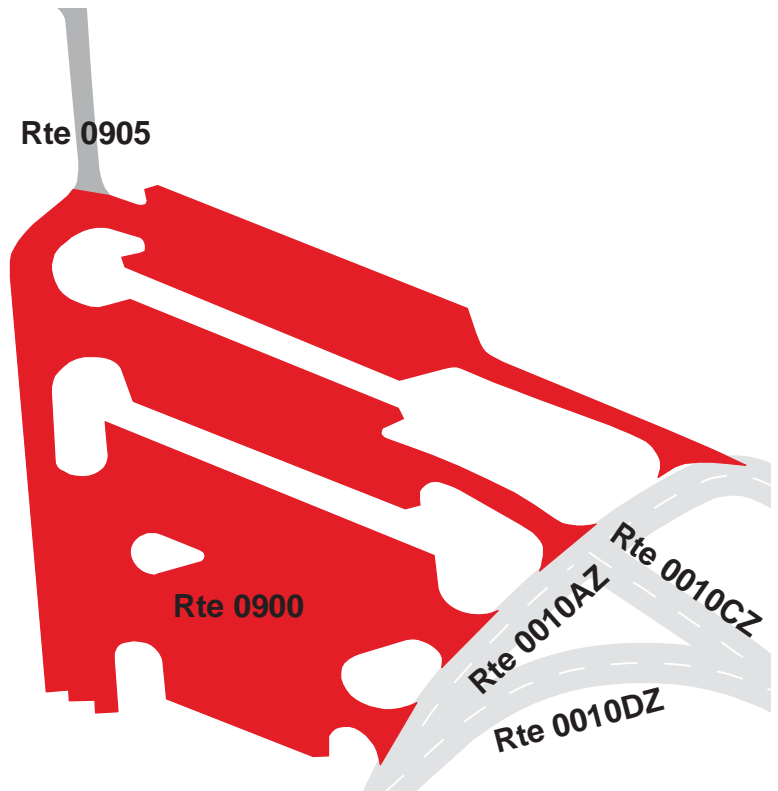
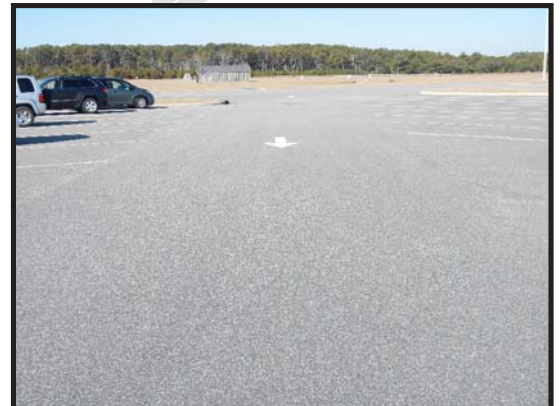
Route Number	Public / NonPublic	Date Visited	Area (sq ft)	Lane Miles *	Surface Type
0900	PUBLIC	2/6/2013	74,842	1.29	AS
Culverts	Drop Inlets	Gates	Curb & Gutter	Curb	PCR
2	5	0	NO CURB AND GUTTER	CONCRETE CURB	FAIR/73

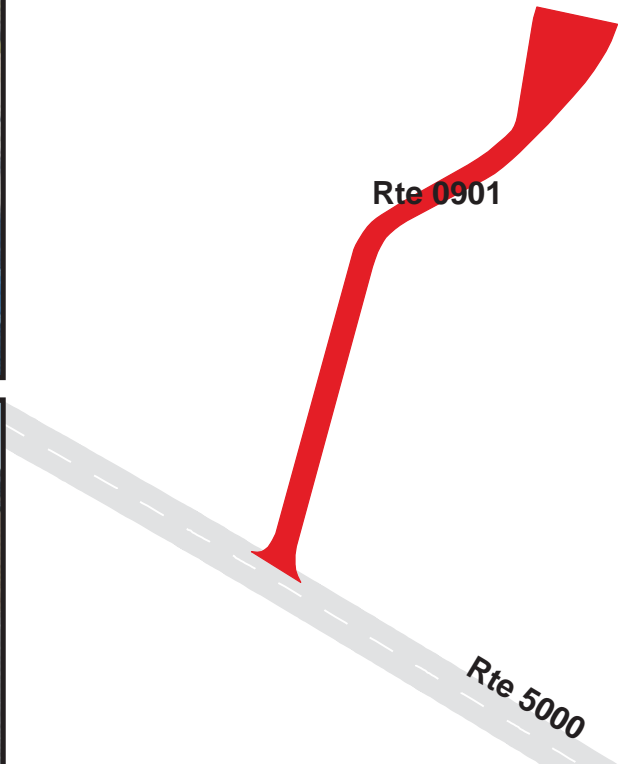
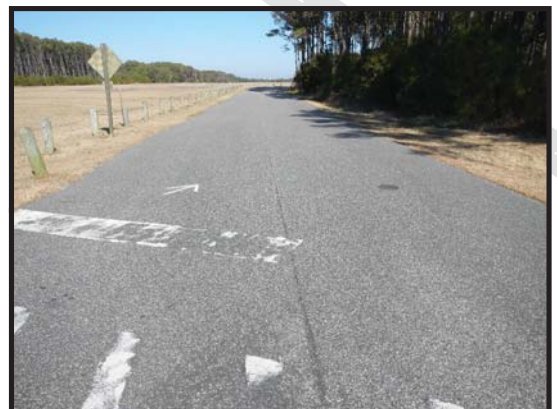
Route 0901

Route Number	Public / NonPublic	Date Visited	Area (sq ft)	Lane Miles *	Surface Type
0901	PUBLIC	2/6/2013	18,363	0.32	AS
Culverts	Drop Inlets	Gates	Curb & Gutter	Curb	PCR
1	0	1	NO CURB AND GUTTER	NO CURB	GOOD/90

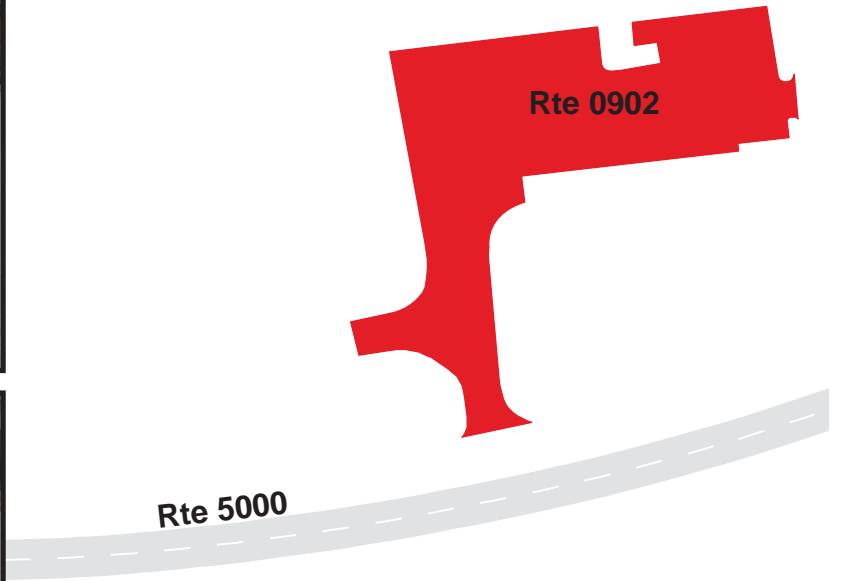
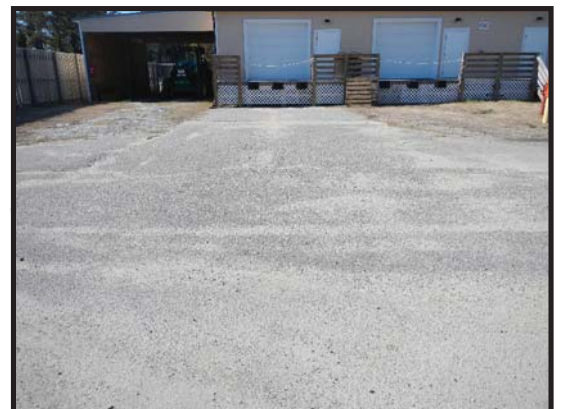
Route 0902

Route Number	Public / NonPublic	Date Visited	Area (sq ft)	Lane Miles *	Surface Type
0902	NONPUBLIC	2/6/2013	16,682	0.29	AS
Culverts	Drop Inlets	Gates	Curb & Gutter	Curb	PCR
0	0	2	NO CURB AND GUTTER	NO CURB	FAIR/73

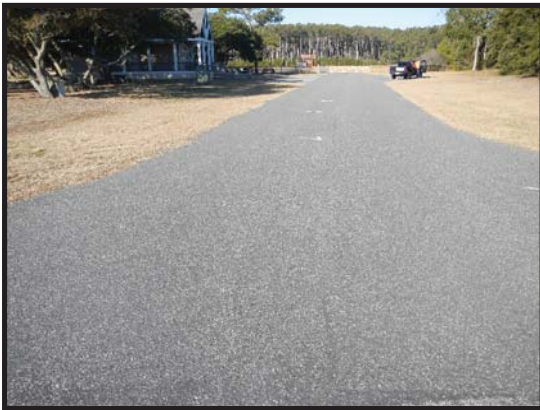
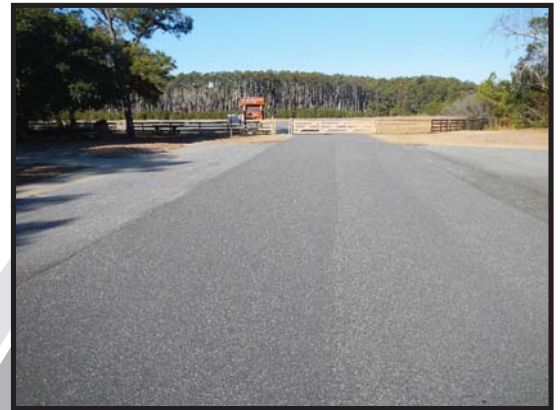
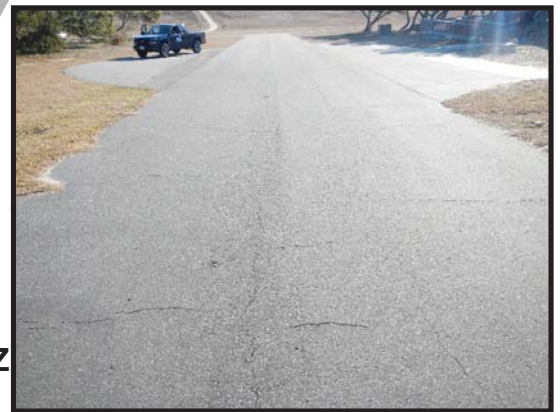
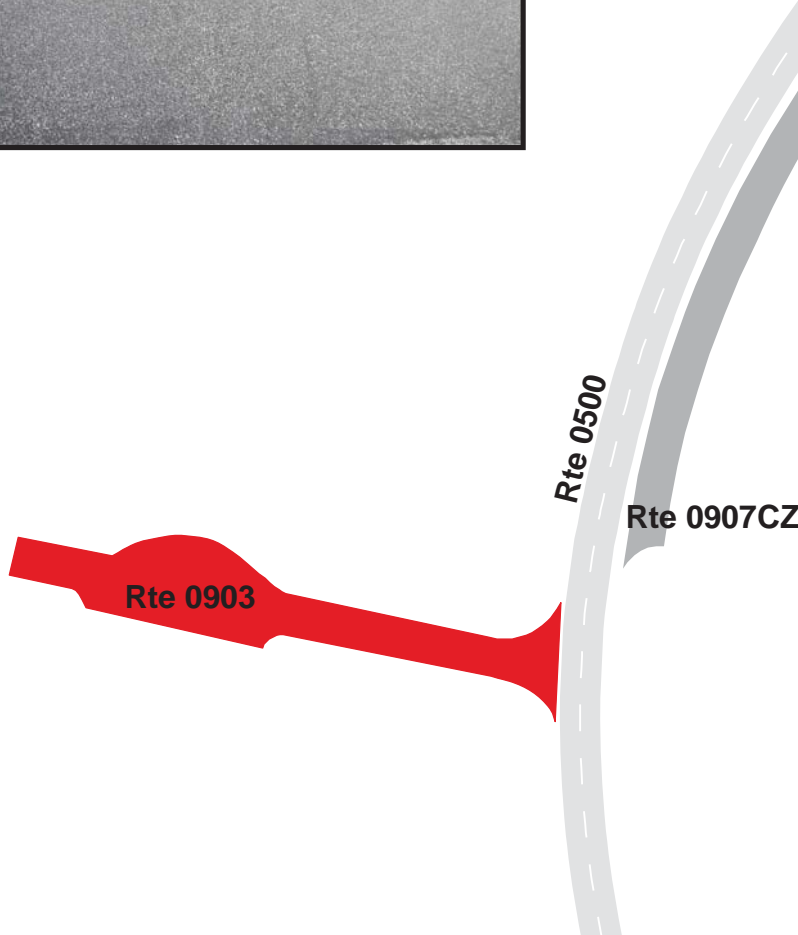
Route 0903

Route Number	Public / NonPublic	Date Visited	Area (sq ft)	Lane Miles *	Surface Type
0903	PUBLIC	2/6/2013	7,281	0.13	AS
Culverts	Drop Inlets	Gates	Curb & Gutter	Curb	PCR
0	0	1	NO CURB AND GUTTER	NO CURB	POOR/45

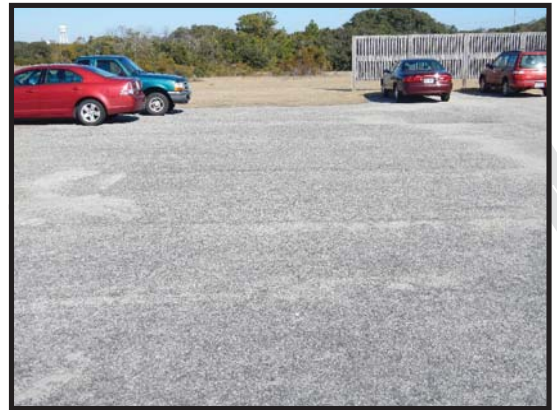
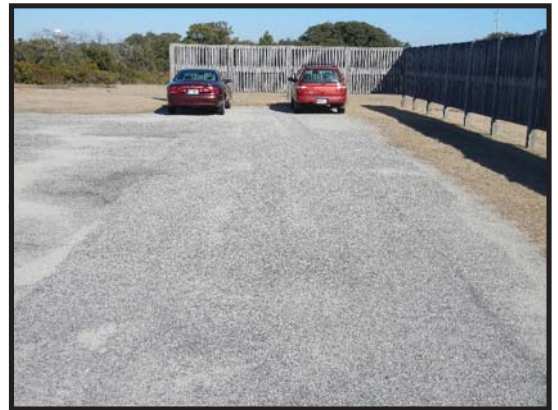
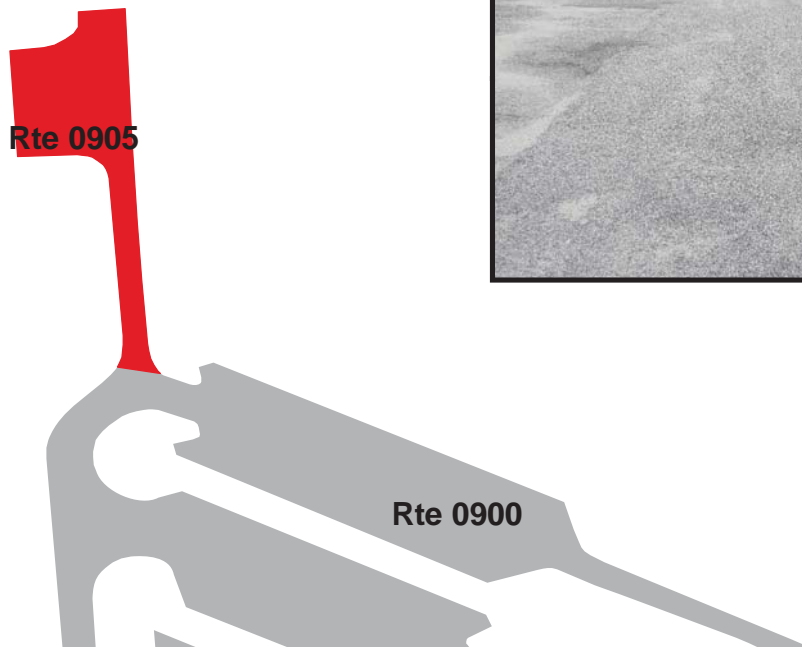
Route 0905

Route Number	Public / NonPublic	Date Visited	Area (sq ft)	Lane Miles *	Surface Type
0905	NONPUBLIC	2/6/2013	6,837	0.12	AS
Culverts	Drop Inlets	Gates	Curb & Gutter	Curb	PCR
0	0	0	NO CURB AND GUTTER	CONCRETE CURB	POOR/45

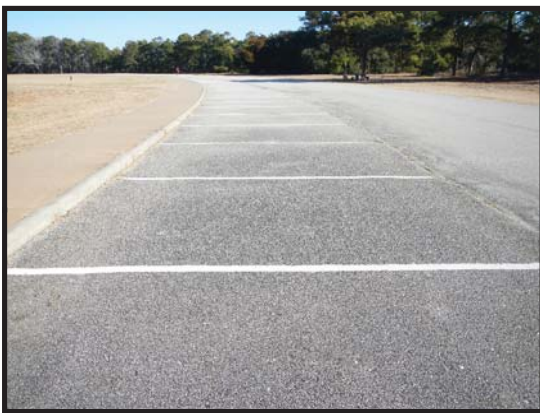
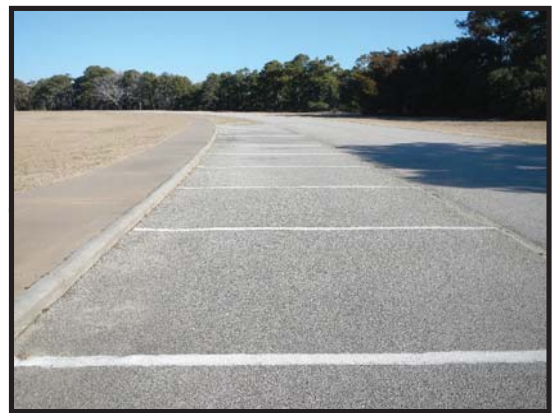
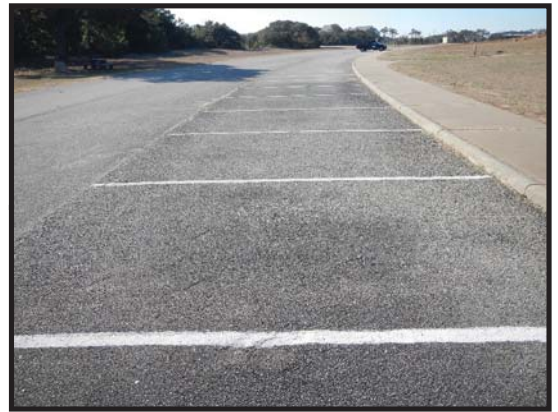
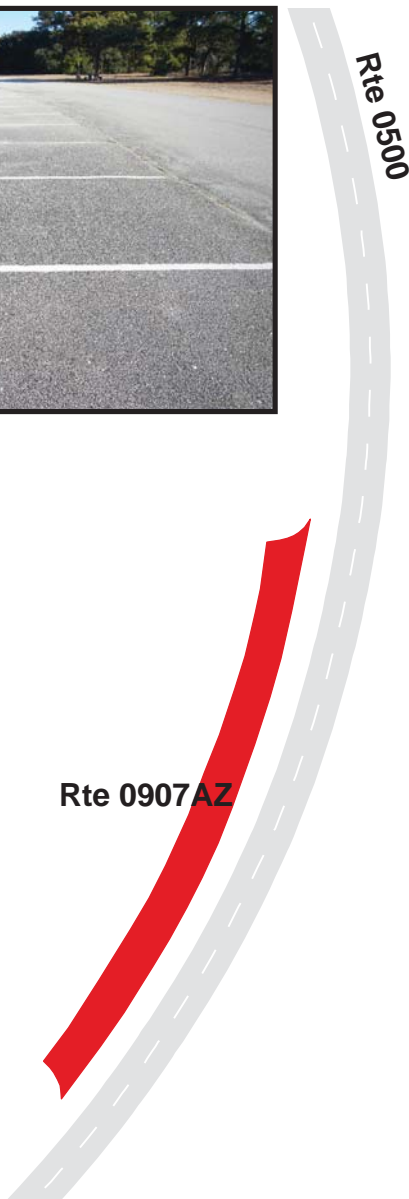
Route 0907AZ

Route Number	Public / NonPublic	Date Visited	Area (sq ft)	Lane Miles *	Surface Type
0907AZ	PUBLIC	2/6/2013	5,261	0.09	AS
Culverts	Drop Inlets	Gates	Curb & Gutter	Curb	PCR
0	1	0	NO CURB AND GUTTER	CONCRETE CURB	GOOD/90

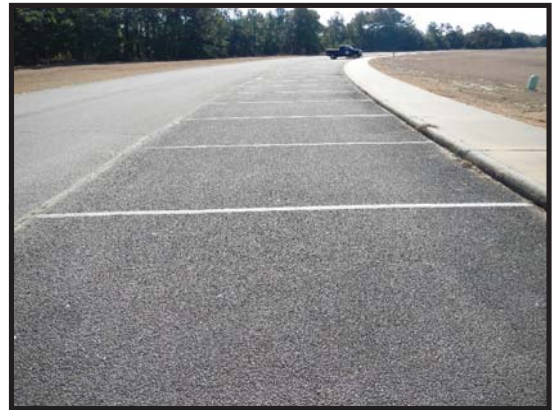
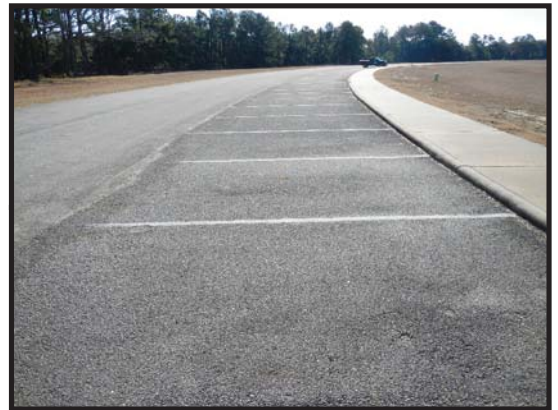
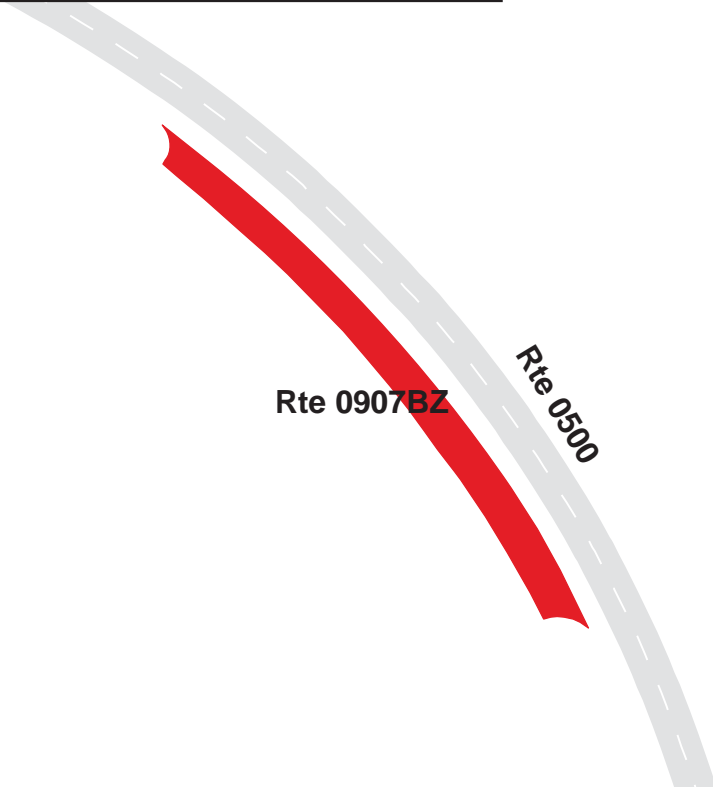
Route 0907BZ

Route Number	Public / NonPublic	Date Visited	Area (sq ft)	Lane Miles *	Surface Type
0907BZ	PUBLIC	2/6/2013	5,101	0.09	AS
Culverts	Drop Inlets	Gates	Curb & Gutter	Curb	PCR
0	1	0	NO CURB AND GUTTER	CONCRETE CURB	GOOD/90

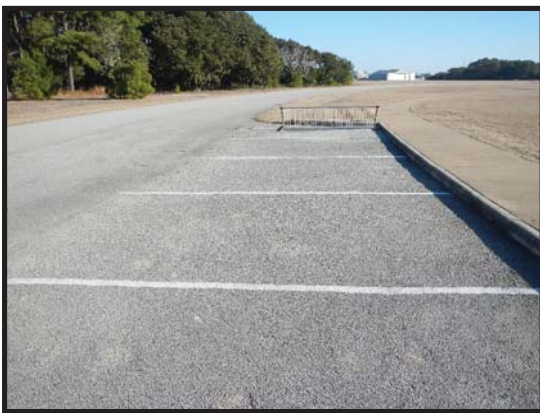
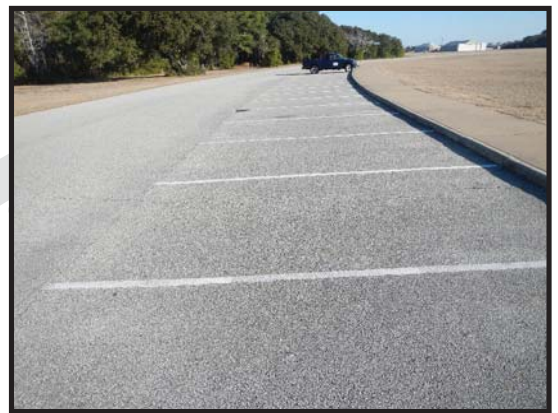
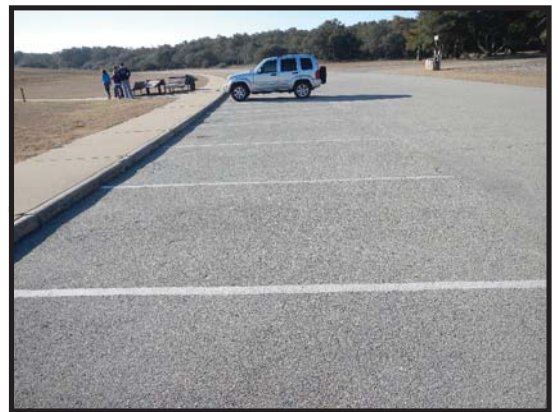
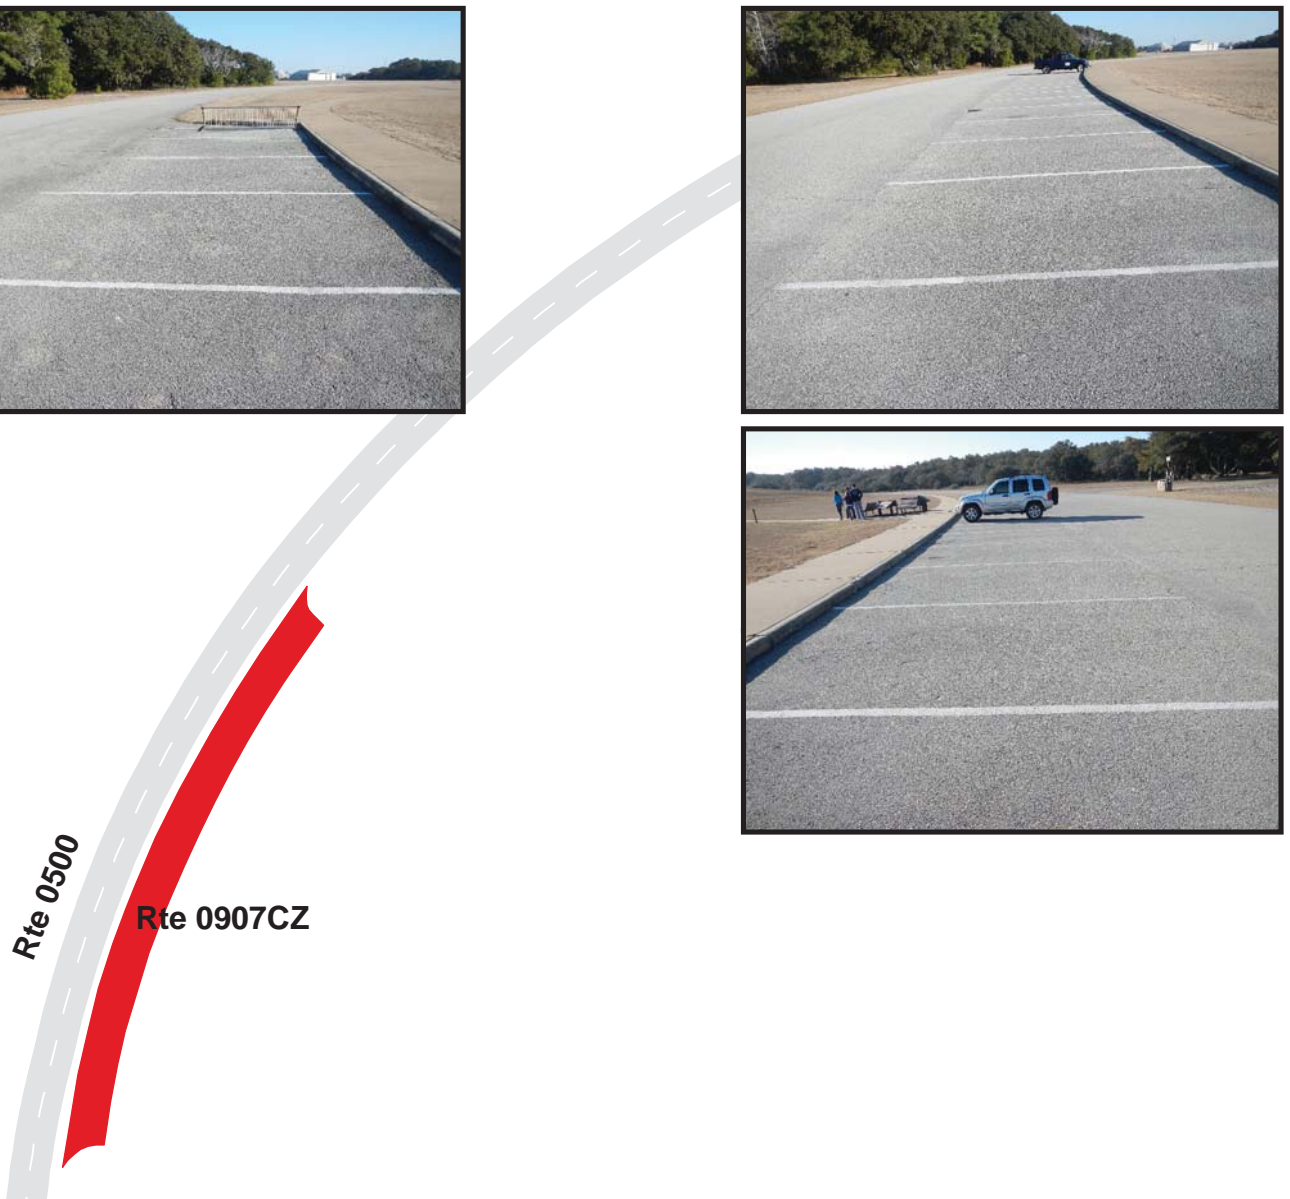
Route 0907CZ

Route Number	Public / NonPublic	Date Visited	Area (sq ft)	Lane Miles *	Surface Type
0907CZ	PUBLIC	2/6/2013	5,183	0.09	AS
Culverts	Drop Inlets	Gates	Curb & Gutter	Curb	PCR
0	1	0	NO CURB AND GUTTER	CONCRETE CURB	FAIR/73

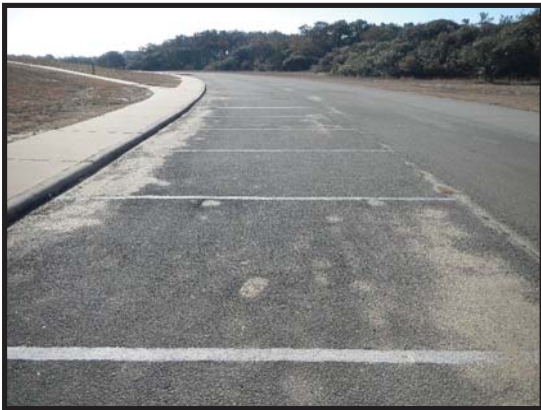
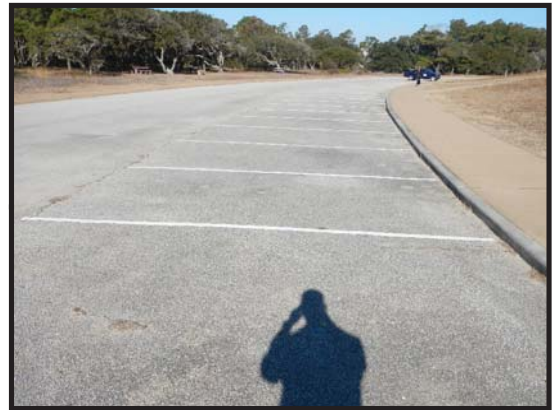
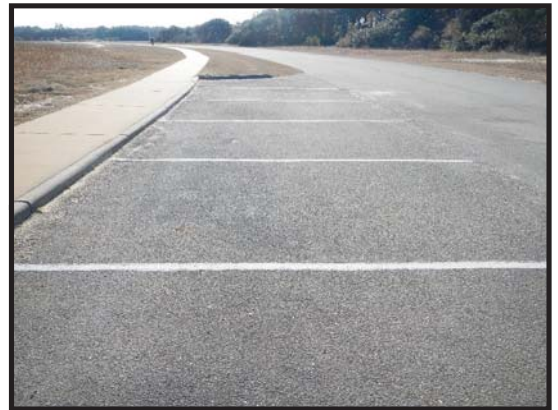
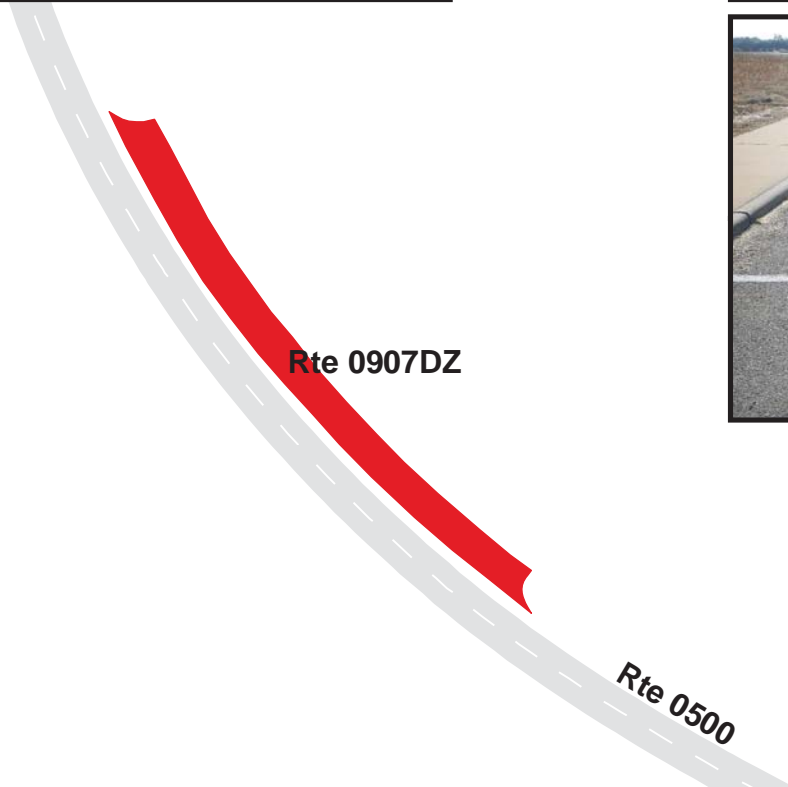
Route 0907DZ

Route Number	Public / NonPublic	Date Visited	Area (sq ft)	Lane Miles *	Surface Type
0907DZ	PUBLIC	2/6/2013	5,123	0.09	AS
Culverts	Drop Inlets	Gates	Curb & Gutter	Curb	PCR
0	1	0	NO CURB AND GUTTER	CONCRETE CURB	FAIR/73

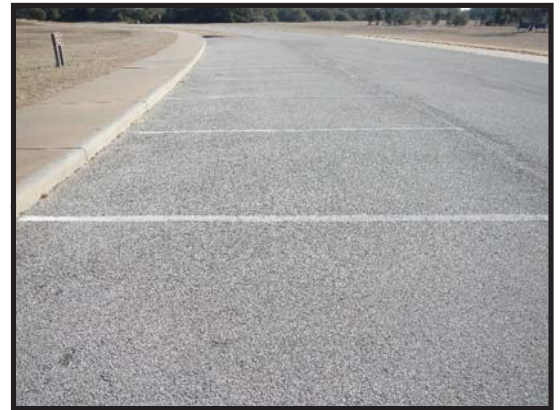
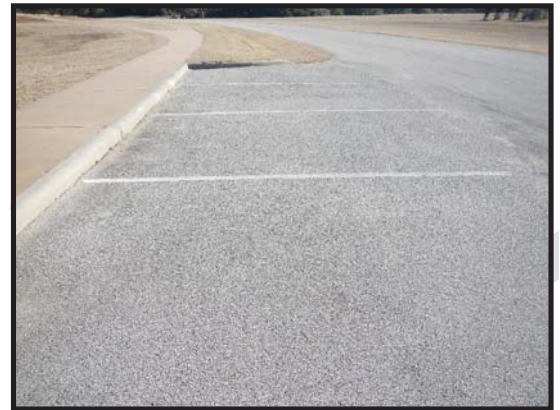
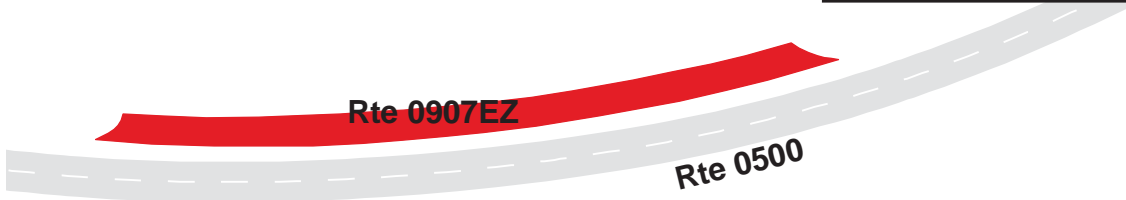
Route 0907EZ

Route Number	Public / NonPublic	Date Visited	Area (sq ft)	Lane Miles *	Surface Type
0907EZ	PUBLIC	2/6/2013	4,921	0.09	AS
Culverts	Drop Inlets	Gates	Curb & Gutter	Curb	PCR
0	1	0	NO CURB AND GUTTER	CONCRETE CURB	GOOD/90

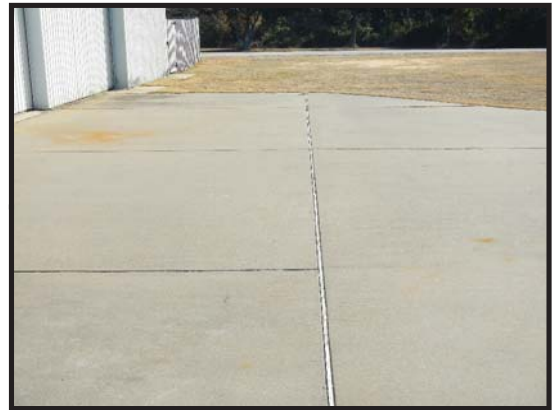
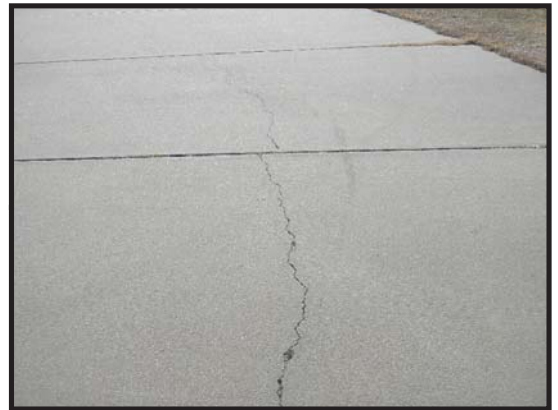
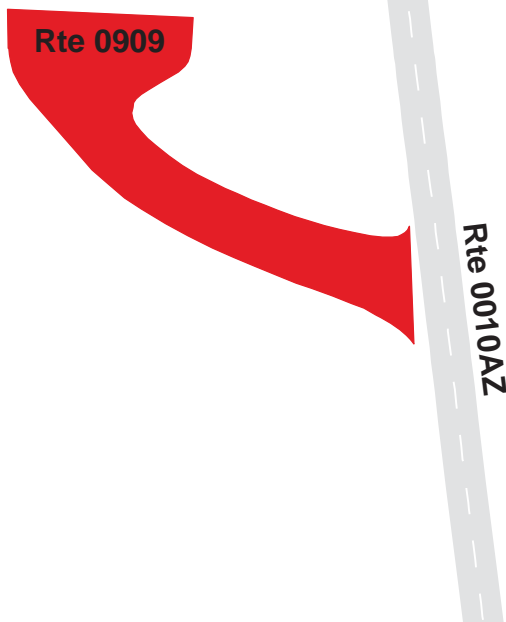
Route 0909

Route Number	Public / NonPublic	Date Visited	Area (sq ft)	Lane Miles *	Surface Type
0909	PUBLIC	2/6/2013	3,895	0.07	CO
Culverts	Drop Inlets	Gates	Curb & Gutter	Curb	PCR
0	0	0	NO CURB AND GUTTER	NO CURB	POOR/45

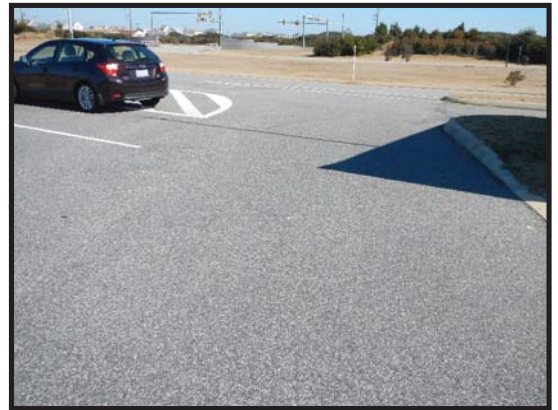
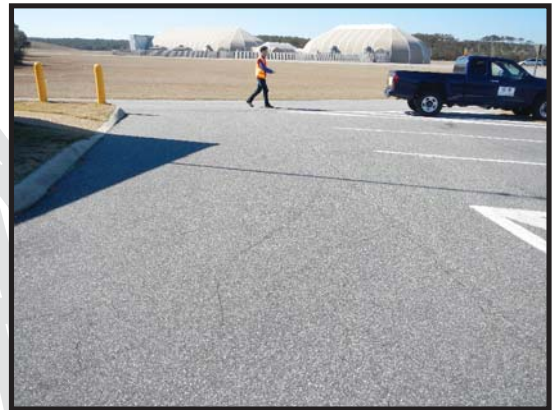
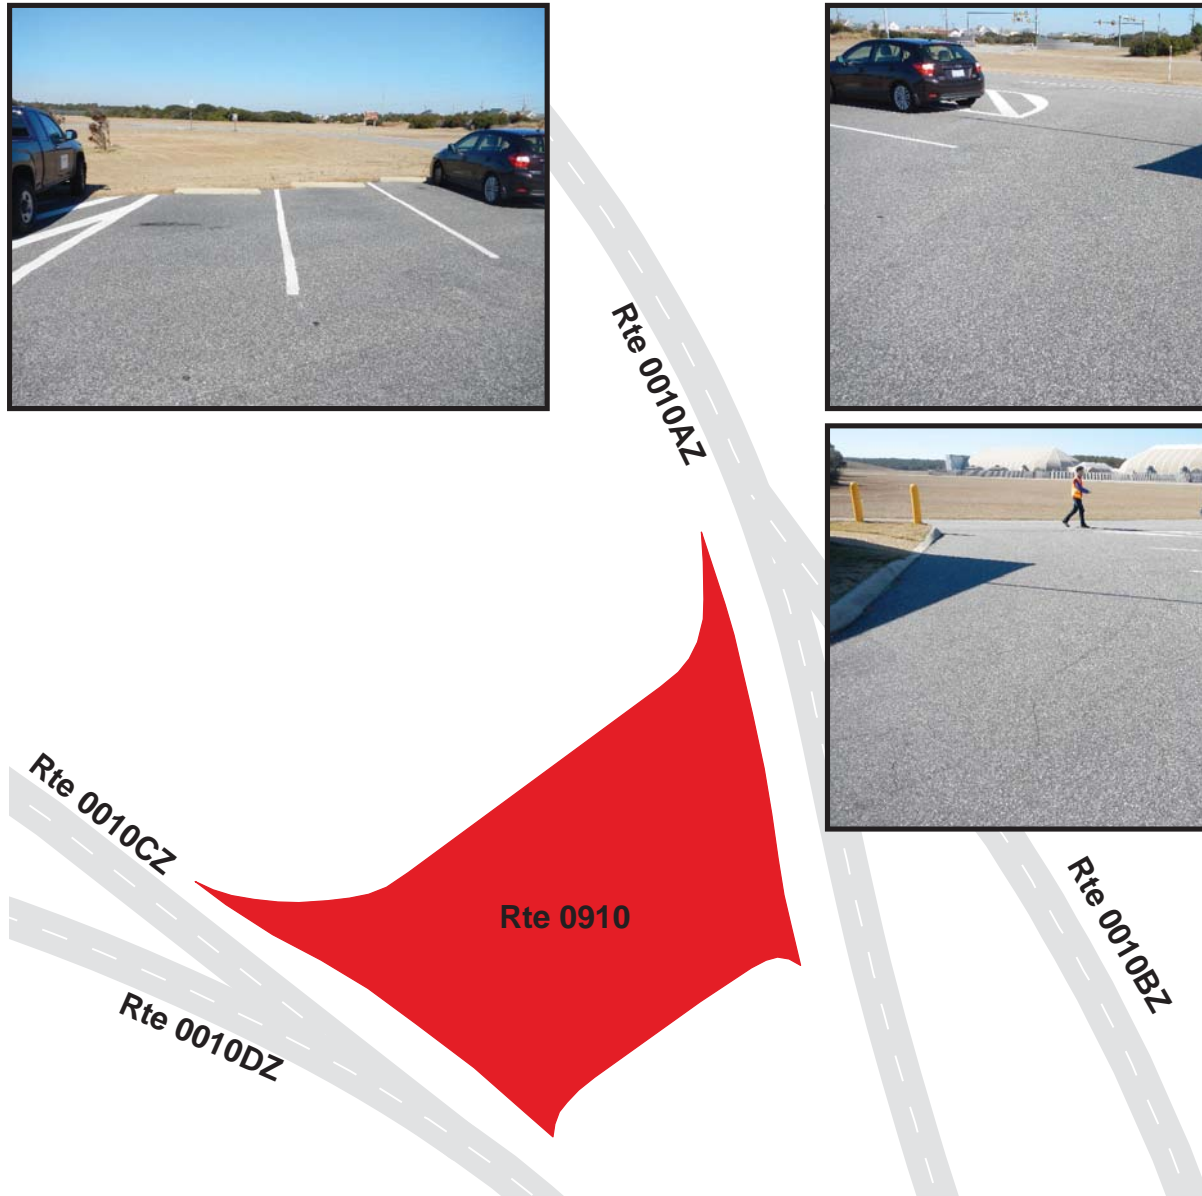
Route 0910

Route Number	Public / NonPublic	Date Visited	Area (sq ft)	Lane Miles *	Surface Type
0910	NONPUBLIC	2/6/2013	1,703	0.03	AS
Culverts	Drop Inlets	Gates	Curb & Gutter	Curb	PCR
0	0	0	NO CURB AND GUTTER	CONCRETE CURB	GOOD/90
