Asbestos Survey

IR Demo Package FY24
MCB Camp Lejeune
Project # 23-0036

Report Prepared By:
Christopher B. Walker
The Walker Group Architecture, Inc
August 11th, 2024
WGA Project No. – 2402.FY24

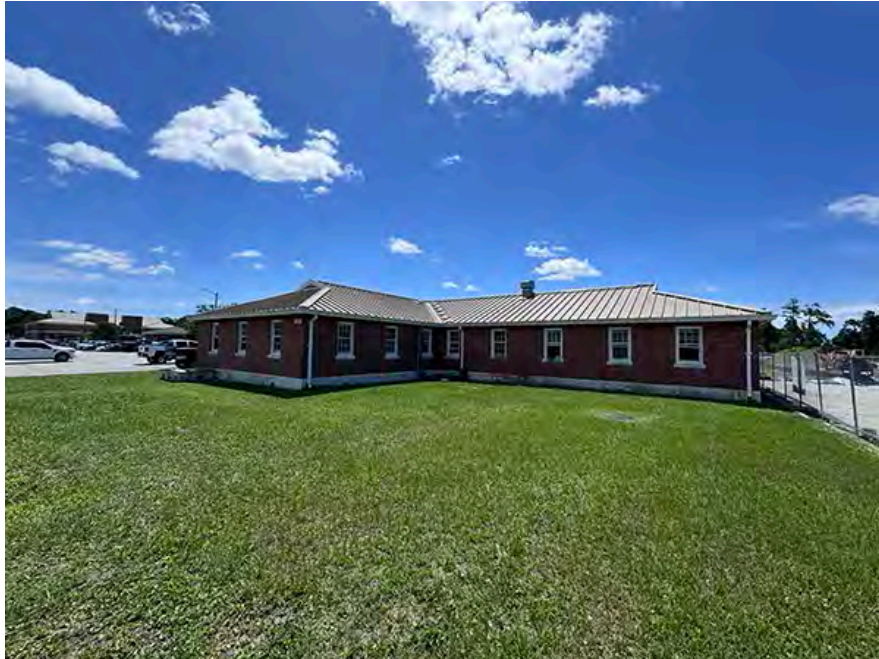
Building Description and Findings (Inspected 07-03-24)

Building 114 is a vacant office building. The building is constructed with concrete foundation, brick exterior walls, metal stud interior walls with plaster and gypsum board. The building has a standing seam metal roof system. HVAC is provided through a forced air mechanical system.

Based on the sample analysis none of the materials sampled were found to be Asbestos Containing Materials.

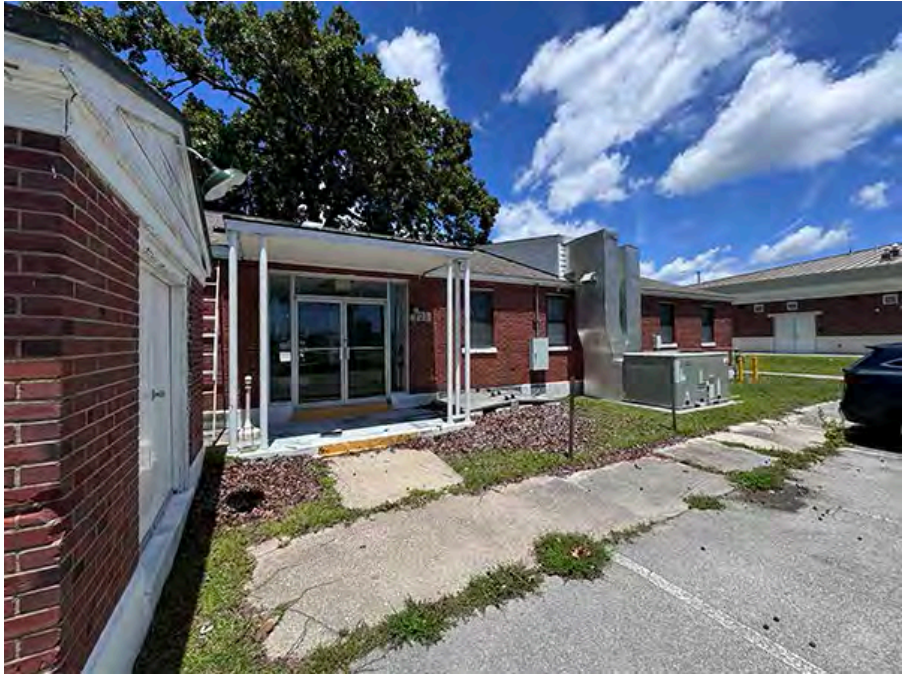
Building Description and Findings (Inspected 07-03-24)

Building 203 is a vacant office building. The building is constructed with concrete foundation, brick exterior walls, metal stud interior walls with plaster and gypsum board. The building has an asphalt shingle roof system. HVAC is provided through a forced air mechanical system.

Based on the sample analysis, the following materials were found to be Asbestos Containing Materials.

Exterior textured concrete foundation

Materials found to contain asbestos in the current inspection report and government provided inspection report should all be considered for the purpose of any demolition/renovation activities and disturbance. See Appendix for Government provided reports.

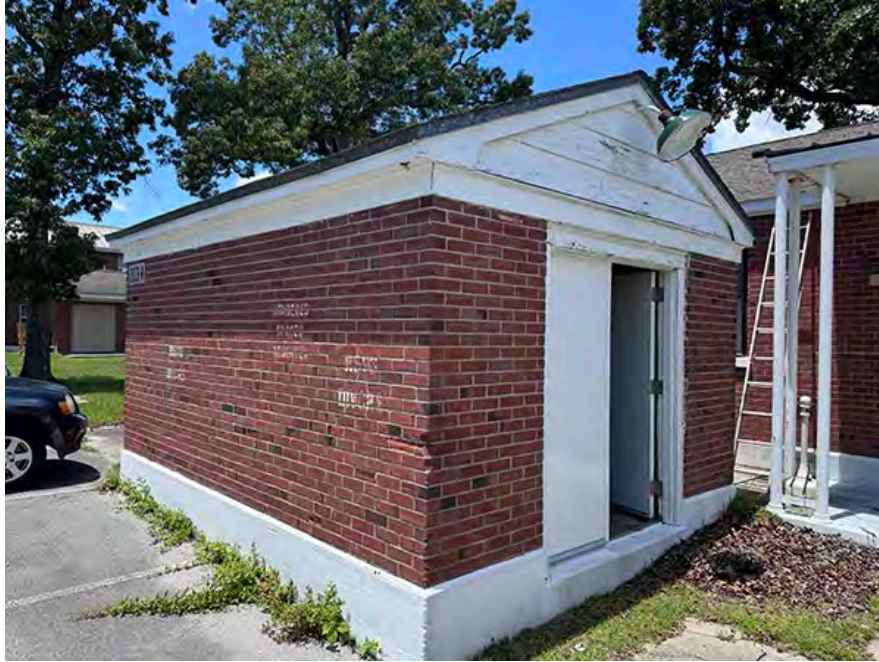
Building 203A

Building Description and Findings (Inspected 07-03-24)

Building 203 is a support building for building 203. The building is constructed with concrete foundation, and brick exterior walls. The building has an asphalt shingle roof system.

Material	Material Type	Location	Friability	Laboratory Result	Approx. Quantity
Ext. door caulk	Misc	Exterior Door	NF	Non-Detected	N/A
Asphalt shingles/felt	Misc	Roof	NF	Non-Detected	N/A
Ext. textured concrete	Surf.	Exterior building foundation	NF	2% Chrysotile	96SF

Based on the sample analysis, the following materials were found to be Asbestos Containing Materials.

Exterior textured concrete foundation

Materials found to contain asbestos in the current inspection report and government provided inspection report should all be considered for the purpose of any demolition/renovation activities and disturbance. See Appendix for Government provided reports.

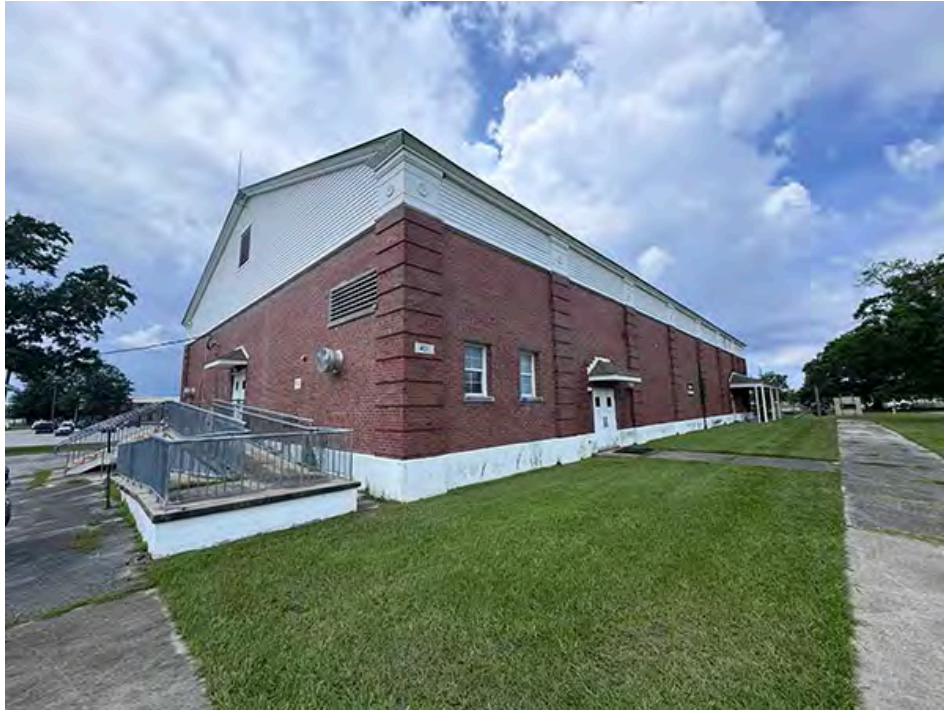
Building Description and Findings (Inspected 07-29-24)

Building 401 is a vacant physical training and office building. The building is constructed with concrete foundation, and brick exterior walls, gypsum board interior walls. The building has an asphalt shingle roof system. HVAC is provided with a forced air mechanical system in the attic.

Based on the sample analysis, the following materials were found to be Asbestos Containing Materials.

Exterior door/window caulk

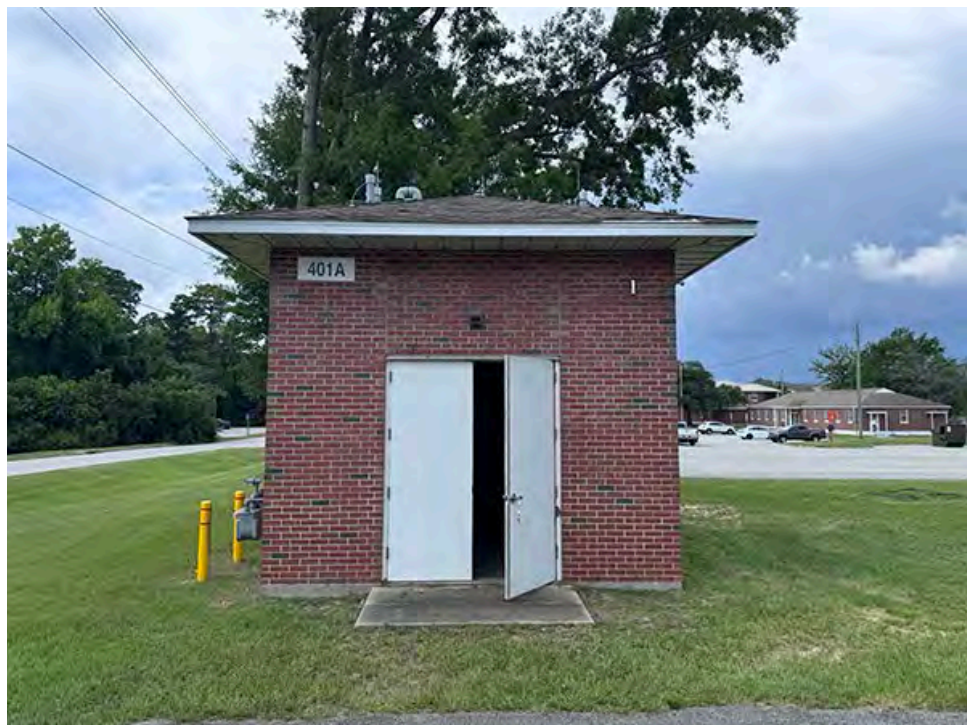
Building Description and Findings (Inspected 07-29-24)

Building 401A is a mechanical support building for Building 401. The building is constructed with concrete foundation, brick and cmu exterior walls. The building has an asphalt shingle roof system.

Based on the sample analysis none of the materials sampled were found to be Asbestos Containing Materials.

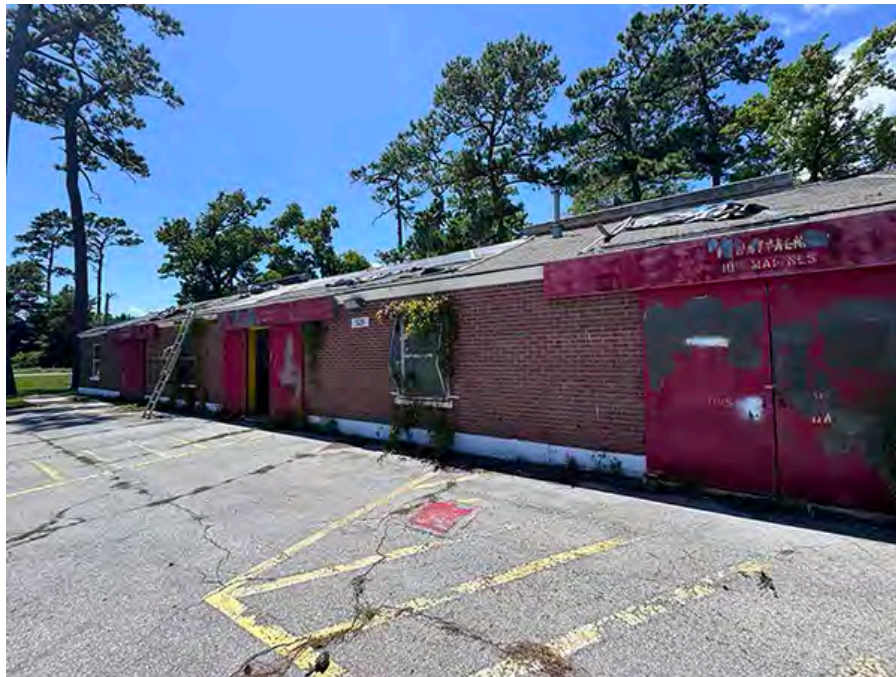
Building Description and Findings (Inspected 07-03-24)

Building 528 is a vacant storage building. The building is constructed with concrete foundation, brick exterior walls, metal stud interior walls with wood and gypsum board. The building has an asphalt shingle roof system.

Based on the sample analysis, the following materials were found to be Asbestos Containing Materials.

ACM Materials found in previous government provided report:
-Transite panel material- approx. 1,600sf

Materials found to contain asbestos in the current inspection report and government provided inspection report should all be considered for the purpose of any demolition/renovation activities and disturbance. See Appendix for Government provided reports.

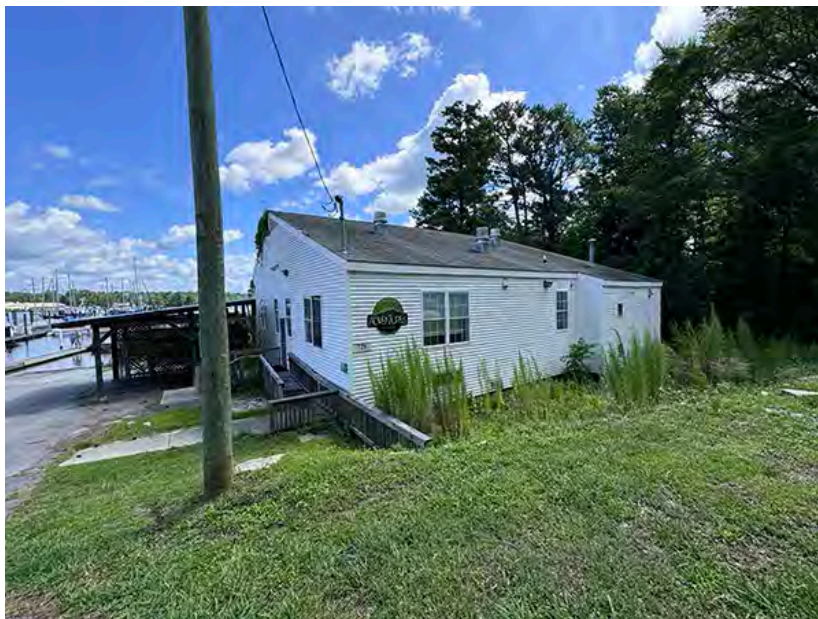
Building Description and Findings (Inspected 07-03-2024)

Building 728 is a vacant office building. The building is a wood framed building with exterior vinyl siding, asphalt shingle roof, wood interior framing and gypsum board walls. Most of the flooring in the building was VCT. HVAC is provided through a forced air mechanical system.

Based on the sample analysis none of the materials sampled were found to be Asbestos Containing Materials.

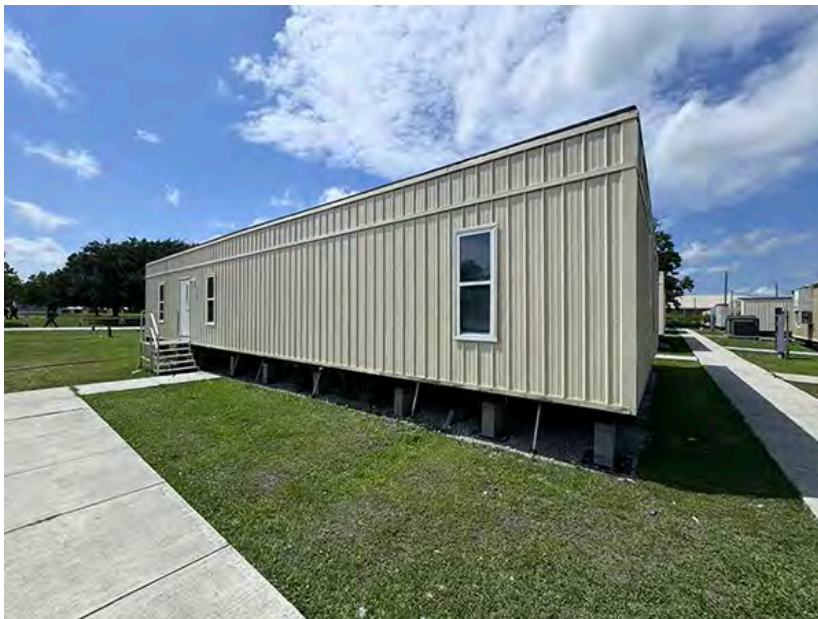
Building Description and Findings (Inspected 07-29-2024)

Building 1005A is a temporary modular office. The building is constructed with wood wall framing, metal siding, and rubber roof system. The interior has VCT flooring, gypsum board walls and ceilings and a forced air mechanical system.

Based on the sample analysis none of the materials sampled were found to be Asbestos Containing Materials

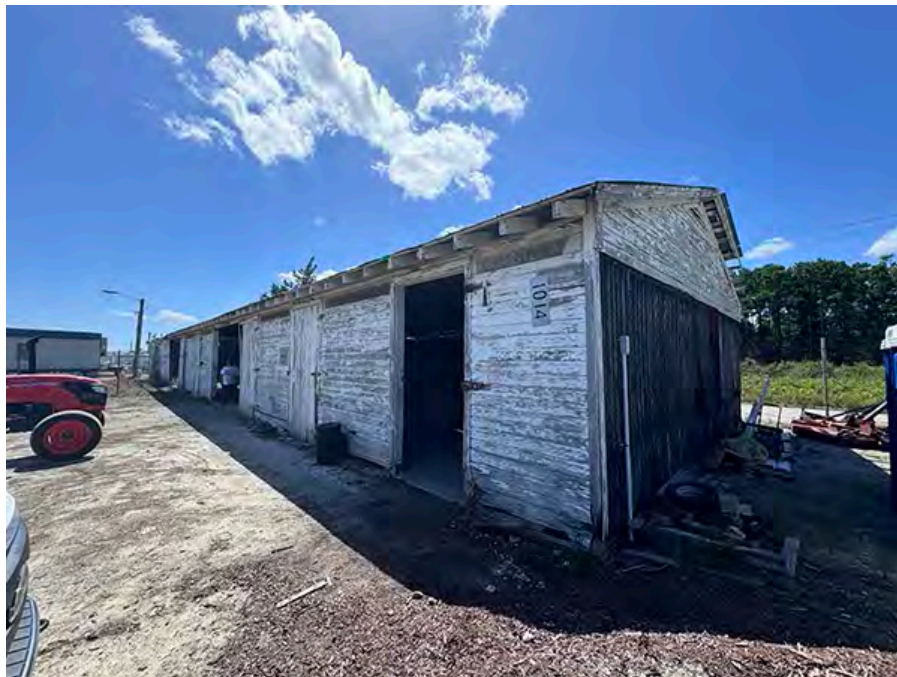
Building Description and Findings (Inspected 04-23-2024)

Building 1014 is a wood storage building that is currently in use. The building is constructed as a pole barn structure with wood walls and roof framing. The roof and

exterior walls are clad with metal. There are no HVAC systems and the building is partially open from a damaged roof.

Based on the sample analysis, the following materials were found to be Asbestos Containing Materials.

Materials found to contain asbestos in the current inspection report and government provided inspection report should all be considered for the purpose of any demolition/renovation activities and disturbance. See Appendix for Government provided reports.

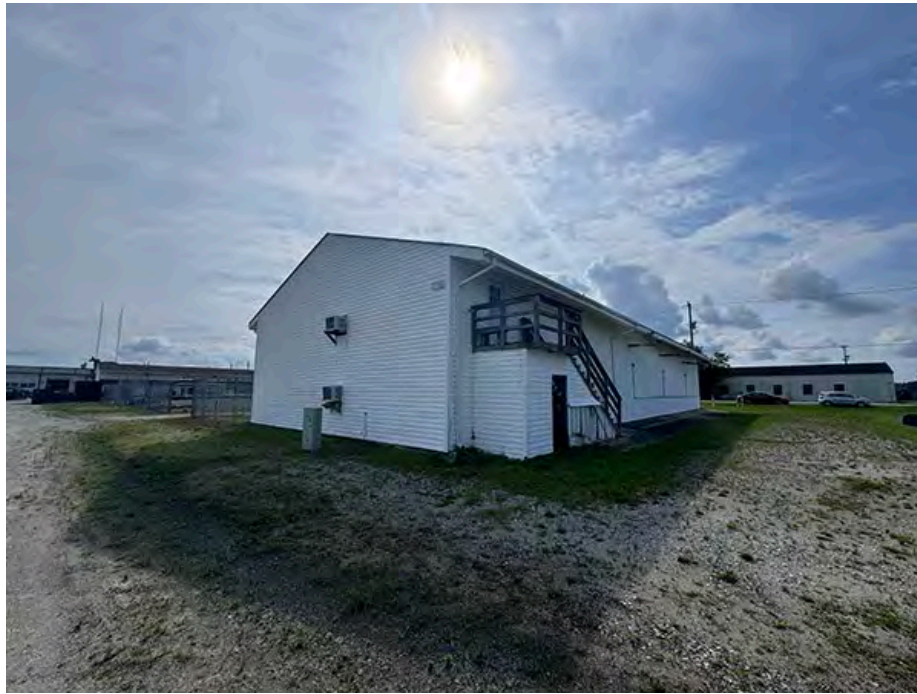
Building Description and Findings (Inspected 07-29-2024)

Building 1306 is a wood maintenance/office building that is currently vacant. The building is constructed with wood/steel structure, interior wood/gypsum board walls, wood roof structure and asphalt shingle roof. HVAC is provided through wall units.

Based on the sample analysis, none of the materials sampled were found to be Asbestos Containing Materials.

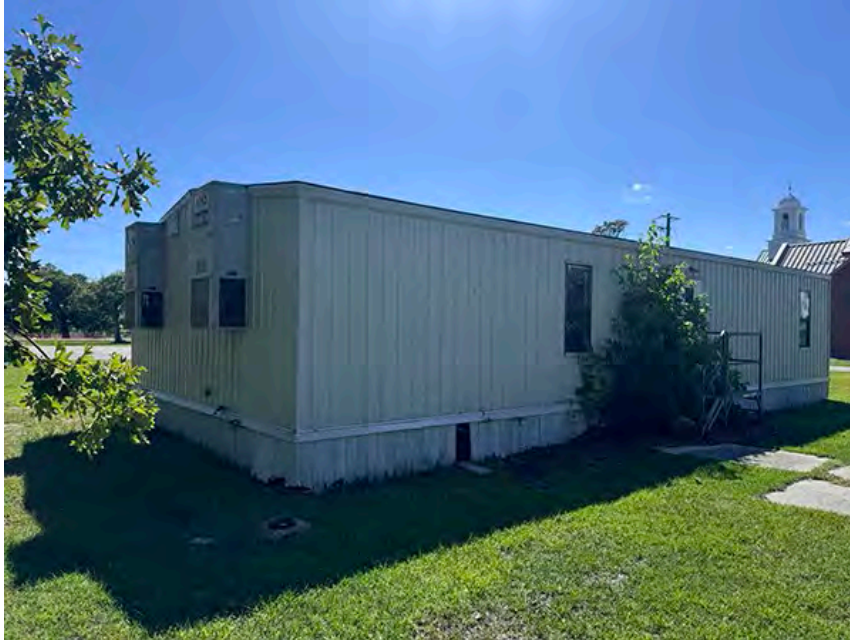
Building 1742A is a temporary modular office. The building is constructed with wood wall framing, metal siding, and rubber roof system. The interior has VCT flooring, gypsum board walls and ceilings and a forced air mechanical system.

Based on the sample analysis none of the materials sampled were found to be Asbestos Containing Materials

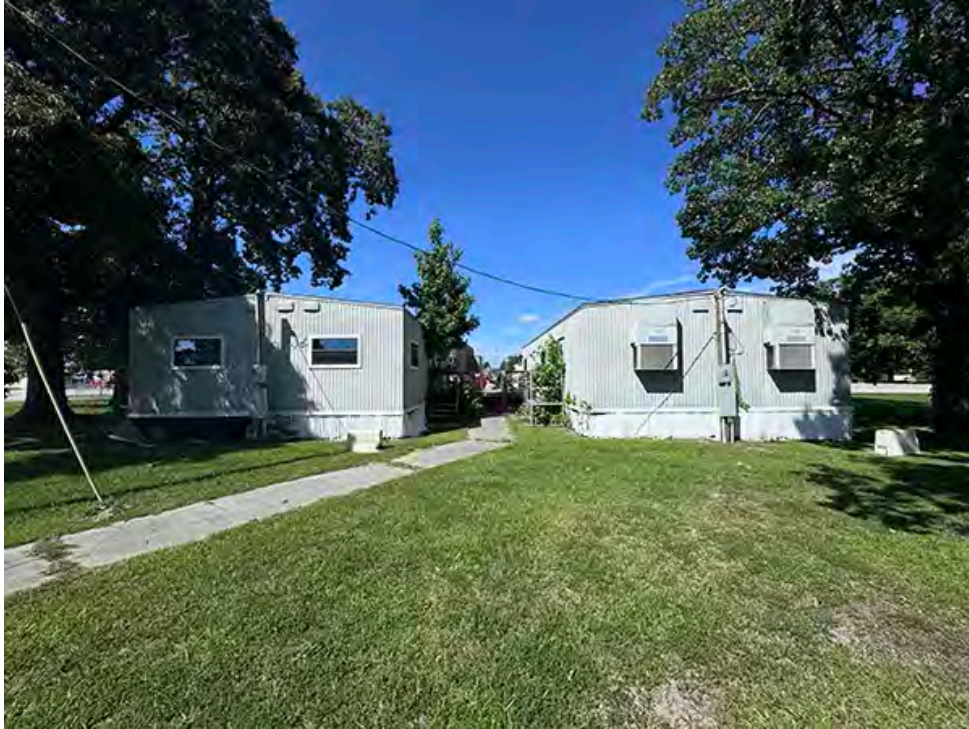
Building 1742B is a temporary modular office. The building is constructed with wood wall framing, metal siding, and rubber roof system. The interior has VCT flooring, gypsum board walls and ceilings and a forced air mechanical system.

Based on the sample analysis none of the materials sampled were found to be Asbestos Containing Materials

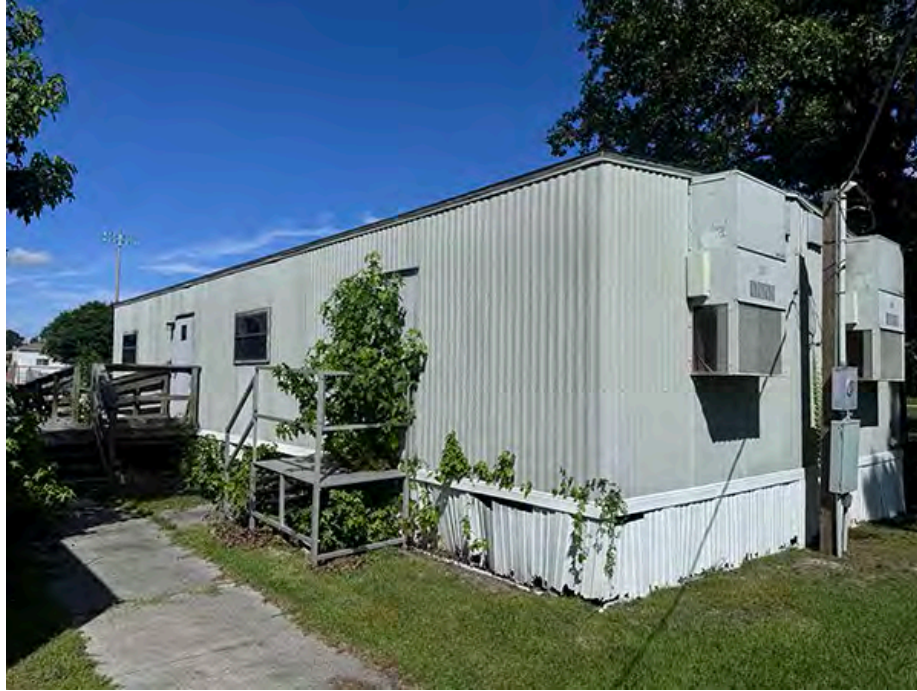
Building 1742C is a temporary modular office. The building is constructed with wood wall framing, metal siding, and rubber roof system. The interior has VCT flooring, gypsum board walls and ceilings and a forced air mechanical system.

Based on the sample analysis none of the materials sampled were found to be Asbestos Containing Materials

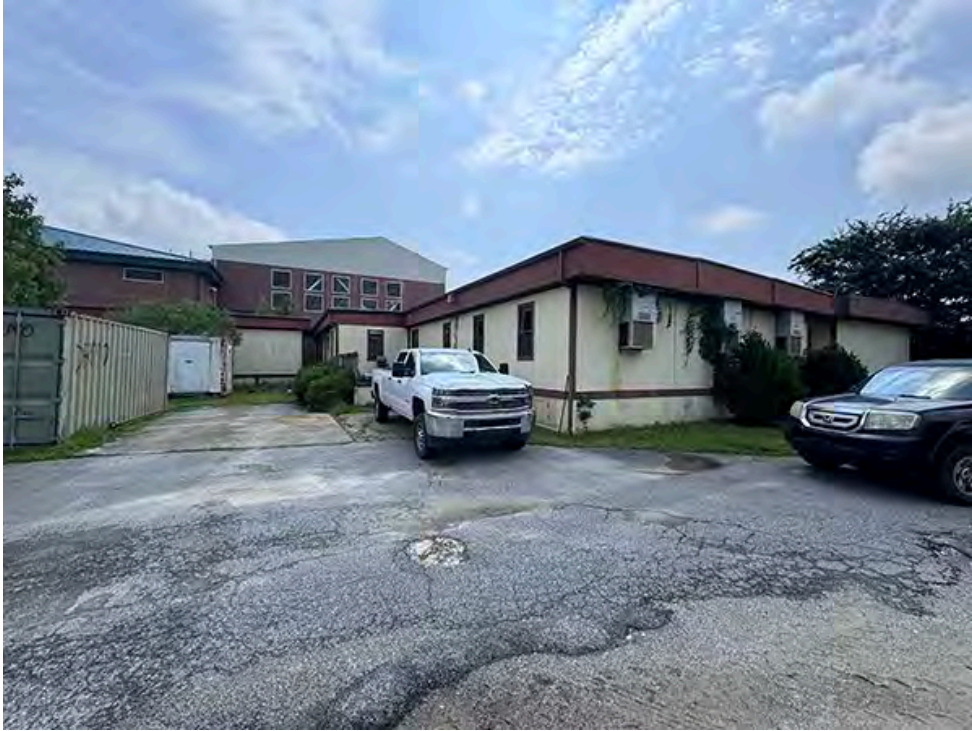
Building AS251 is a temporary modular office. The building is constructed with wood wall framing, fiber cement siding, and rubber roof system. The interior has VCT flooring, gypsum board walls and ceilings and a forced air mechanical system.

Based on the sample analysis none of the materials sampled were found to be Asbestos Containing Materials

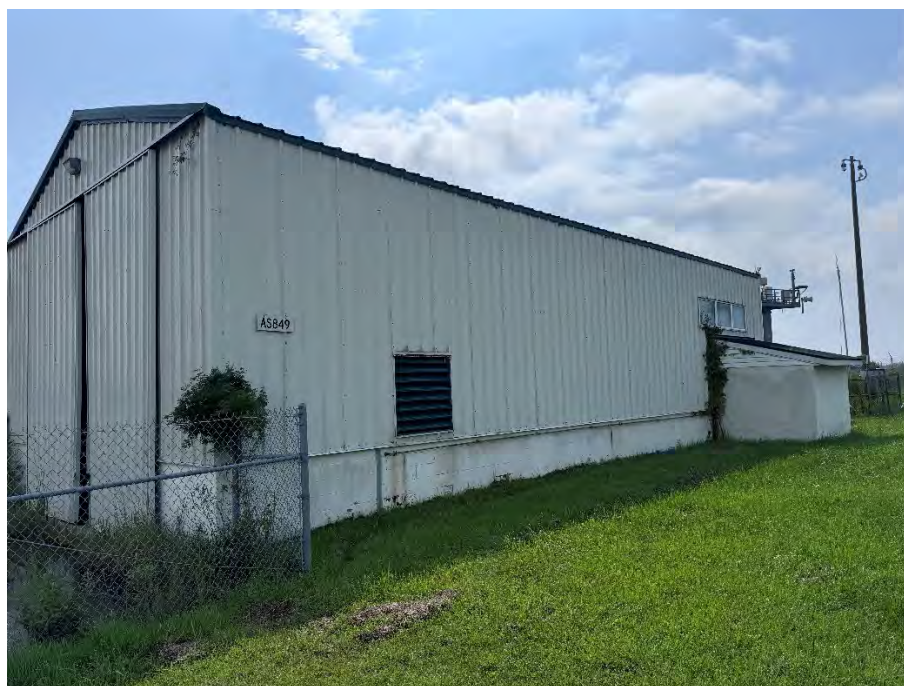
Building Description and Findings (Inspected 04-20-20)

Building AS849 is a vacant maintenance structure. The building is constructed with a slab on grade, metal building system, metal exterior walls and roof, wood interior walls with gypsum board. There is a masonry stem wall on the exterior of the building.

Based on the sample analysis, the following materials were found to be Asbestos Containing Materials.

Materials found to contain asbestos in the current inspection report and government provided inspection report should all be considered for the purpose of any demolition/renovation activities and disturbance. See Appendix for Government provided reports.

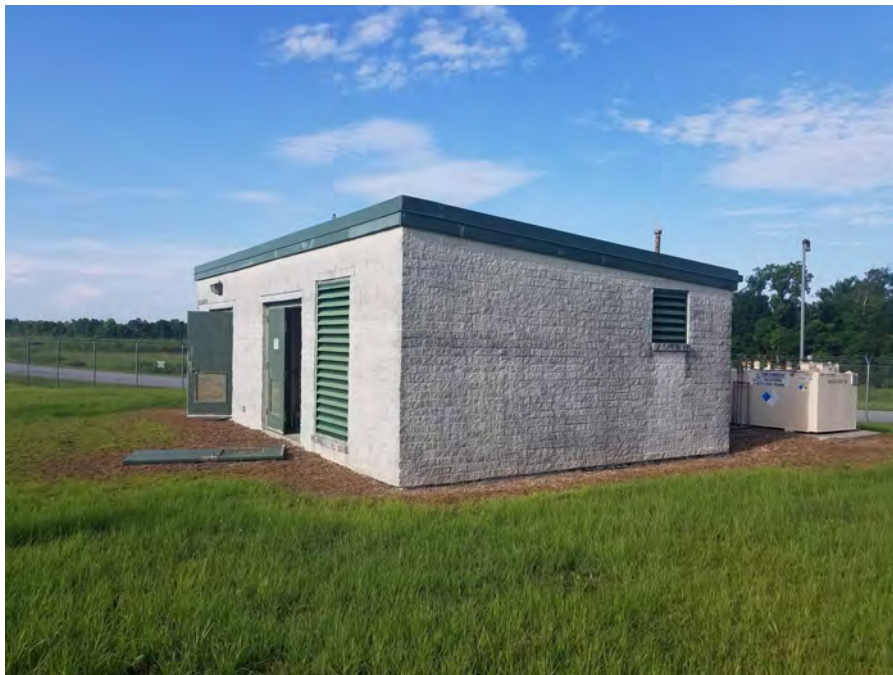
Building Description and Findings (Inspected 07-18-24)

Building AS3450 is a decommissioned mechanical and storage building. The building is constructed with slab on grade, masonry bearing walls, steel structure, and a modified bitumen roof system.

Based on the sample analysis, the following materials were found to be Asbestos Containing Materials.

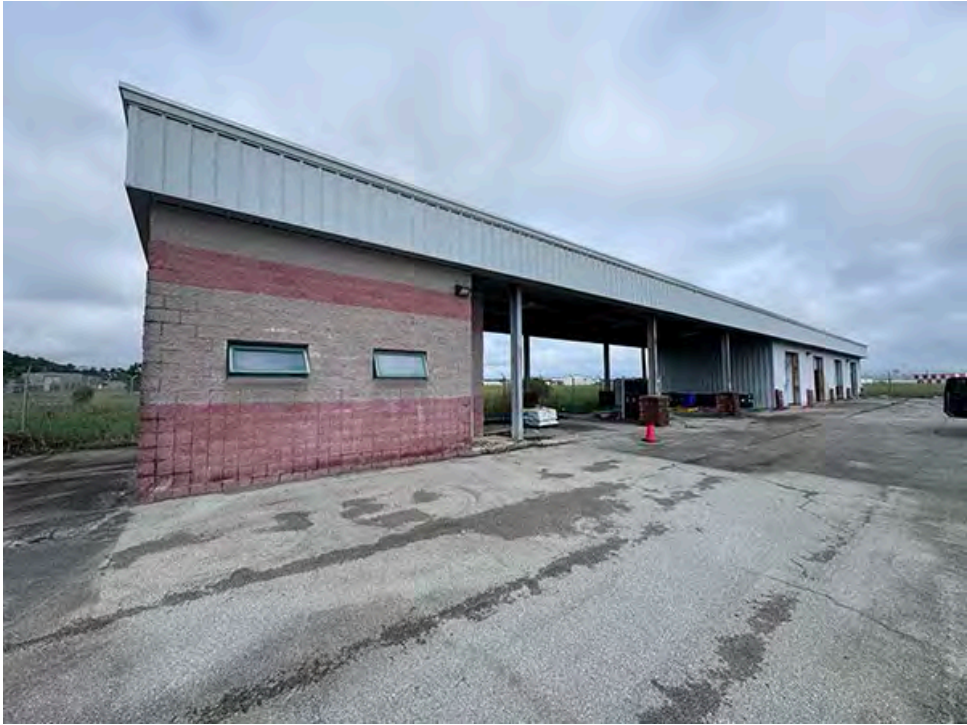
Building Description and Findings (Inspected 08-12-24)

Building AS3540 is a vacant storage building. The building is constructed with slab on grade, masonry bearing walls, steel structure, and a standing seam roof system.

Based on the sample analysis, the following materials were found to be Asbestos Containing Materials.

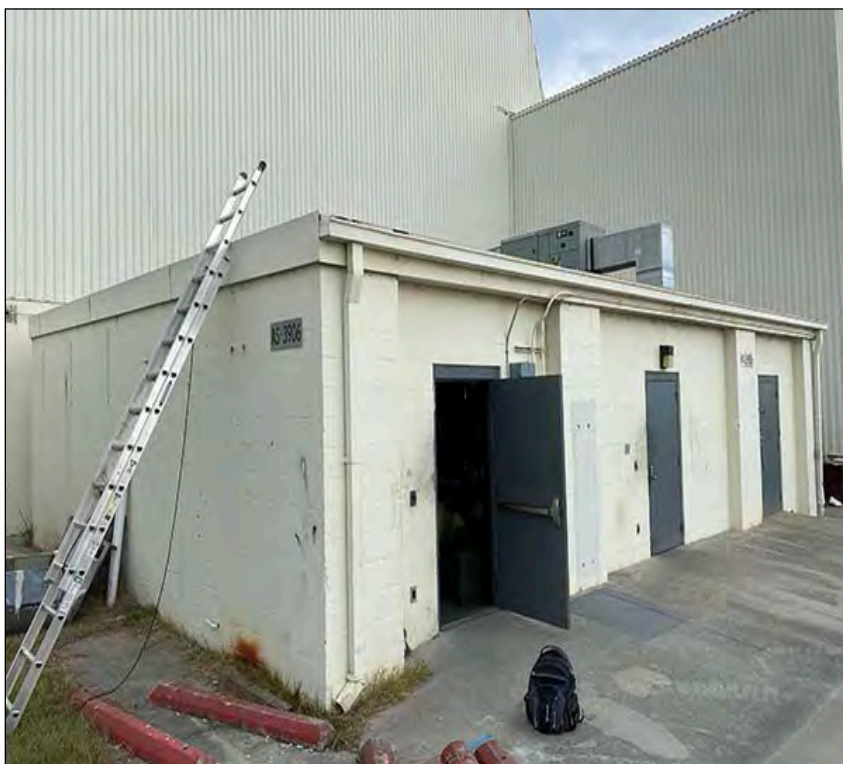
Building AS3906

Based on the sample analysis, none of the materials tested were found to be Asbestos Containing Materials.

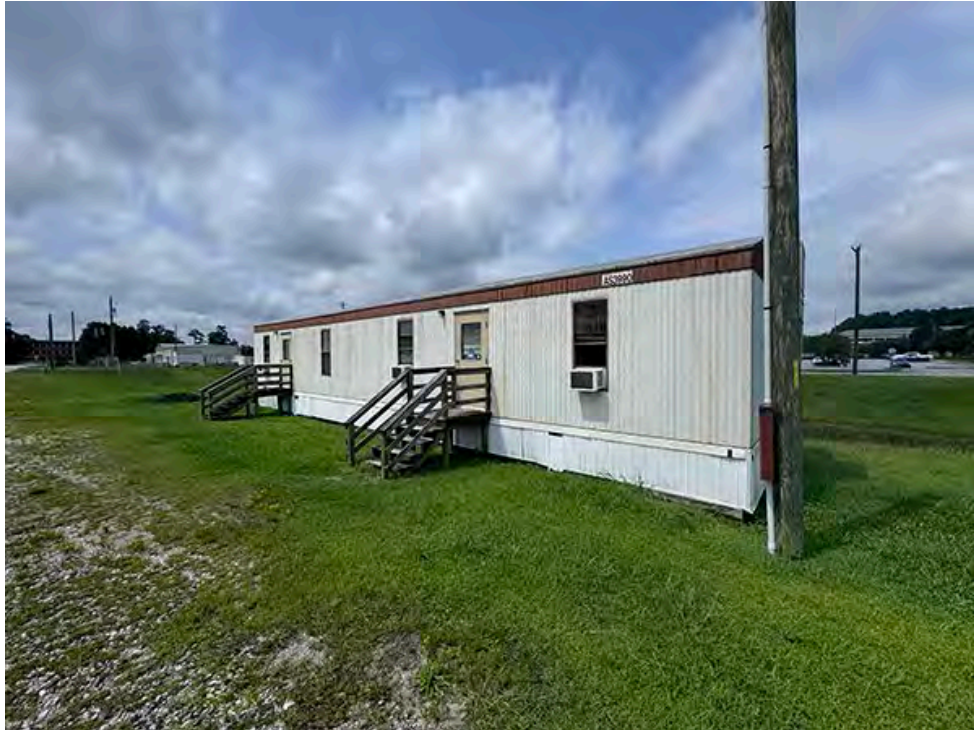
Building AS3990 is a temporary modular office. The building is constructed with wood wall framing, metal siding, and rubber roof system. The interior has VCT flooring, gypsum board walls and ceilings and a forced air mechanical system.

Based on the sample analysis none of the materials sampled were found to be Asbestos Containing Materials

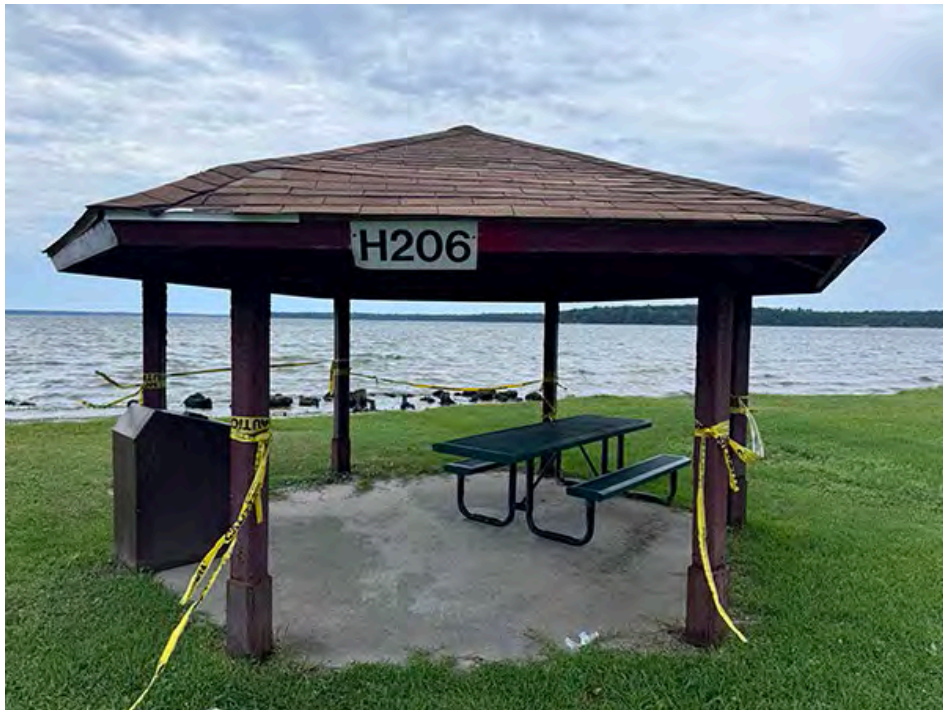
Structures H206, H207, H208, H209

Structures H206, H207, HG208, H209 are identical storage shelters with steel and wood framing, concrete slab, and asphalt shingle roof systems.

Based on the sample analysis none of the materials sampled were found to be Asbestos Containing Materials

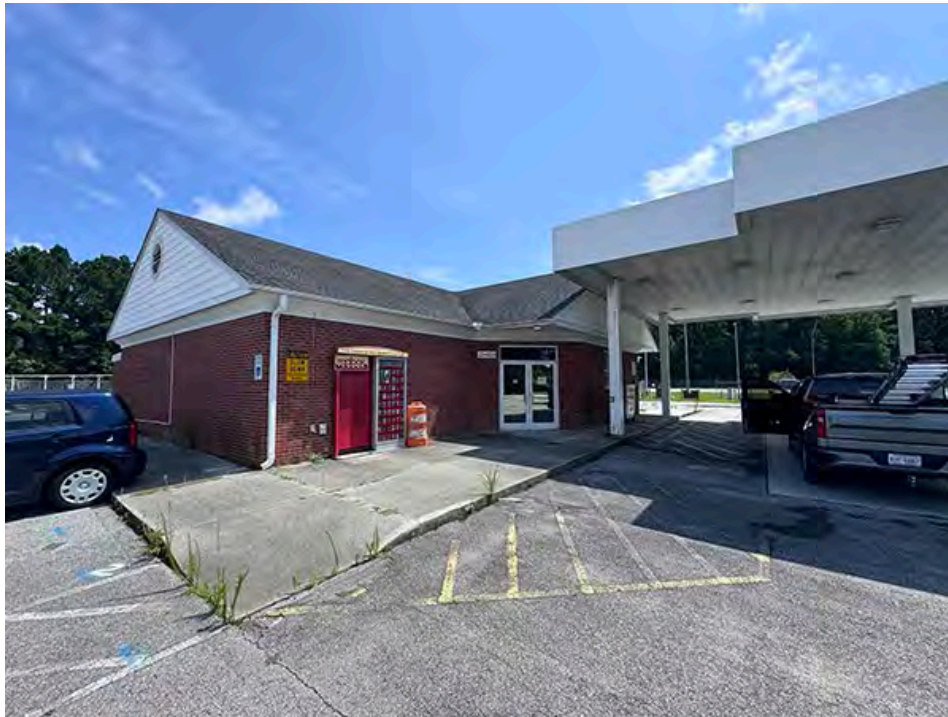
Building LCH4034 is a vacant gas station. The building is constructed with brick exterior walls and interior wood/metal framing, vinyl siding, and asphalt shingle roof. The interior has VCT flooring, gypsum board walls and acoustical ceilings and a forced air mechanical system.

Based on the sample analysis none of the materials sampled were found to be Asbestos Containing Materials

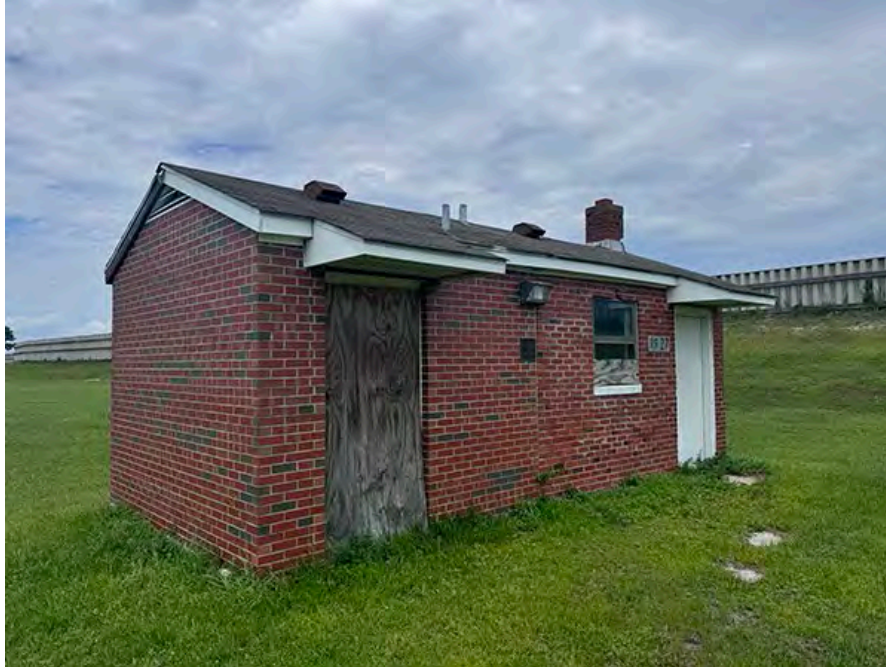
Building RR27 is a vacant head structure. The building is constructed with a slab on grade, wood wall and roof framing, asphalt shingle roof, and wood/gypsum board interior walls.

Based on the sample analysis, none of the sampled materials were found to be Asbestos Containing Materials.

Materials found to contain asbestos in the current inspection report and government provided inspection report should all be considered for the purpose of any demolition/renovation activities and disturbance. See Appendix for Government provided reports.

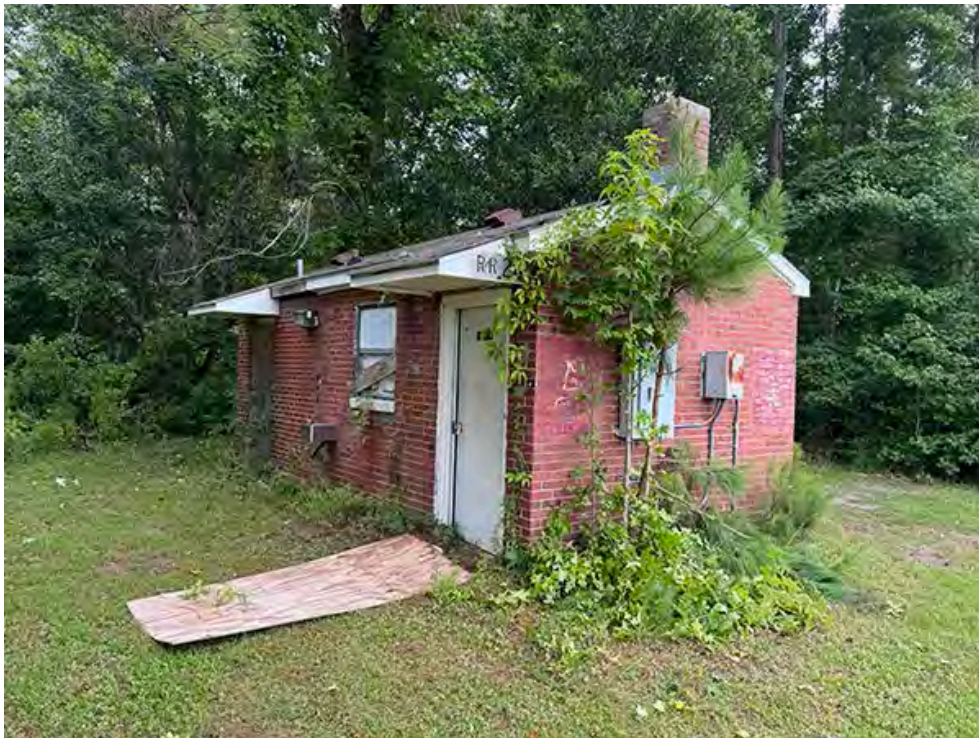
Building Description and Findings (Inspected 07-18-24)

Building RR28 is a vacant head structure. The building is constructed with a slab on grade, wood wall and roof framing, asphalt shingle roof, and wood/gypsum board interior walls.

Based on the sample analysis, none of the sampled materials were found to be Asbestos Containing Materials.

ACM Materials found in previous government provided report:
-Exterior caulking at door perimeter (under existing) - 15LF

Materials found to contain asbestos in the current inspection report and government provided inspection report should all be considered for the purpose of any demolition/renovation activities and disturbance. See Appendix for Government provided reports.

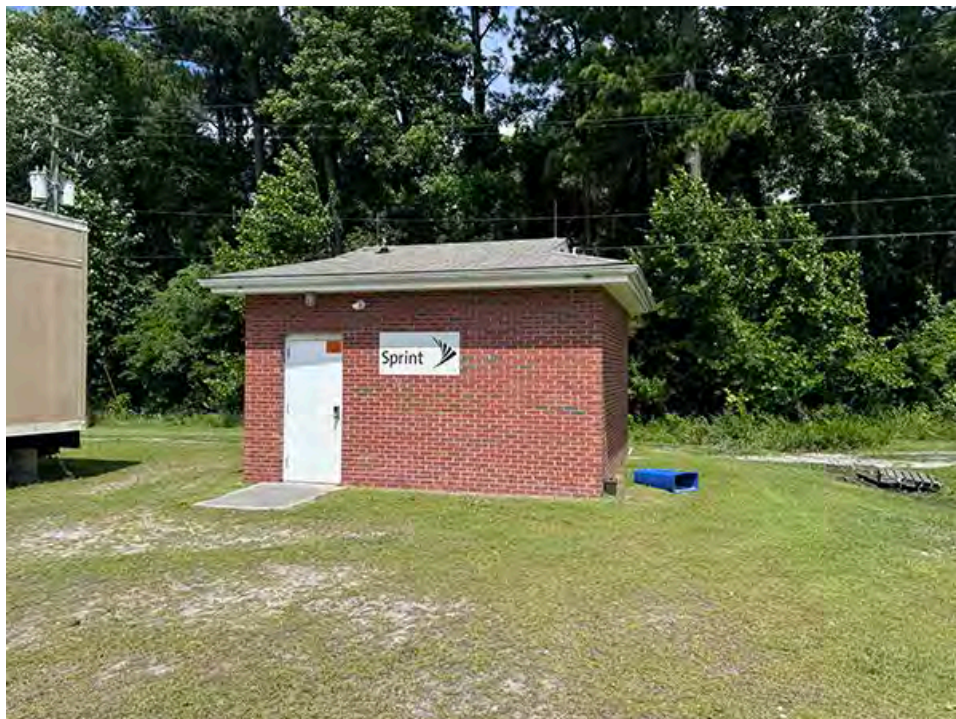
Building Description and Findings (Inspected 07-18-24)

Building RR108 is a vacant telecom structure. The building is constructed with a slab on grade, wood wall and roof framing, asphalt shingle roof, and wood/gypsum board interior walls.

Based on the sample analysis, the following materials were found to be Asbestos Containing Materials.

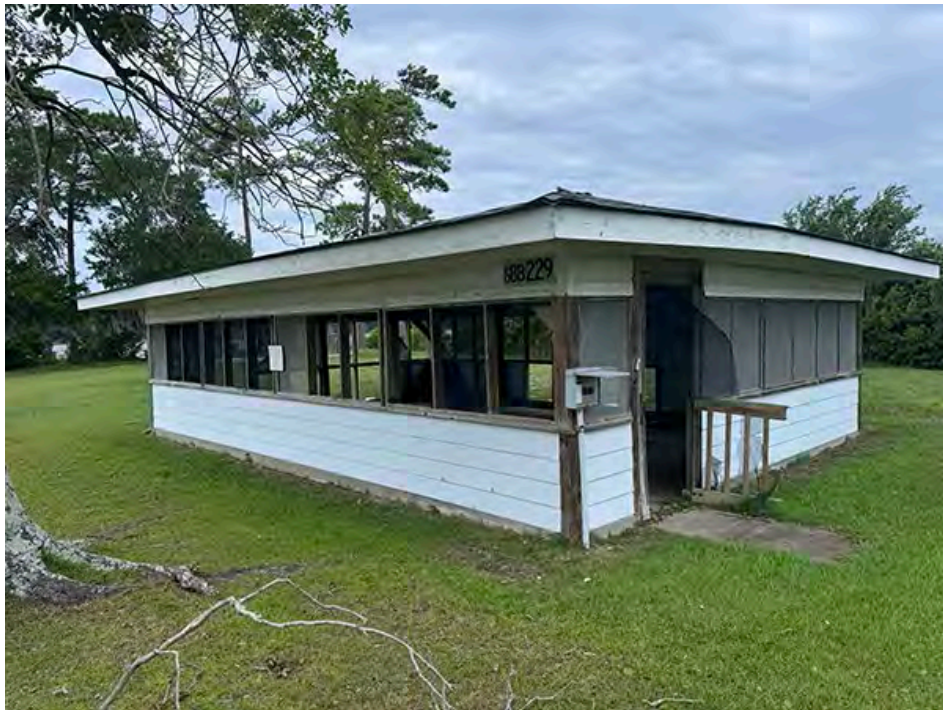
Building SBB229 is an abandoned shelter structure. The building consists of a concrete slab on grade, wood wall and roof structure, and asphalt shingle roof.

Based on the sample analysis none of the materials sampled were found to be Asbestos Containing Materials

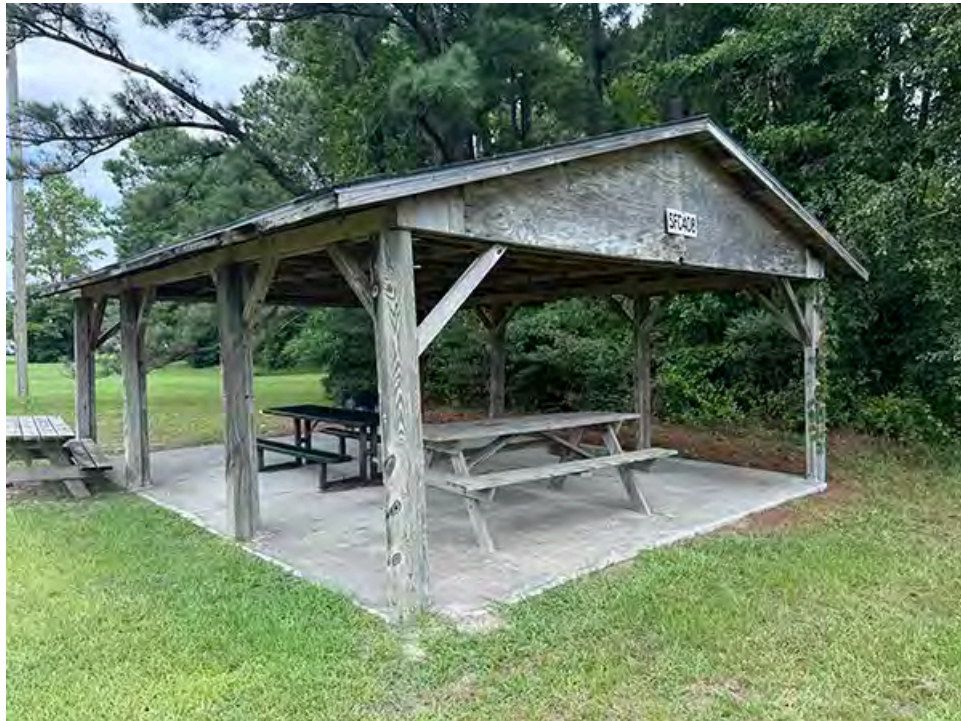
Structure SFC408 is a shelter structure. The structure consists of a concrete slab on grade, wood structure, and asphalt shingle roof.

Based on the sample analysis none of the materials sampled were found to be Asbestos Containing Materials

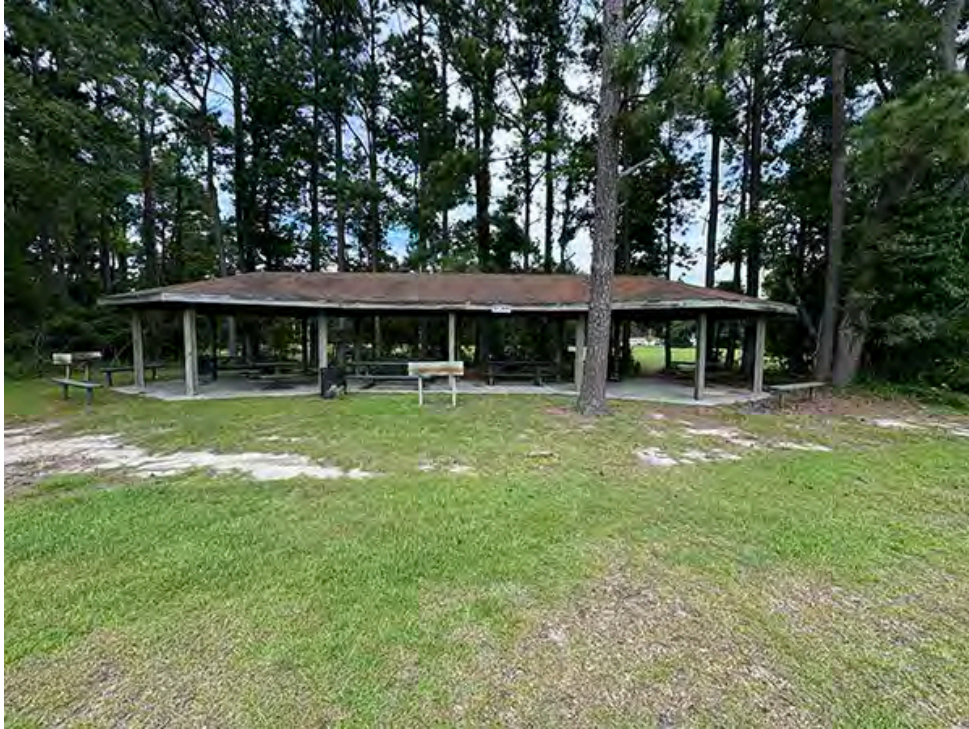
Structure SFC499 is a shelter structure. The structure consists of a concrete slab on grade, wood structure, and asphalt shingle roof.

Based on the sample analysis none of the materials sampled were found to be Asbestos Containing Materials

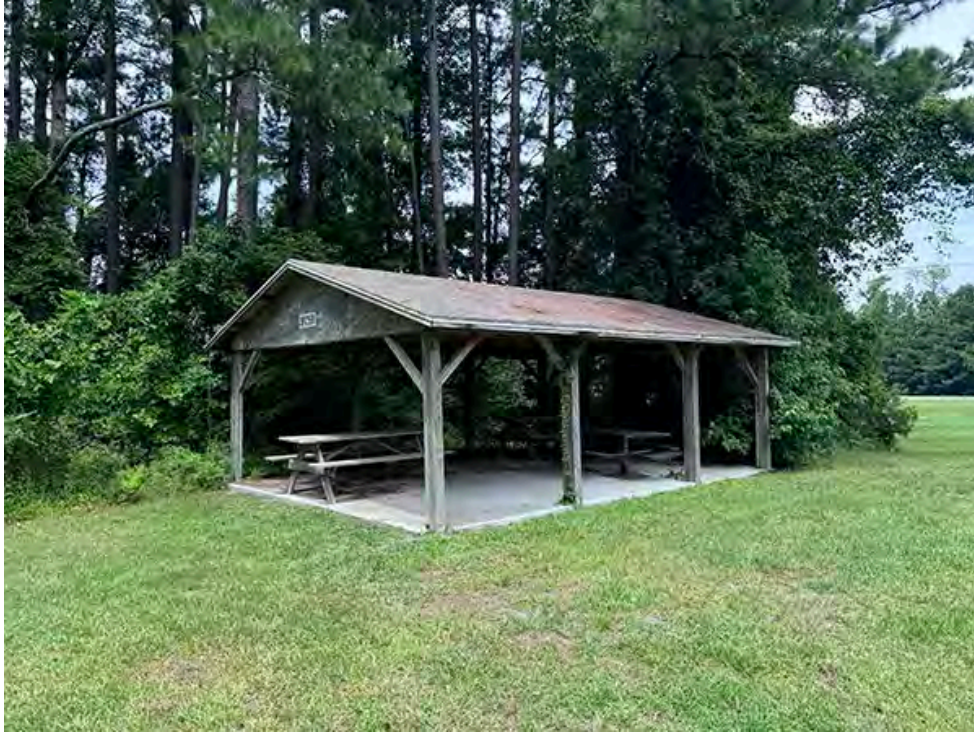
Structure SFC581 is a shelter structure. The structure consists of a concrete slab on grade, wood structure, and asphalt shingle roof.

Based on the sample analysis none of the materials sampled were found to be Asbestos Containing Materials

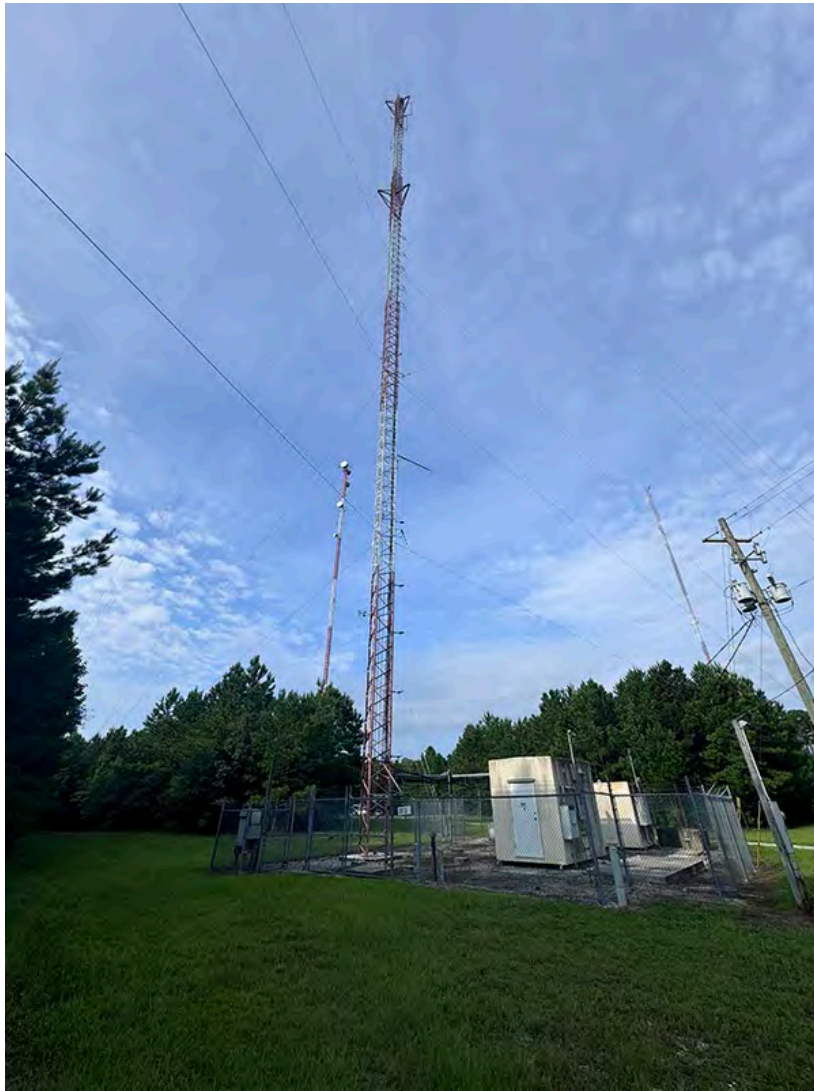
Structure ST13 is a decommissioned communication tower. The structure consists of a concrete foundation and steel tower and miscellaneous steel storage structures within the perimeter fencing.

Based on the sample analysis none of the materials sampled were found to be Asbestos Containing Materials.
