Asbestos Survey

IR Demo Package FY24
MCB Camp Lejeune
Project # 23-0036

Report Prepared By:
Christopher B. Walker
The Walker Group Architecture, Inc
August 11th, 2024
WGA Project No. – 2402.FY24

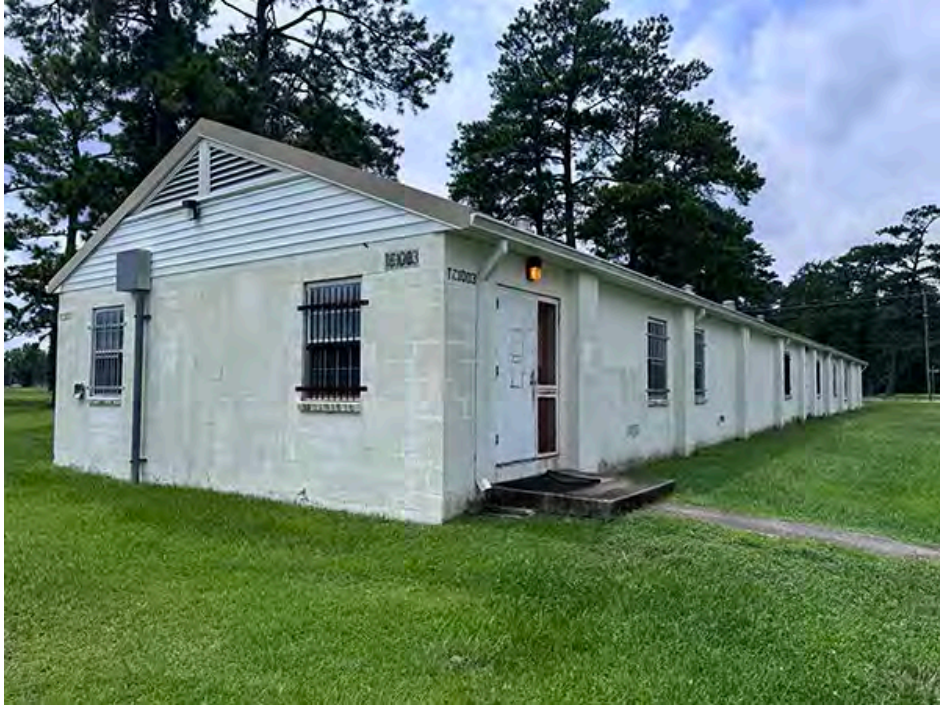
Building Description and Findings (Inspected 08-12-24)

Building TC1003 is a vacant office building. The building is constructed with concrete foundation, CMU exterior walls, metal stud interior walls with gypsum board. The building has an standing seam metal roof system. HVAC is provided through a forced air mechanical system.

Based on the sample analysis, the following materials were found to be Asbestos Containing Materials.

Materials found to contain asbestos in the current inspection report and government provided inspection report should all be considered for the purpose of any demolition/renovation activities and disturbance. See Appendix for Government provided reports.

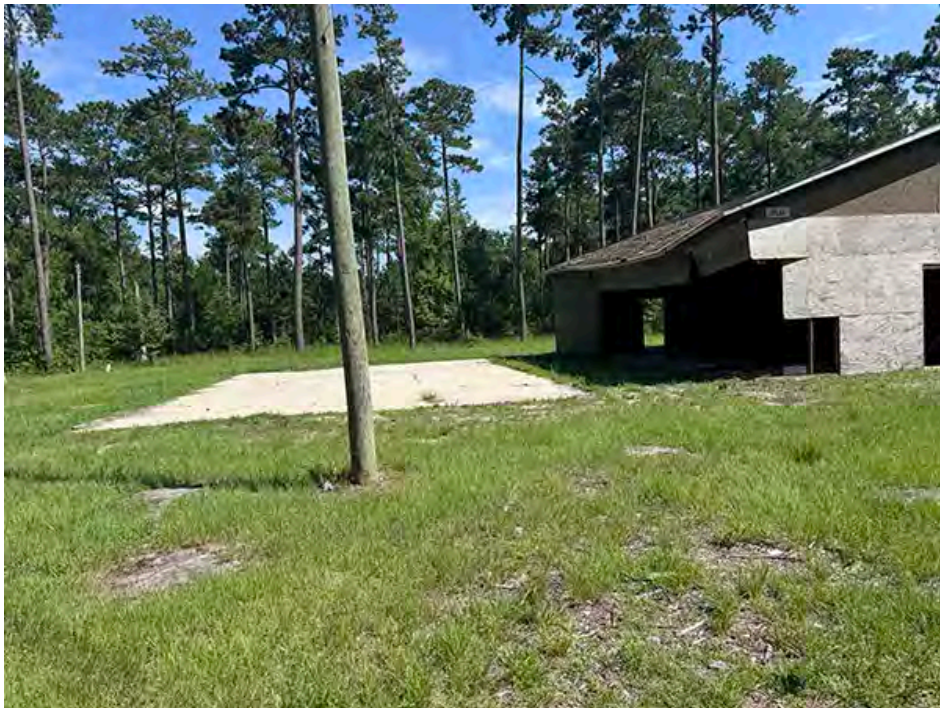
Structure VL61 is a shelter structure. The structure consists of a concrete slab on grade, wood structure, and asphalt shingle roof.

Based on the sample analysis none of the materials sampled were found to be Asbestos Containing Materials
