B109 USO  
Fort Moore

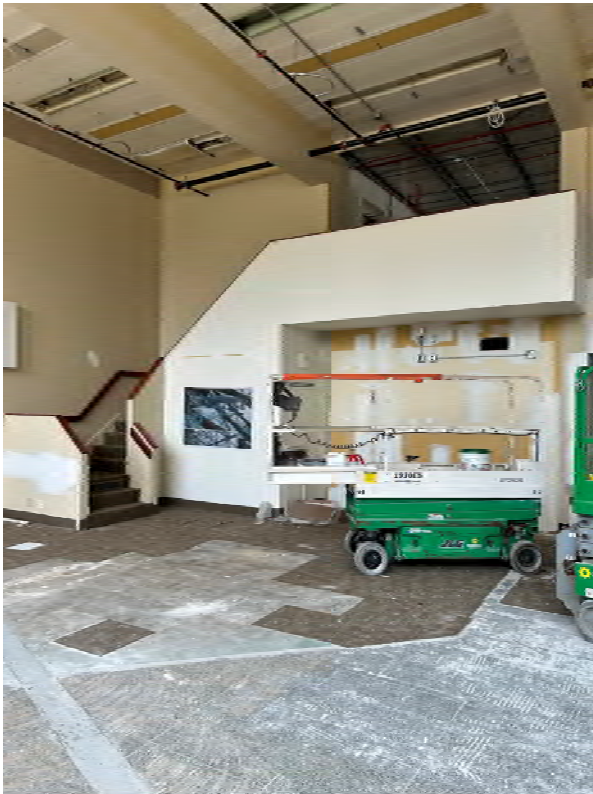
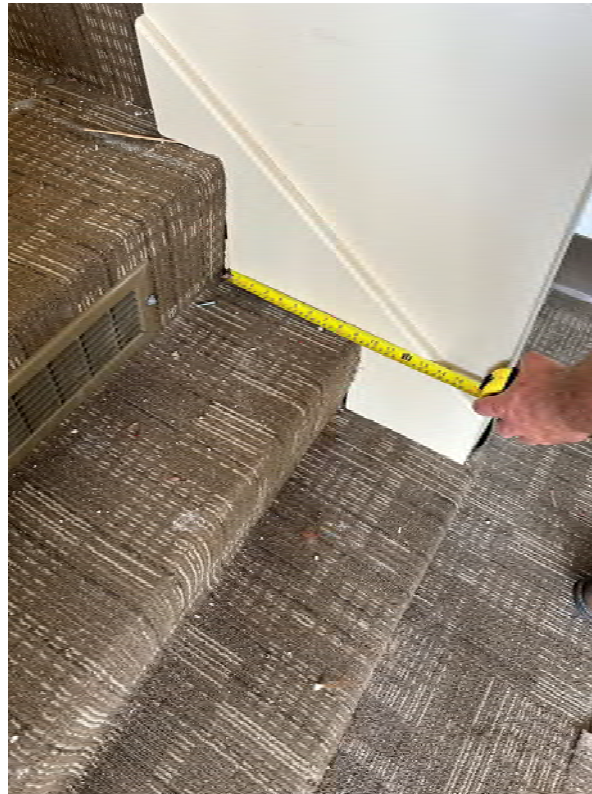
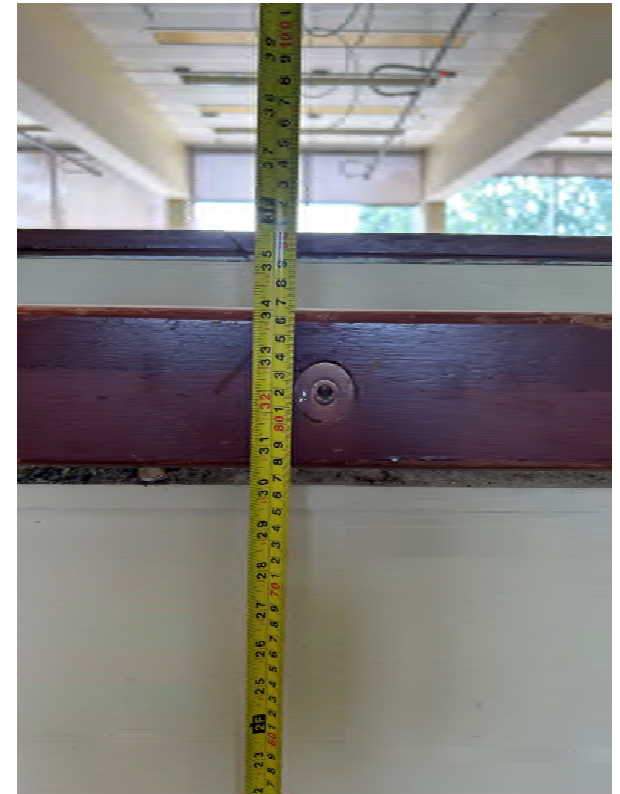
Open Stair behind Reception 101:

1. The handrails and knee wall are below the min. required height.

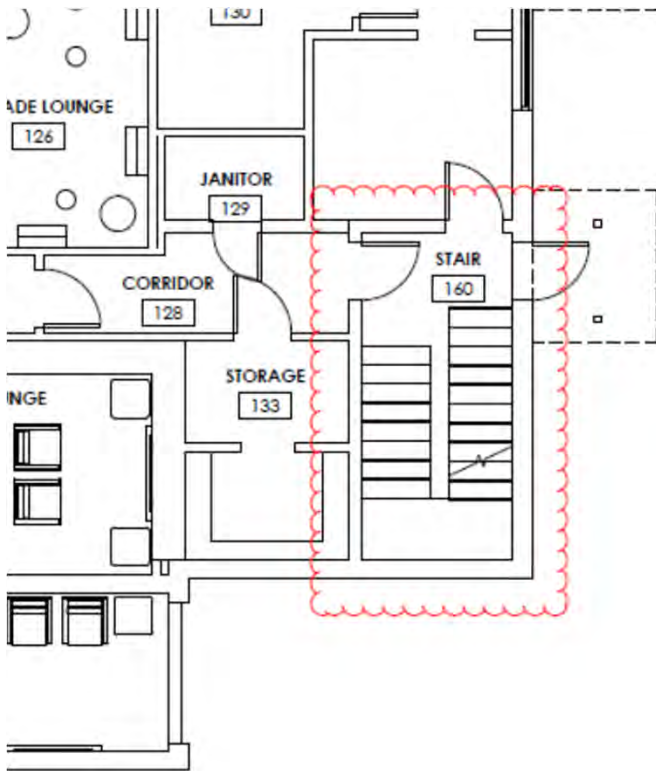
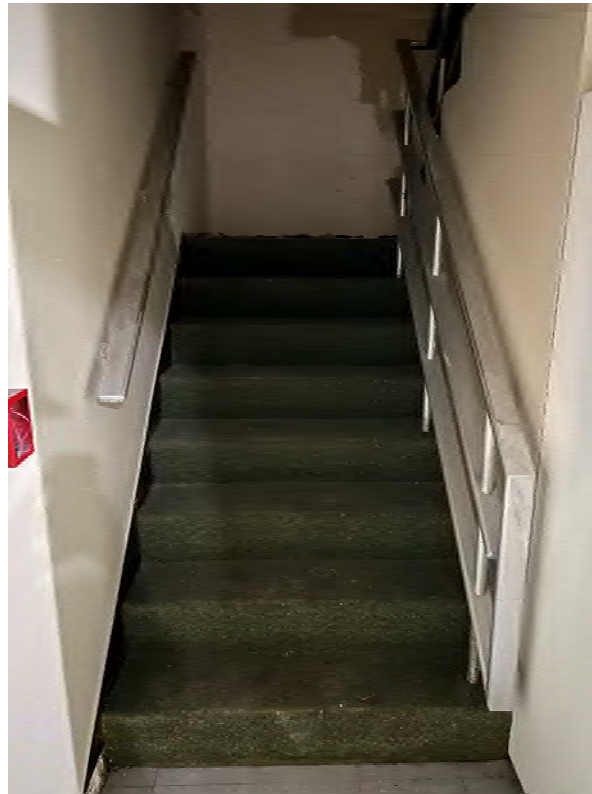
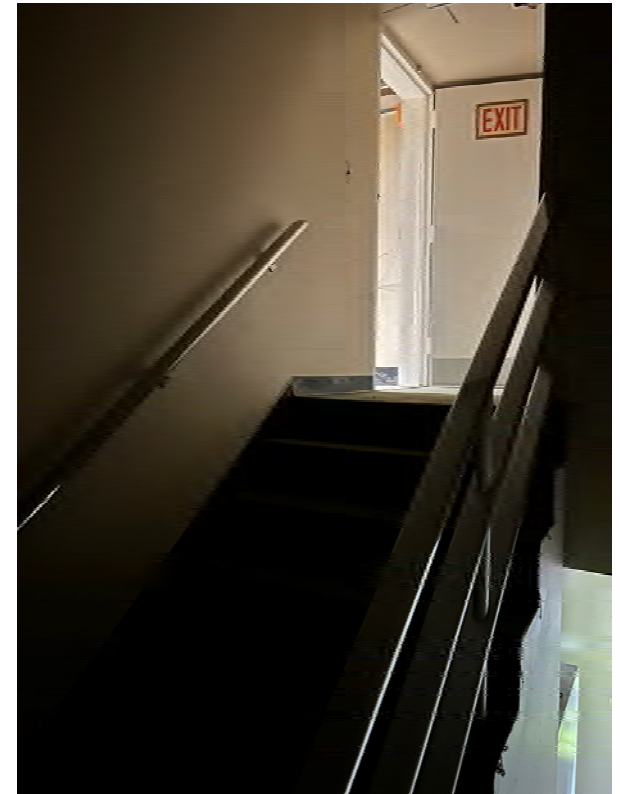
Stair 160:

1. Handrailing below the min. requirements for the overall design.
2. Neither of the entry/exit doors are labeled as fire rated.

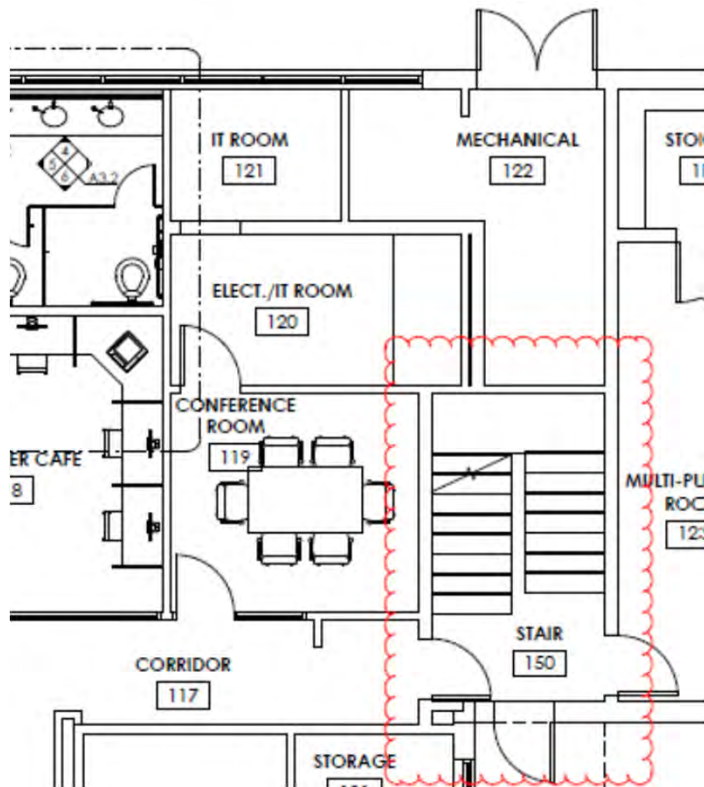
Stair 150:

1. Width of stairs are less than 36" wide
2. Handrailing below the min. required height and open guards exceed 4" allowing a 4-inch sphere to pass through.
3. A built-in custom wood cabinet was installed on the landing of the stair years ago. The landing dimensions are not compliant.
4. The top riser is 10" and the bottom riser is 3".
5. The stairwell is not fully rated 1 hour:
  - a. Neither of the entry/exit doors are labeled as fire rated. One door is wood with a vision panel at second floor.
  - b. The CMU walls do not extend to the underside of the roof decking.
